COLORADO CULTURAL RESOURCE SURVEY

Architectural Inventory Form

- 1. Resource number: **5SM.1560**
- 2. Temporary resource number: **N/A**
- 3. County: **San Miguel**
- 4. City: **Telluride**
- 5. Historic Building Name: **House**
- 6. Current Building Name: **House**
- 7. Building Address: **320 W. Colorado Avenue**
- 8. Owner Name and Address: **El Prado Properties Ltd. No. II
c/o SNIP 321 Cleveland Ct
San Antonio, TX 78209**

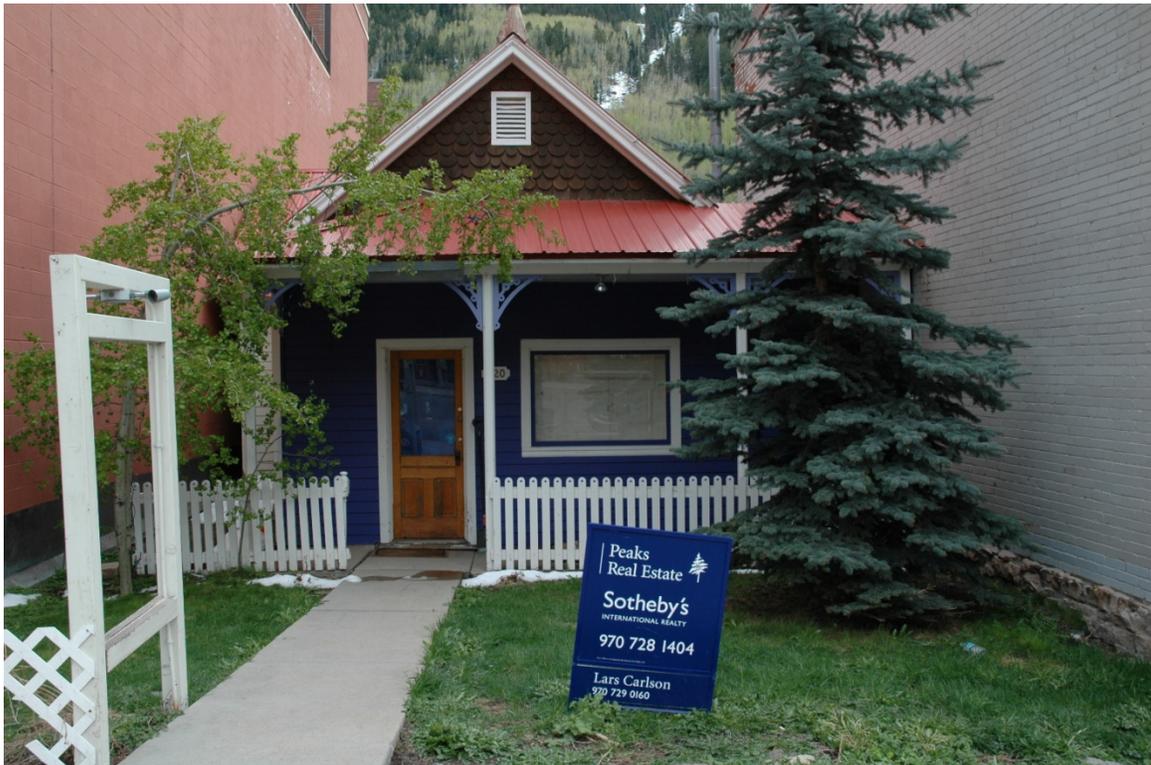
21. General architectural description:
This single story wood frame dwelling is located on the south side of W. Colorado Avenue, set back from the street between the enlarged Elks Building to the east and the Tomboy Gold Mines Company Office Building to the west. A small nonhistoric connecting element extends the dwelling's façade to the east wall of the Tomboy Gold Mines Office Building. The house features a cross-gabled plan, with painted deep blue horizontal wood siding on the facade (north elevation), and painted white horizontal wood siding on the secondary elevations, with painted white 1" by 4" corner boards. Stained dark brown fish scale shingles appear in the facade's upper gable end, however. The cross-gabled roof is moderately-pitched, and is covered with red metal roofing material. The eaves are boxed with painted white wood trim. Two tall red brick chimneys, with corbelled caps, are located on the roof ridges. A stained natural brown wood-paneled front door, with one upper sash light, enters the house from the front porch which extends across the full width of the facade. The porch features a concrete floor, a low painted white picket fence rail, bracketed, painted white, chamfered columns, and a shed roof. The facade wall is penetrated by a single-light fixed-pane window, which is probably not original.

- There are two small additions to the south (rear) elevation. One is a historic shed-roofed addition, of wood frame construction. This addition's walls are clad with rolled asphalt siding with a faux brick pattern. A set of eight wooden steps leads to a white metal-paneled door on this addition's south elevation. The other addition is a non-historic shed-roofed and gable-roofed element of wood frame construction, with stained natural brown horizontal wood siding. This addition is penetrated by a 2-light metal-framed window.**
