COLORADO CULTURAL RESOURCE SURVEY

Architectural Inventory Form

- 1. Resource number: **5SM.1601**
- 2. Temporary resource number: **N/A**
- 3. County: **San Miguel**
- 4. City: **Telluride**
- 5. Historic Building Name: **Unknown**
- 6. Current Building Name: **McClure House**
- 7. Building Address: **411 W. Colorado Avenue**
- 8. Owner Name and Address: **Joe and Gail McClure
872 Preston Rd
Cataula, GA 31804**

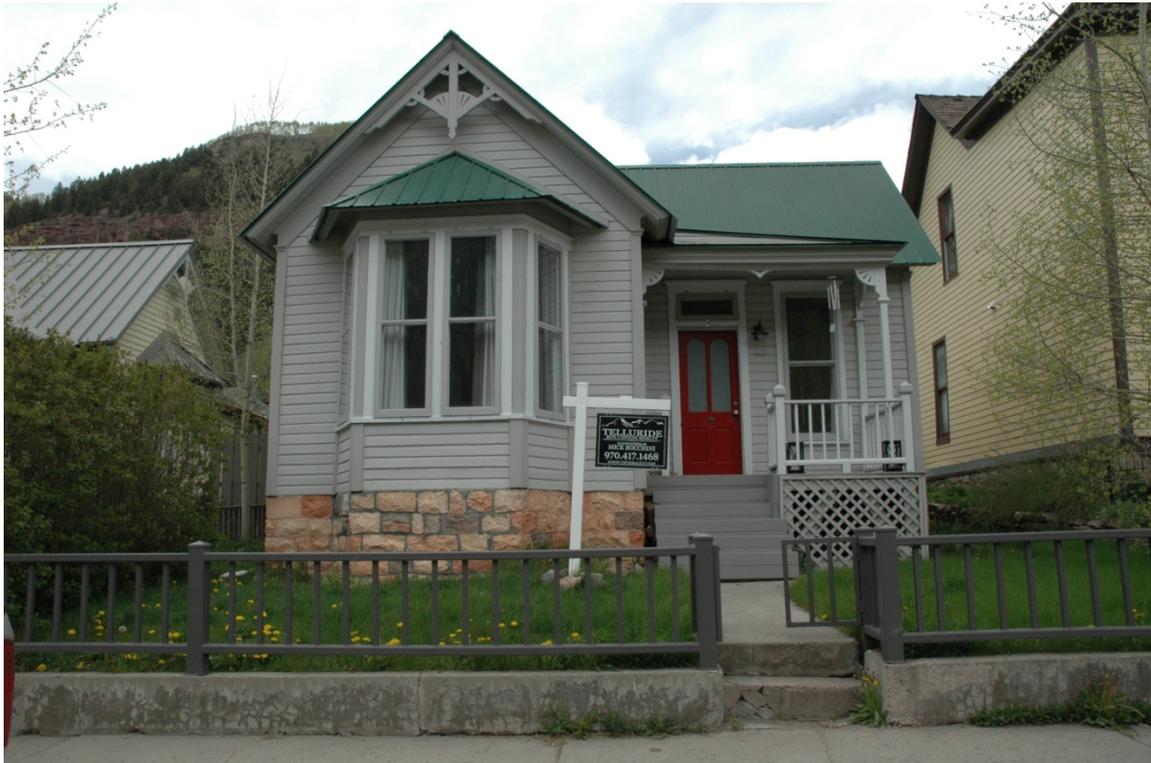
18. Roof configuration: **Gabled Roof/Cross Gabled Roof**
19. Primary external roof material: **Metal Roof**
20. Special features: **Porch**
21. General architectural description:
This single-story, wood frame, dwelling measures 49' N-S (deep) by 26' E-W (across). It is supported by a low, unpainted, coursed sandstone foundation, and its exterior walls are clad with painted pale grey horizontal weatherboard siding with 1" by 4" corner boards. The house is covered by a cross gable roof, with green metal roofing material, and with painted grey boxed eaves. The house features an asymmetrical façade which faces toward Colorado Avenue on the south elevation. Two historic wood-paneled doors enter the house from an open front porch at the east end of the façade. Both of these doors are topped by transom lights, and each has two vertically-oriented upper sash lights with rounded tops. The porch is approached by five wooden steps, and features a non-historic painted white open wood railing, painted white chamfered wood posts with incised brackets, and a shed roof. A 1/1 double-hung sash window overlooks the front porch to the east of the entry doors. A canted hip-roofed bay, with four narrow 1/1 double-hung sash windows, dominates the façade wall to the west of the porch. A distinctive pierced gable ornament is located in the façade's upper gable end, directly above the bay. Windows on the home's secondary elevations are predominantly single and paired 1/1 double-hung sash with painted wood frames and surrounds. The original building appears to have been extended to the rear (north) elevation by a low-profile gabled addition. A wood-paneled door enters this portion of the house near the north end of the east elevation. Another entry door, with a storm door, enters the addition's north elevation from a "Trex" type deck. This door is topped by a transom light, and is flanked on either side by an awning type window.
