COLORADO CULTURAL RESOURCE SURVEY

Architectural Inventory Form

I. IDENTIFICATION

- 1. Resource number: **5SM.1600/THAS51**
- 2. Temporary resource number: **N/A**
- 3. County: **San Miguel**
- 4. City: **Telluride**
- 5. Historic Building Name: **Unknown**
- 6. Current Building Name: **Cusack House**
- 7. Building Address: **417 W. Colorado Avenue**
- 8. Owner Name and Address: **Rosemary Cusack  
P. O. Box 892  
Telluride, CO 81435-0892**

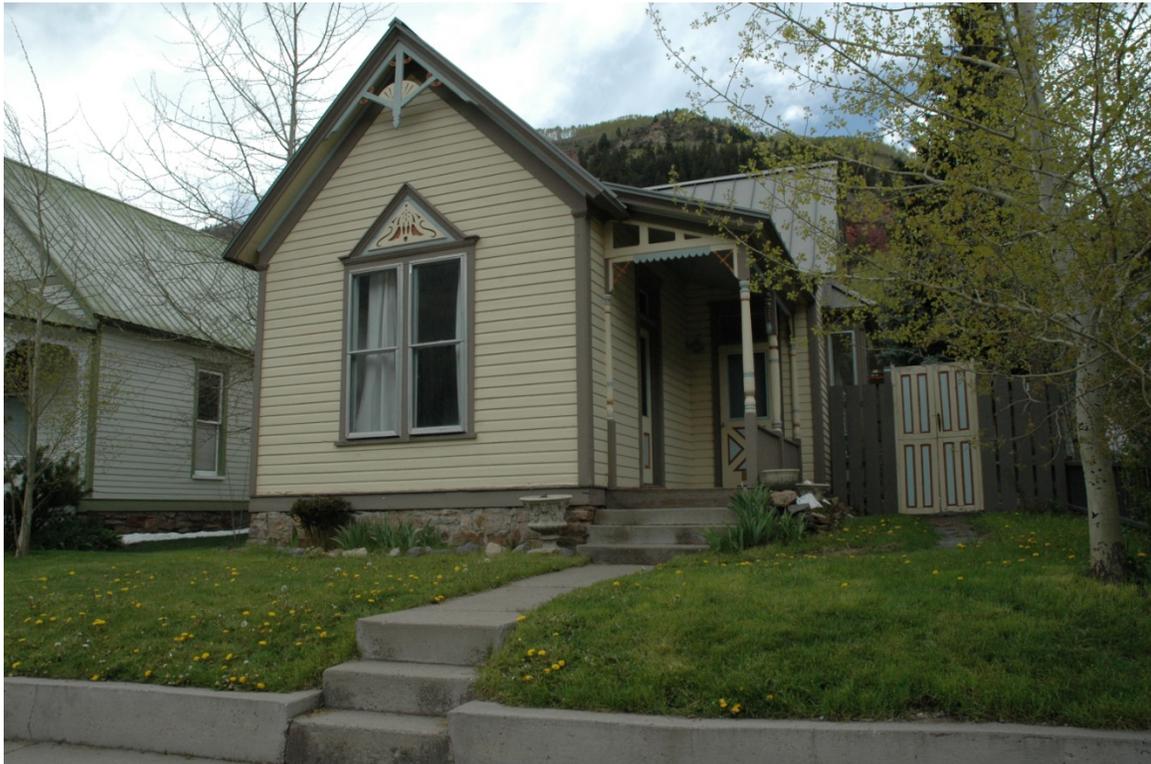
**Ornamentation/Decorative Shingles**
21. General architectural description:  
**Dating from the early 1890s, this single-story, wood frame, dwelling is supported by a low, uncoursed, sandstone foundation, and its exterior walls are clad with painted cream yellow horizontal weatherboard siding with painted beige 1" by 4" corner boards. A painted beige 1" by 6" board with a narrow wood water table, separates the foundation from the weatherboard siding above. The original house featured a T-shape plan, and is covered with a steeply-pitched cross gable roof. The roof is finished with metal roofing material, and the eaves are boxed with painted light blue and beige wood trim. A red brick chimney is located on the ridge. The house features an asymmetrical façade which faces toward Colorado Avenue on the south elevation. Two wood-paneled doors, each with an upper sash light and a transom light, enter the house from a 13' by 5' porch at the east end of the façade. The porch is approached by three concrete steps, and features a tongue-in-groove wood floor, an open wood balustrade, turned columns with brackets, a sawtooth frieze, and a shed roof. A set of paired 1/1 double-hung sash windows, with painted blue wood frames, painted beige wood surrounds, and with a distinctive pierced pediment, penetrates the façade wall to the west of the porch. A distinctive, pierced, gable ornament is located in the façade's upper gable end, directly above these windows. Two non-historic awning type windows are located on the west (side) elevation. A canted hip-roofed bay is located near the south (front) end of the east elevation. An older (but apparently post 1922) enclosed gabled porch addition has been built onto the west end of the north (rear) elevation. A 10-light glass-in-wood-frame door enters the addition on its north elevation. Another glass-in-wood-frame door enters the rear of the original building from a deck/patio.**
