COLORADO CULTURAL RESOURCE SURVEY

Architectural Inventory Form

- 1. Resource number: **5SM.1562**
- 2. Temporary resource number: **N/A**
- 3. County: **San Miguel**
- 4. City: **Telluride**
- 5. Historic Building Name: **Unknown**
- 6. Current Building Name: **Bocchini House**
- 7. Building Address: **420 W. Colorado Avenue**
- 8. Owner Name and Address: **1978 Trust LLC c/o Michael Bocchini
522 Virginia Street No. 4
Dunedin, FL 34698**

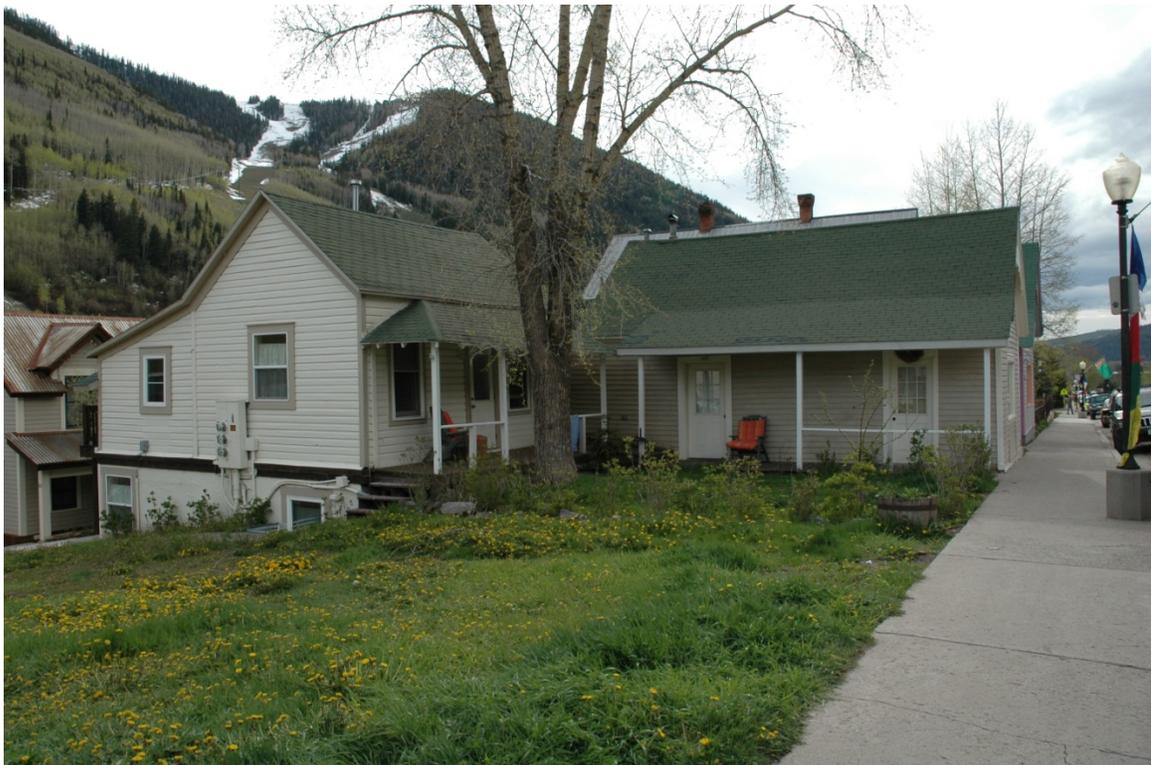
21. General architectural description:
This is a 1 ½-story wood frame dwelling which is supported by a low foundation which is covered by painted white concrete pargeting. (Previous survey forms indicate that the foundation is made of concrete blocks; however, this was not independently confirmed.) The house's exterior walls are clad with painted cream white horizontal wood siding, with 1" by 4" corner boards. The roof is a moderately-pitched side gable, with a shed-roofed and gable-roofed rear addition. The roof is covered with green asphalt shingles, and the eaves are boxed. The facade, which fronts to Colorado Avenue on the north elevation, is nearly symmetrical. A painted cream white wood-paneled front entry door, with one upper sash light, is flanked on either side by a 1/1 double-hung sash window. The front entry door enters the dwelling from a full-width front porch which features a wood plank floor, painted cream white 4" by 4" wood posts, and a low-pitched hipped roof. The east (side) elevation is penetrated by two 1/1 double-hung sash first story windows, and by two 1/1 double-hung sash basement level windows. Windows on the west (side) elevation include: a 1/1 double-hung sash window located in the upper gable end; a casement type window, near the south end of the first story; and a 1/1 double-hung sash basement level window.

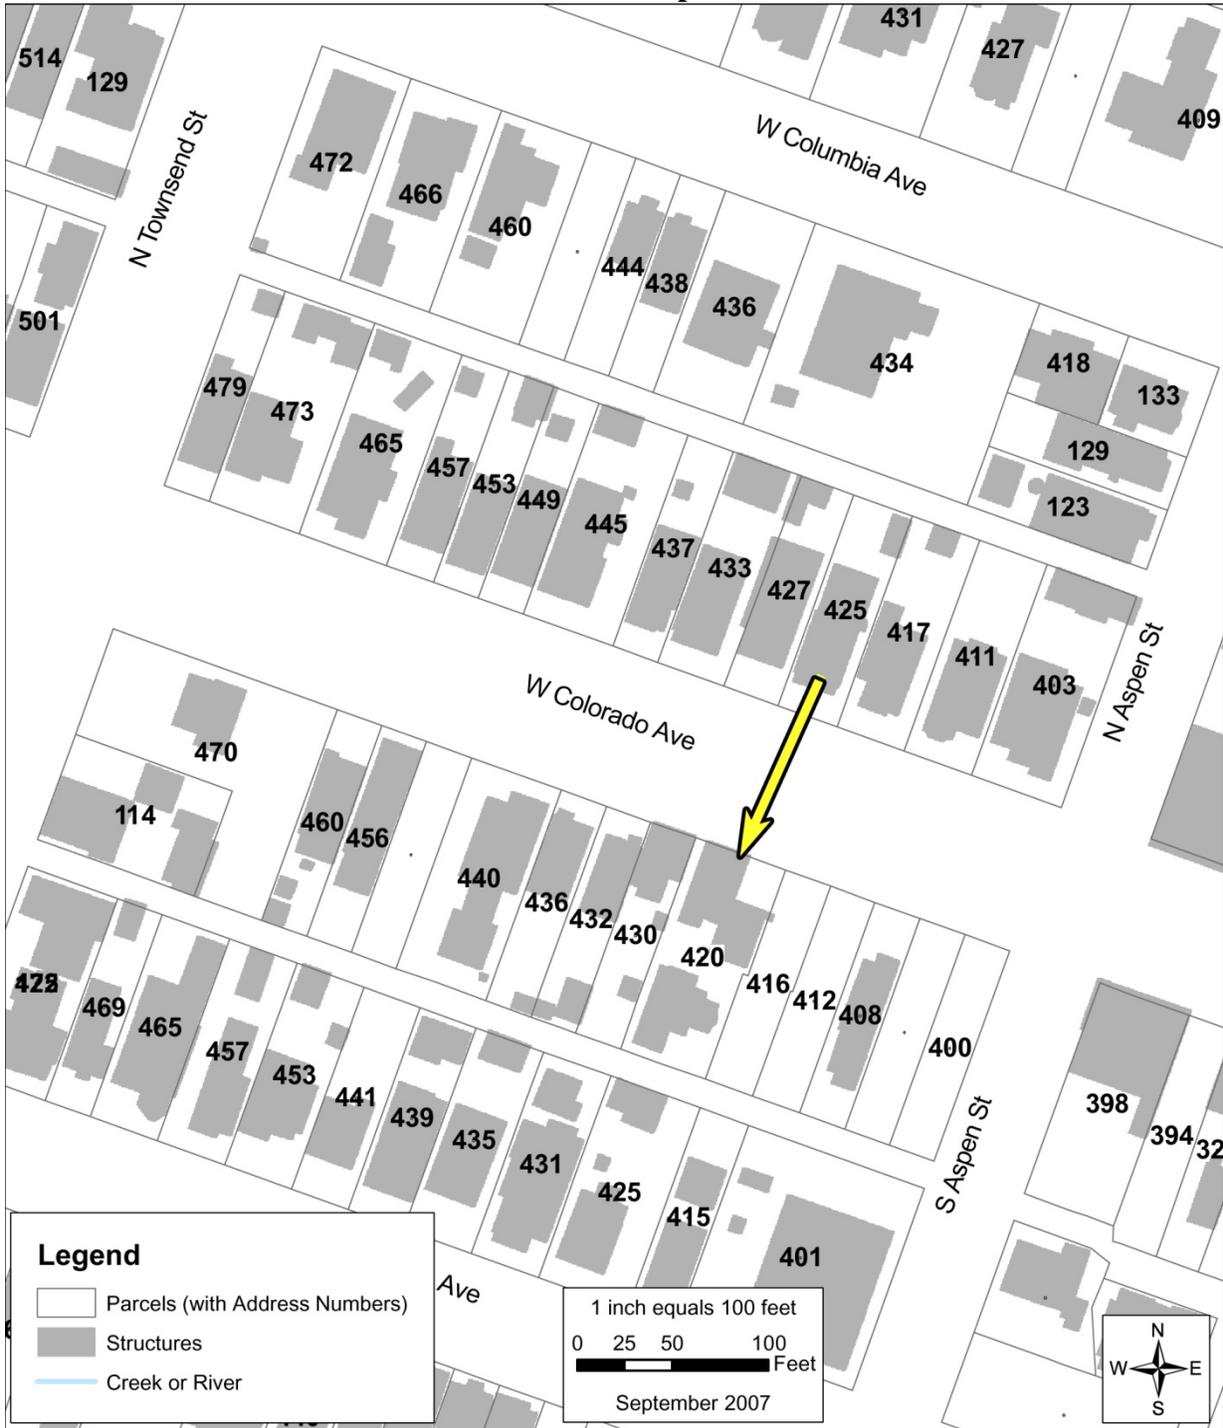
Sketch Map

A non-historic dwelling, with the address of 422 Colorado Avenue is located behind both this house and the house next door to the west at 424 W. Colorado Avenue.

Secondary Residence
A non-historic secondary residence is located behind this dwelling and the dwelling at 424 W. Colorado Avenue, next door to the west.
