COLORADO CULTURAL RESOURCE SURVEY

Architectural Inventory Form

- 1. Resource number: **5SM.1599/THAS50**
- 2. Temporary resource number: **N/A**
- 3. County: **San Miguel**
- 4. City: **Telluride**
- 5. Historic Building Name: **Unknown**
- 6. Current Building Name: **Dalton Brothers House**
- 7. Building Address: **425 W. Colorado Avenue**
- 8. Owner Name and Address: **Dalton Brothers of Telluride LLC
P. O. Box 982
Telluride, CO 81435-0982**

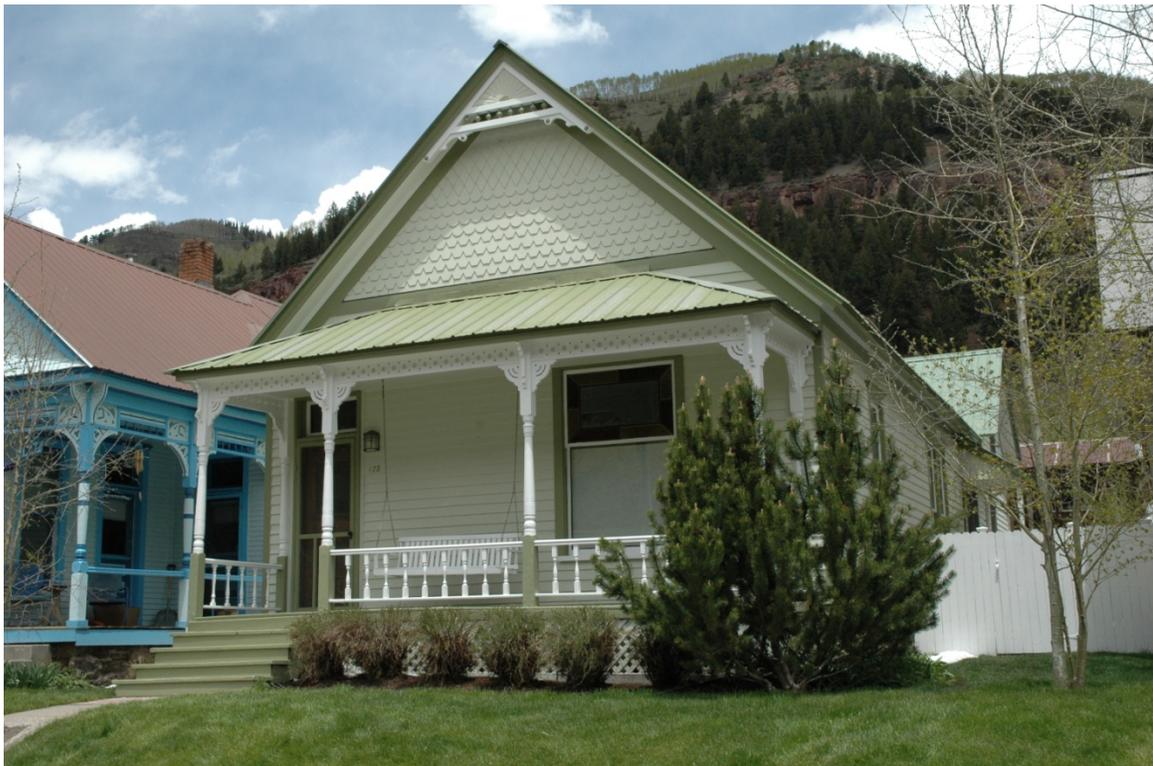
21. General architectural description:
This is a historic wood frame, front-gabled, dwelling, with a gabled addition to the north (rear) elevation. The original single-story house is supported by a low, uncoursed, stone foundation, and its exterior walls are clad with painted pale green horizontal wood siding with painted olive green 1" by 4" corner boards. A painted pale green 1" by 6" board with a wood water table, separates the foundation from the horizontal siding. Painted pale green variegated wood shingles, and a gable ornament, appear in the façade's upper gable end (south elevation). The house's front gable roof is steeply-pitched, and is covered with green metal roofing material. The eaves are boxed with painted pale green and olive green wood trim. The house features a distinctive stained natural brown wood-paneled front door, with a single light in its upper sash, scrollwork and an egg-and-dart motif in its top rail, and a dentil course and an egg-and dart motif in its locking rail. This door is also topped by a transom light, and is covered by a painted olive green wood storm door. It enters the west end of the façade from a nearly full-width front porch. Approached by four wooden steps at its west end, the porch features a tongue-in-groove wood floor, a painted white open wood balustrade with turned balusters, painted white turned columns with ornate brackets, and a low-pitched hip porch roof. A single-hung sash window, with stained glass upper sash lights, overlooks the front porch to the east of the entry door. Windows on the east and west (side) elevations are primarily single and paired 1/1 double-hung sash with painted white wood frames and painted pale green wood surrounds. The original rear portion of the house has been replaced by a circa 2002, approximately 25' N-S by 21' E-W, gabled addition. The gable roof over the addition is slightly lower than the roof over the original front part of the house. The entry door into the addition is located at the north end of the east elevation.
