COLORADO CULTURAL RESOURCE SURVEY

Architectural Inventory Form

- 1. Resource number: **5SM.1564**
- 2. Temporary resource number: **N/A**
- 3. County: **San Miguel**
- 4. City: **Telluride**
- 5. Historic Building Name: **House**
- 6. Current Building Name: **Miller House**
- 7. Building Address: **430 W. Colorado Avenue**
- 8. Owner Name and Address: **Coast Property Enterprises LLC
408 Alameda Ave
Half Moon Bay, CA 94019**

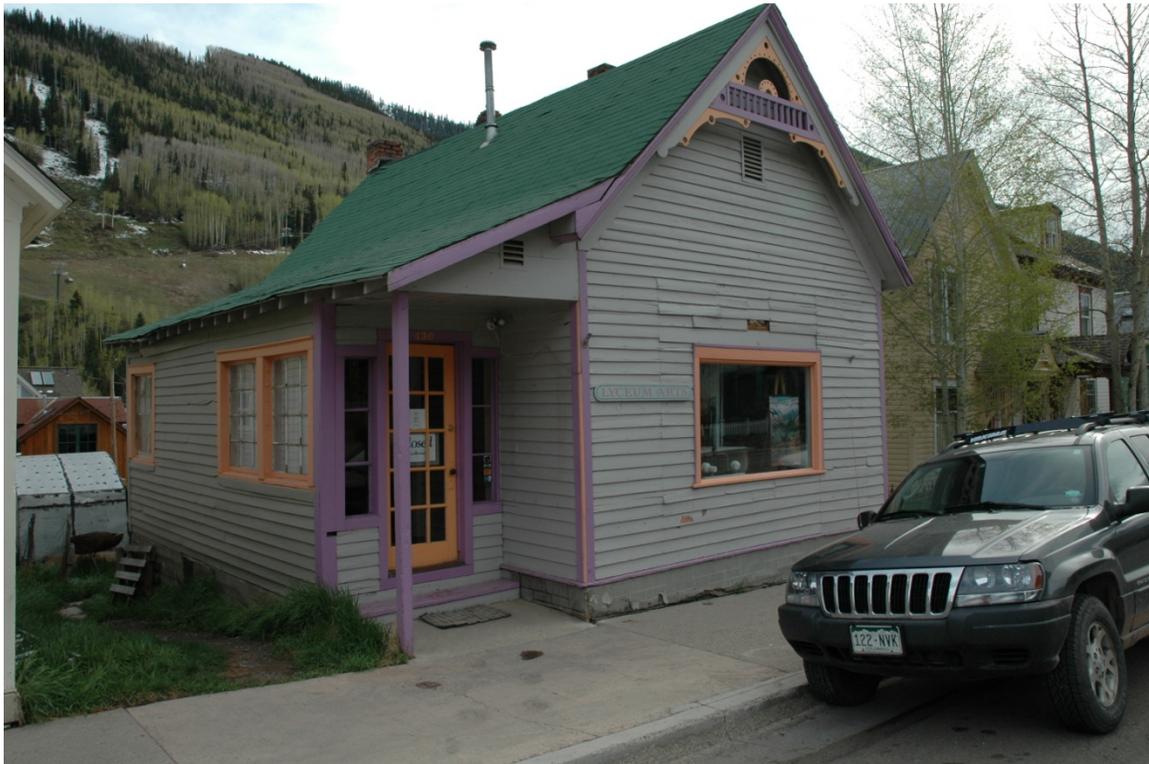
21. General architectural description:
This is a single story, wood frame, dwelling which fronts directly onto the concrete sidewalk paralleling Colorado Avenue on the north elevation. The foundation walls above grade are covered with rolled asphalt with a faux concrete block pattern. The house's exterior walls are clad with painted pale grey horizontal wood siding, with painted purple with orange trim 1" by 4" corner boards. A painted purple wooden water table separates the foundation from the horizontal wood siding. The house features an asymmetrical façade which fronts toward Colorado Avenue on the north elevation. Here, a painted orange, 15-light, glass-in-wood-frame door, with flanking sidelights, enters the dwelling from a from a shed-roofed entry porch at the east end of the façade. The front (south) end of the porch is open, while the rear portion, extending along the east (side) elevation, is enclosed. The house is covered by a steeply-pitched front gable roof, with green asphalt composition shingles laid over 1x wood decking and 2x wood rafters. The rafter ends are painted grey, and are exposed beneath the eave on the east elevation; the eave is boxed on the west elevation. A red brick chimney is located at the south (rear) end of the gable roof. A distinctive painted purple and orange gable ornament, with vergeboard, is located in the upper gable end on the façade (north elevation). A single-light, fixed-pane window penetrates the façade wall below the gable ornament. A single 1/1 double-hung sash window is located on the west elevation. The original dwelling has been extended to the rear (south elevation) by a hip-roofed addition. A set of ten wooden stairs leads to a painted white wood-paneled door, with one upper sash light, which enters the addition. The addition is also penetrated by two 2-light windows and by a 1/1 double-hung sash window.
