COLORADO CULTURAL RESOURCE SURVEY

Architectural Inventory Form

- 1. Resource number: **5SM.1597/THAS48**
- 2. Temporary resource number: **N/A**
- 3. County: **San Miguel**
- 4. City: **Telluride**
- 5. Historic Building Name: **Unknown**
- 6. Current Building Name: **Massa House**
- 7. Building Address: **433 W. Colorado Avenue**
- 8. Owner Name and Address: **Marsha Massa  
P. O. Box 873  
Telluride, CO 81435-0873**

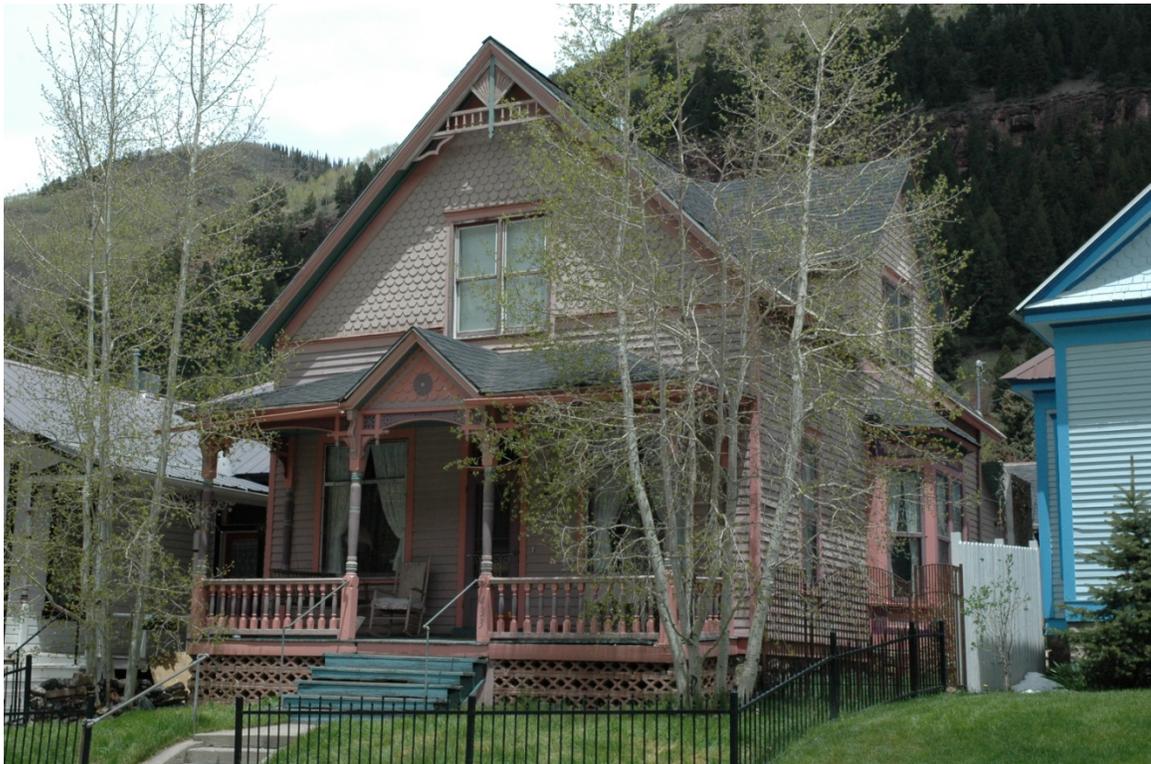
**Chimney**  
**Ornamentation/Decorative Shingles**  
**Fence**
21. General architectural description:  
**This is a 1.5-story, wood frame, late nineteenth century, dwelling. Overall, the house measures 58' N-S (deep) by 24' E-W (across). Included in these dimensions are: the main 1.5-story portion, which measures 44' N-S by 24' E-W; an enclosed single-story rear porch extension on the north (rear) elevation, which measures 8' N-S by 24' E-W; and an open front porch on the façade (south elevation), which measures 6' N-S by 22' E-W. Not included is a canted hip-roofed bay window on the east elevation. The dwelling is supported by an unpainted coursed sandstone foundation, and its exterior walls are clad with painted pale beige color horizontal wood siding, with painted salmon color 1" by 4" corner boards. Painted pale beige color fishscale and octagon pattern shingles appear in the façade's upper gable end. The house is covered by a steeply-pitched front gable roof, with intersecting gables on the east and west elevations. The roof is covered with black asphalt composition shingles, and the eaves are boxed with painted salmon color wood trim. A red brick chimney is located on the ridge. A wood-paneled front door, with one upper sash light and a transom light, and with a wood screen door, enters the center of the symmetrical façade from the nearly full-width front porch. The door is flanked on either side by a 1/1 double-hung sash window, with painted salmon color wood surrounds, which overlook the porch. The porch itself is approached by five painted green wood steps, and features a tongue-in-groove wood floor, an open wood balustrade with turned balusters, turned columns with decorative scrolled brackets, and a low-pitched hip roof with an intersecting gable over the entry. A gable ornament with a sunburst motif is located in the façade's upper gable end, directly above a set of paired 1/1 double-hung sash windows. The canted hip-roof bay**

on the east elevation is penetrated by four 1/1 double-hung sash windows, with decorative wood panels above and below, and with a dentil course beneath its roof eave. A non-historic door enters the rear shed-roofed extension at the north end of the east elevation. Another non-historic, horizontal sliding glass bypass door enters the shed-roofed extension at the east end of the north elevation.

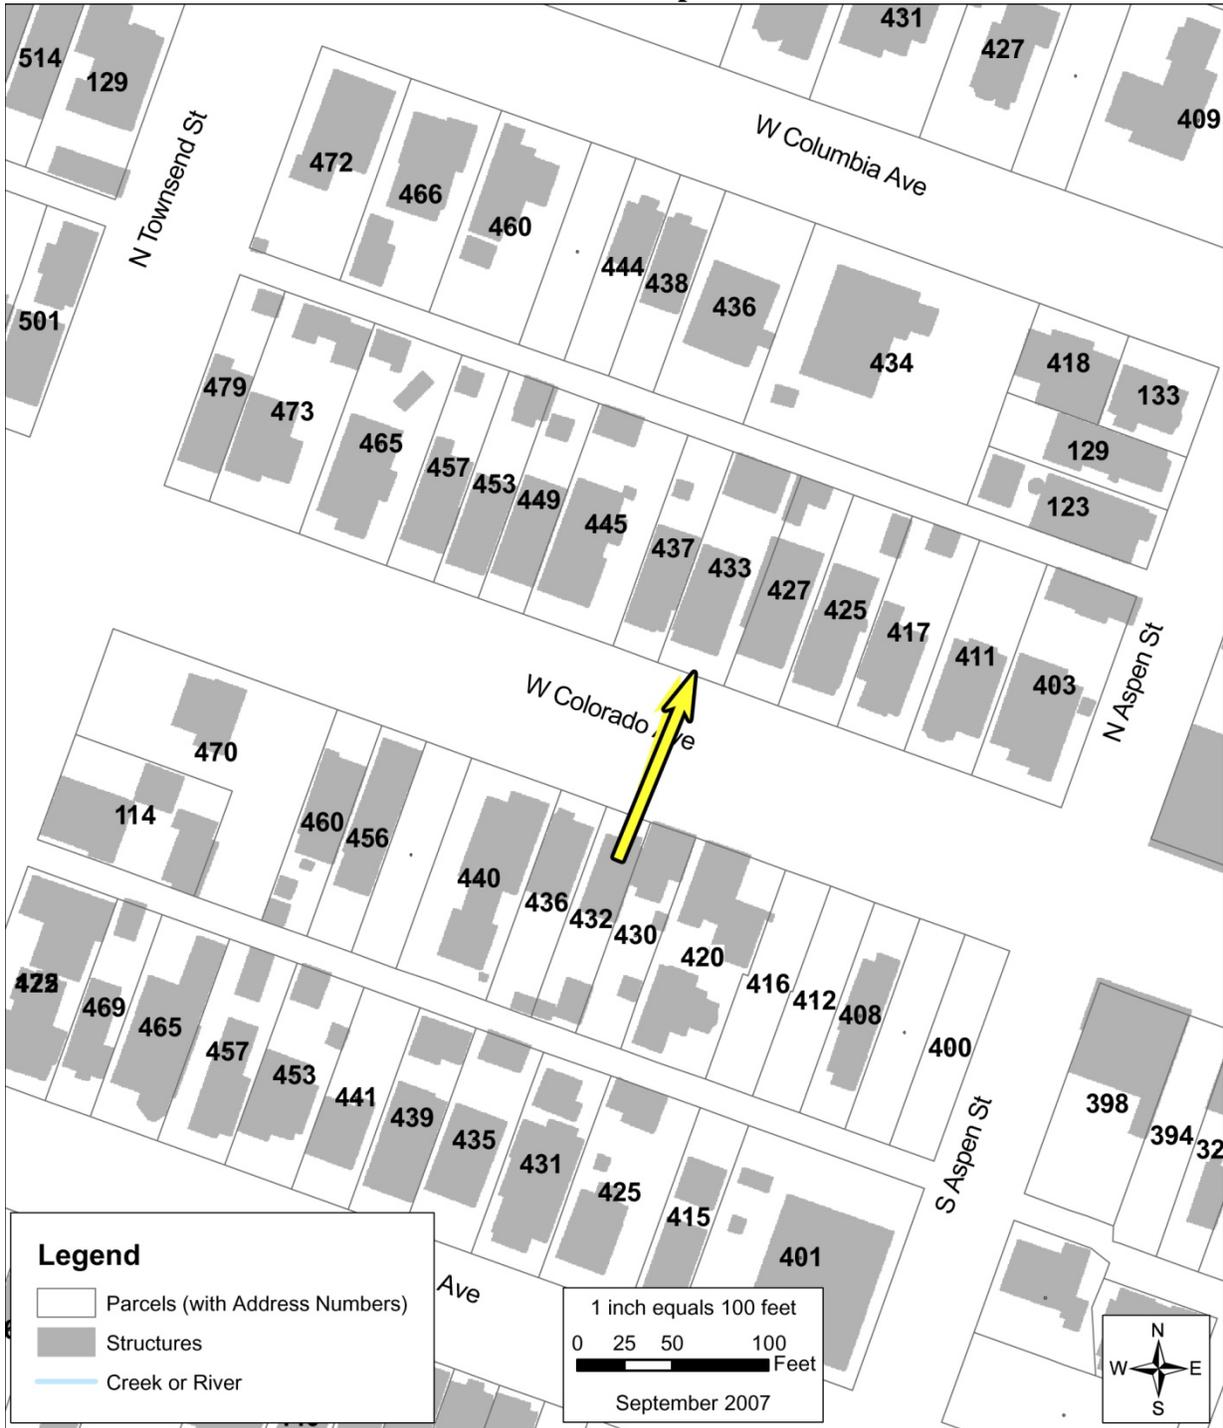
## Sketch Map

22. Architectural style: **Late Victorian**  
 Building type:
23. Landscape or special setting features: **This property is located on the north side of Colorado Avenue in the block between Aspen and Townsend Streets.**
24. Associated buildings, features or objects:

<b>Secondary Residence (THAS #48)</b>
<p>A secondary residence (originally a barn, and likely later a garage) is located adjacent to the alley at the rear of the property. This building measures 20' N-S by 28' E-W, not including a small, 12' by 3' shed-roofed extension to the west elevation. This building's walls are made of coursed CMU blocks, with rolled asphalt in the upper gable ends. The gable roof is covered with corrugated metal roofing material laid over 1x wood decking and 2x wood rafters. A vertical wood plank, horizontal sliding, barn door is located at the west end of the north elevation (facing the alley). Although this barn door is no longer in use, its historic hardware is still intact. A set of paired vertical wood plank doors, and a single vertical wood plank door, both side-hinged with metal strap hinges, enter the shed-roofed extension on the west elevation. One 4-light window penetrates the east elevation. A non-historic 1x1 horizontal sliding window penetrates the north elevation. One other entry door is located on the south elevation.</p>
