COLORADO CULTURAL RESOURCE SURVEY

Architectural Inventory Form

I. IDENTIFICATION

- 1. Resource number: **5SM.1596/THAS47**
- 2. Temporary resource number: **N/A**
- 3. County: **San Miguel**
- 4. City: **Telluride**
- 5. Historic Building Name: **Unknown**
- 6. Current Building Name: **Cohen House**
- 7. Building Address: **437 W. Colorado Avenue**
- 8. Owner Name and Address: **The Cohen Family Trust of 1991  
24858 Malibu Rd.  
Malibu, CA 90265**

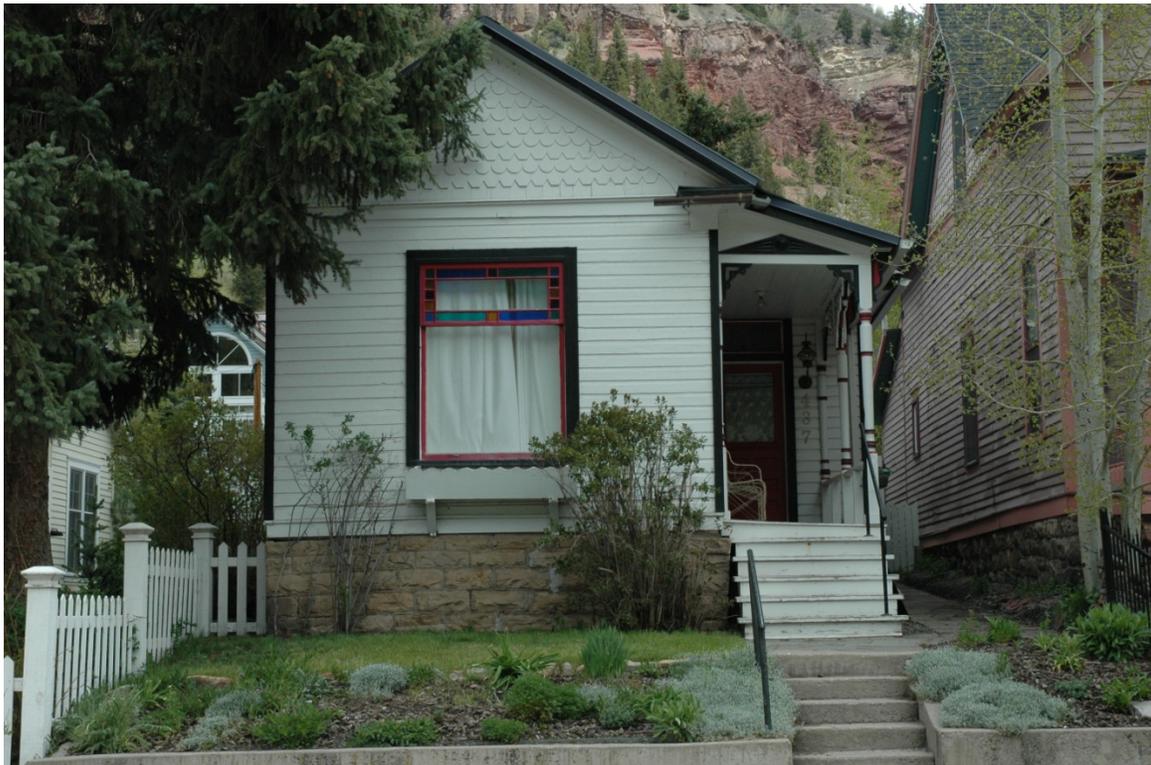
**Fence**  
**Window/Stained Glass**
21. General architectural description:  
**This is a single-story, wood frame, dwelling which measures 51' N-S (deep) by 19' E-W (across). It is supported by a low, unpainted, coursed sandstone foundation, and its exterior walls are clad with painted white horizontal weatherboard siding with painted black 1" by 4" corner boards. The house is covered by a moderately-pitched gable and hip roof, with metal roofing material and with painted black and white boxed eaves. Painted white variegated wood shingles appear in the upper gable end on the façade (south elevation). The dwelling features an asymmetrical façade which faces toward Colorado Avenue on the south elevation. A painted red wood-paneled door, with one upper sash light and with a transom light, enters the house from a 15' by 5' front porch at the east end of the façade. This porch is approached by six wood steps, and features a tongue-in-groove wood floor, painted white bracketed columns, with painted red and green trim, and a shed roof. A distinctive single-hung sash window, with stained glass Queen Anne lights, and with a painted red wood frame and a painted black wood surround, penetrates the façade wall to the west of the porch. Windows on the home's secondary elevations are predominantly 1/1 double-hung sash with painted red wood frames and painted black wood surrounds. A rear entry door is located at the north end of the east elevation.**

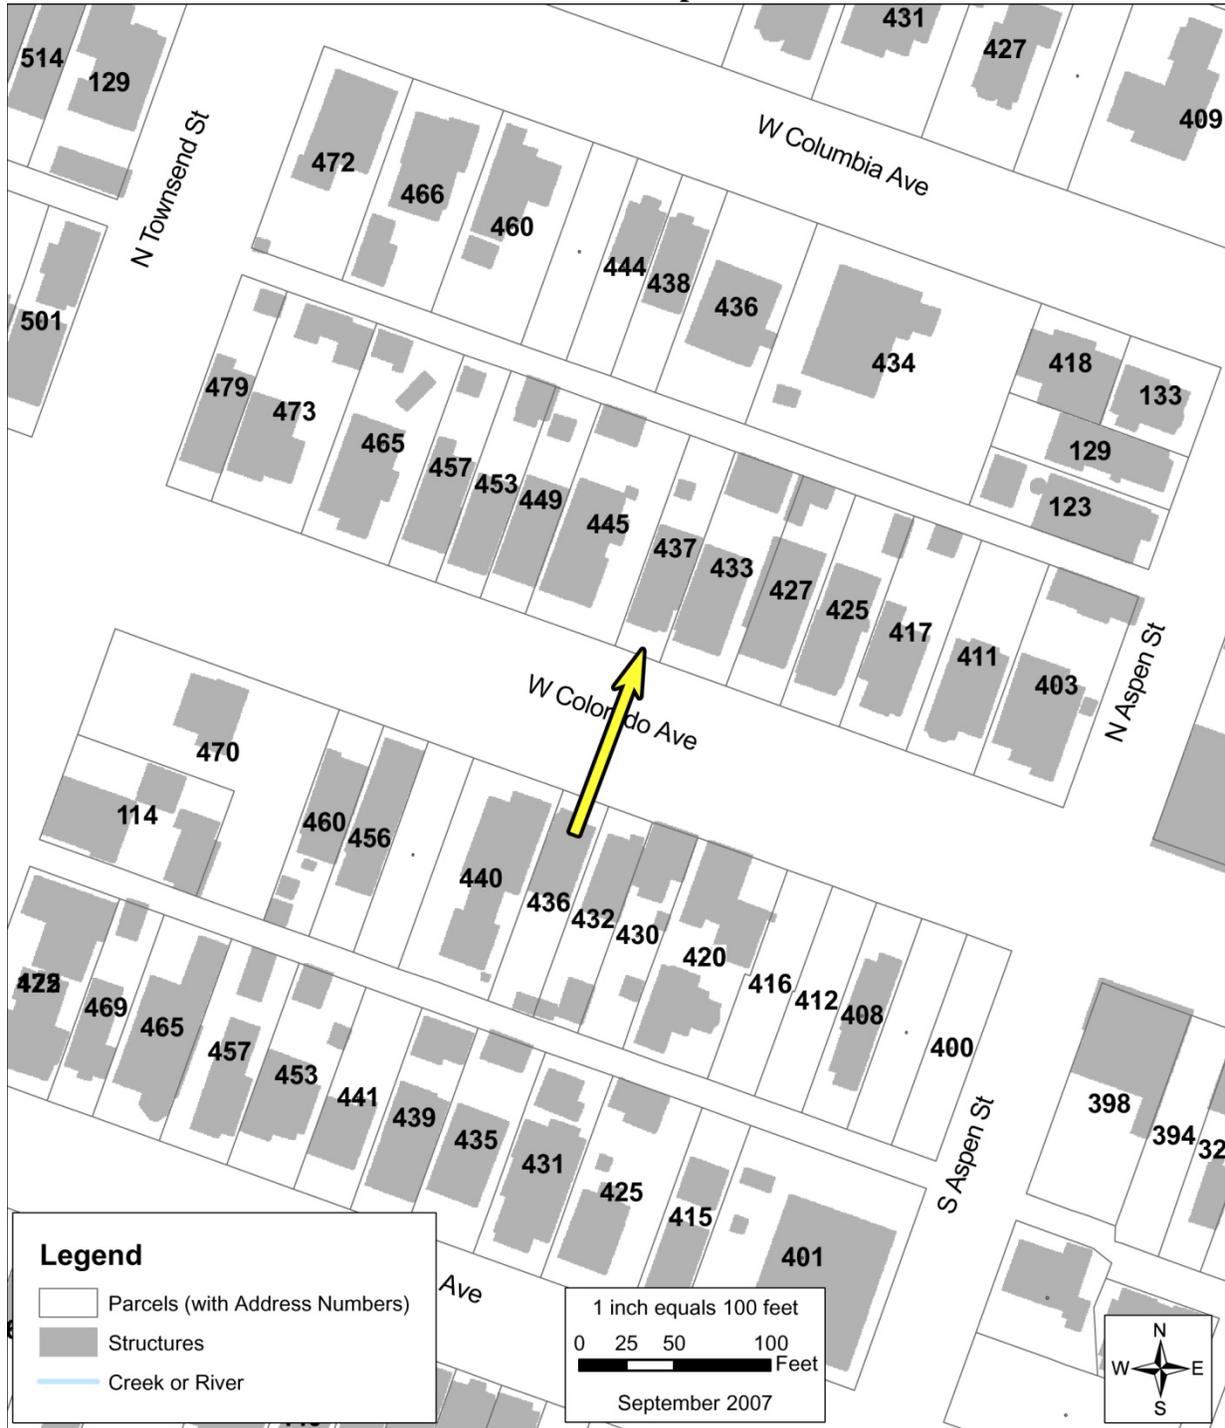
## Sketch Map

23. Landscape or special setting features: **This property is located on the north side of Colorado Avenue in the block between Aspen and Townsend Streets.**

<b>Shed (THAS #47)</b>
<p>A small wood frame shed, which measures approximately 8' by 8', is located near the rear of the property. This small structure is supported by a wood timbers on bricks foundation, and its exterior walls are made of painted white board and batten. It is covered by a shed roof, with corrugated metal roofing material laid over 1x wood decking and 2x wood rafters. A wood-paneled door enters the south elevation from the backyard.</p>
