COLORADO CULTURAL RESOURCE SURVEY

Architectural Inventory Form

- 1. Resource number: **5SM.1594/THAS45**
- 2. Temporary resource number: **N/A**
- 3. County: **San Miguel**
- 4. City: **Telluride**
- 5. Historic Building Name: **Unknown**
- 6. Current Building Name: **Stone/Hayes House**
- 7. Building Address: **449 W. Colorado Avenue**
- 8. Owner Name and Address: **Alvah Stone and Diana F. Hayes
2370 Cedar Hollow Road
Georgetown, TX 78628**

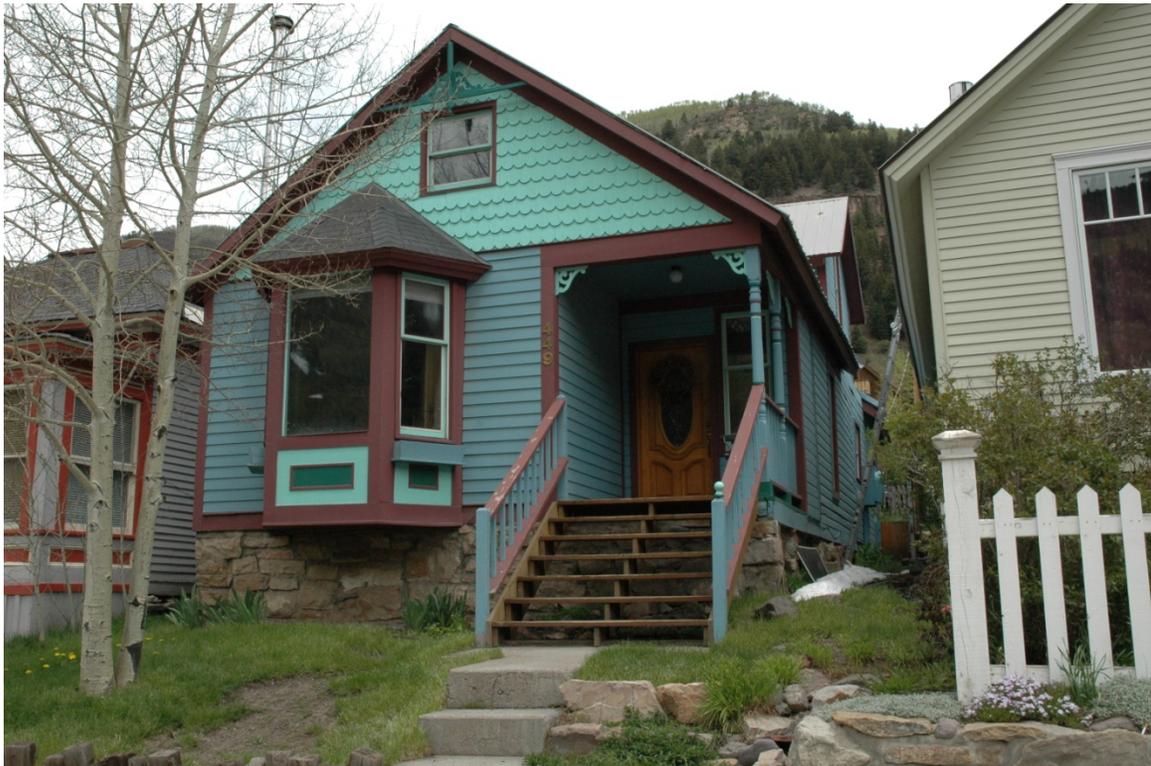
21. General architectural description:
This is a 1.5-story wood frame dwelling, with a 1.5-story addition to its north (rear) elevation. The house, including the addition, presently measures 53.5' N-S (deep) by 21' E-W (across). The original dwelling is supported by a coursed stone foundation, and its exterior walls are clad with painted blue horizontal wood siding with painted brown 1" by 6" corner boards. A painted blue 1" by 6" board separates the foundation from the horizontal wood siding. The house is covered by a front gable roof, with corrugated metal roofing material and with painted brown boxed eaves. Painted light green fishscale shingles appear in the upper gable end on the façade (south elevation). A large gabled dormer, with a 1/1 double-hung sash window, is located on the east-facing roof slope. A non-historic stained brown wood-paneled door, with an oval light, enters the east end of the façade from a 12' by 7' front porch. This porch is approached by seven wood steps, and is recessed under the front southeast corner of the house's gable roof. The porch features an open wood railing and turned columns with brackets. A non-historic oriel type window penetrates the façade wall to the west of the porch. A simple, non-historic, gable ornament adorns the façade's upper gable end. Windows on the home's secondary elevations are primarily 1/1 double-hung sash, with painted blue wood frames and painted brown wood surrounds. Two glass-in-wood-frame doors enter the rear addition on the north elevation.
