COLORADO CULTURAL RESOURCE SURVEY

Architectural Inventory Form

- 1. Resource number: **5SM.1570**
- 2. Temporary resource number: **N/A**
- 3. County: **San Miguel**
- 4. City: **Telluride**
- 5. Historic Building Name: **Unknown**
- 6. Current Building Name: **Ballas House**
- 7. Building Address: **504 W. Colorado Avenue**
- 8. Owner Name and Address: **Nigel Timms
PO BOX 790368
Paia, HI 96779**

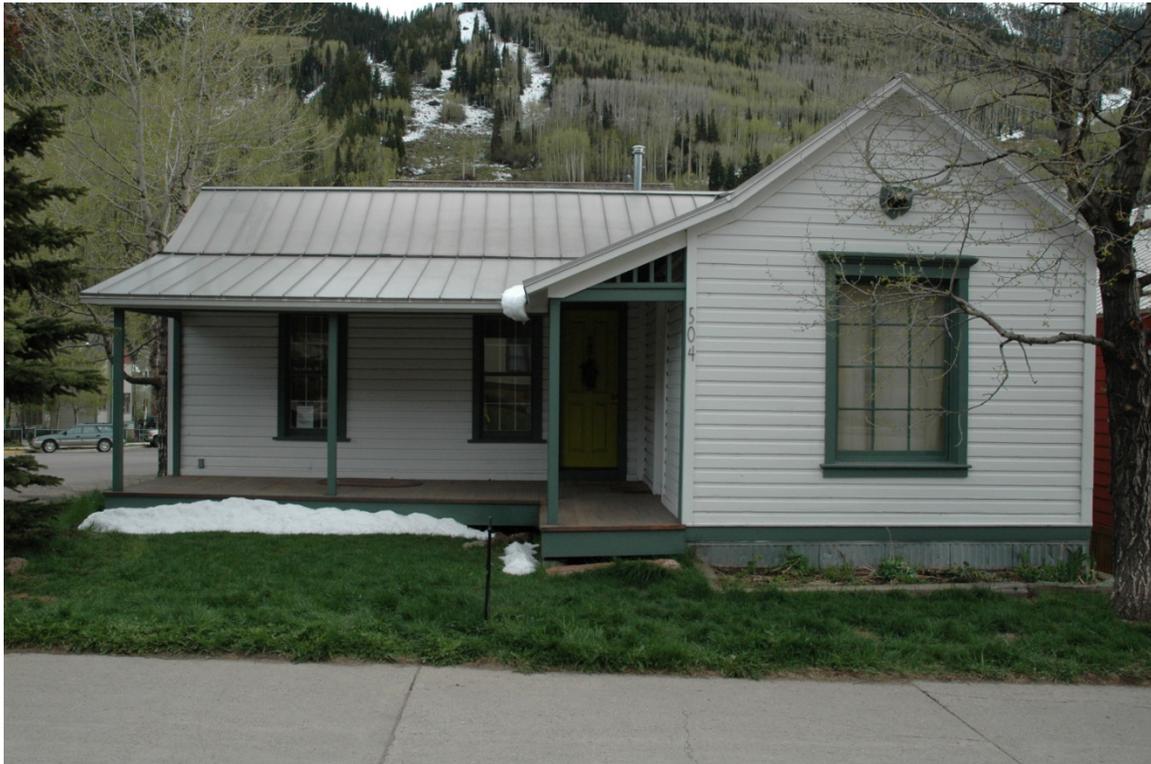
18. Roof configuration: **Gabled Roof/Cross Gabled Roof**
19. Primary external roof material: **Metal Roof**
20. Special features: **Porch**
21. General architectural description:
This is a 1½-story, L-shaped dwelling, with a gabled addition to its east (side) elevation, and two shed-roofed additions to its south (rear) elevation. The main part of the house is covered by a cross-gabled roof, which overall measures 35' N-S (deep) by 32.5' E-W (across). The addition to the east end of the south elevation is covered by a shed roof, and measures 12' N-S by 21' E-W. The addition to the west end of the south elevation is covered by a gable roof, and measures 12' N-S by 16' E-W. The house is supported by a concrete foundation covered with corrugated metal. A 2-light basement window penetrates the foundation wall on the east elevation. The house's exterior walls are primarily clad with painted white horizontal weatherboard siding, with 1" by 4" corner boards. Portions of the west elevation are clad with board-and-batten siding, however. A painted green 1" by 6" board separates the foundation from the siding. The cross-gabled roof is covered with metal roofing material, and the eaves are boxed with painted white wood trim. Two wood-paneled doors enter the dwelling from an L-shaped front porch which comprises the west end of the façade (north elevation). This porch features a wood plank floor, painted green 4" by 4" wood posts, and a shed roof. The west end of the façade wall is penetrated by a large 12-light window with a painted green wood frame. A narrow horizontal weatherboard door enters the gabled addition near the west end of the south elevation.

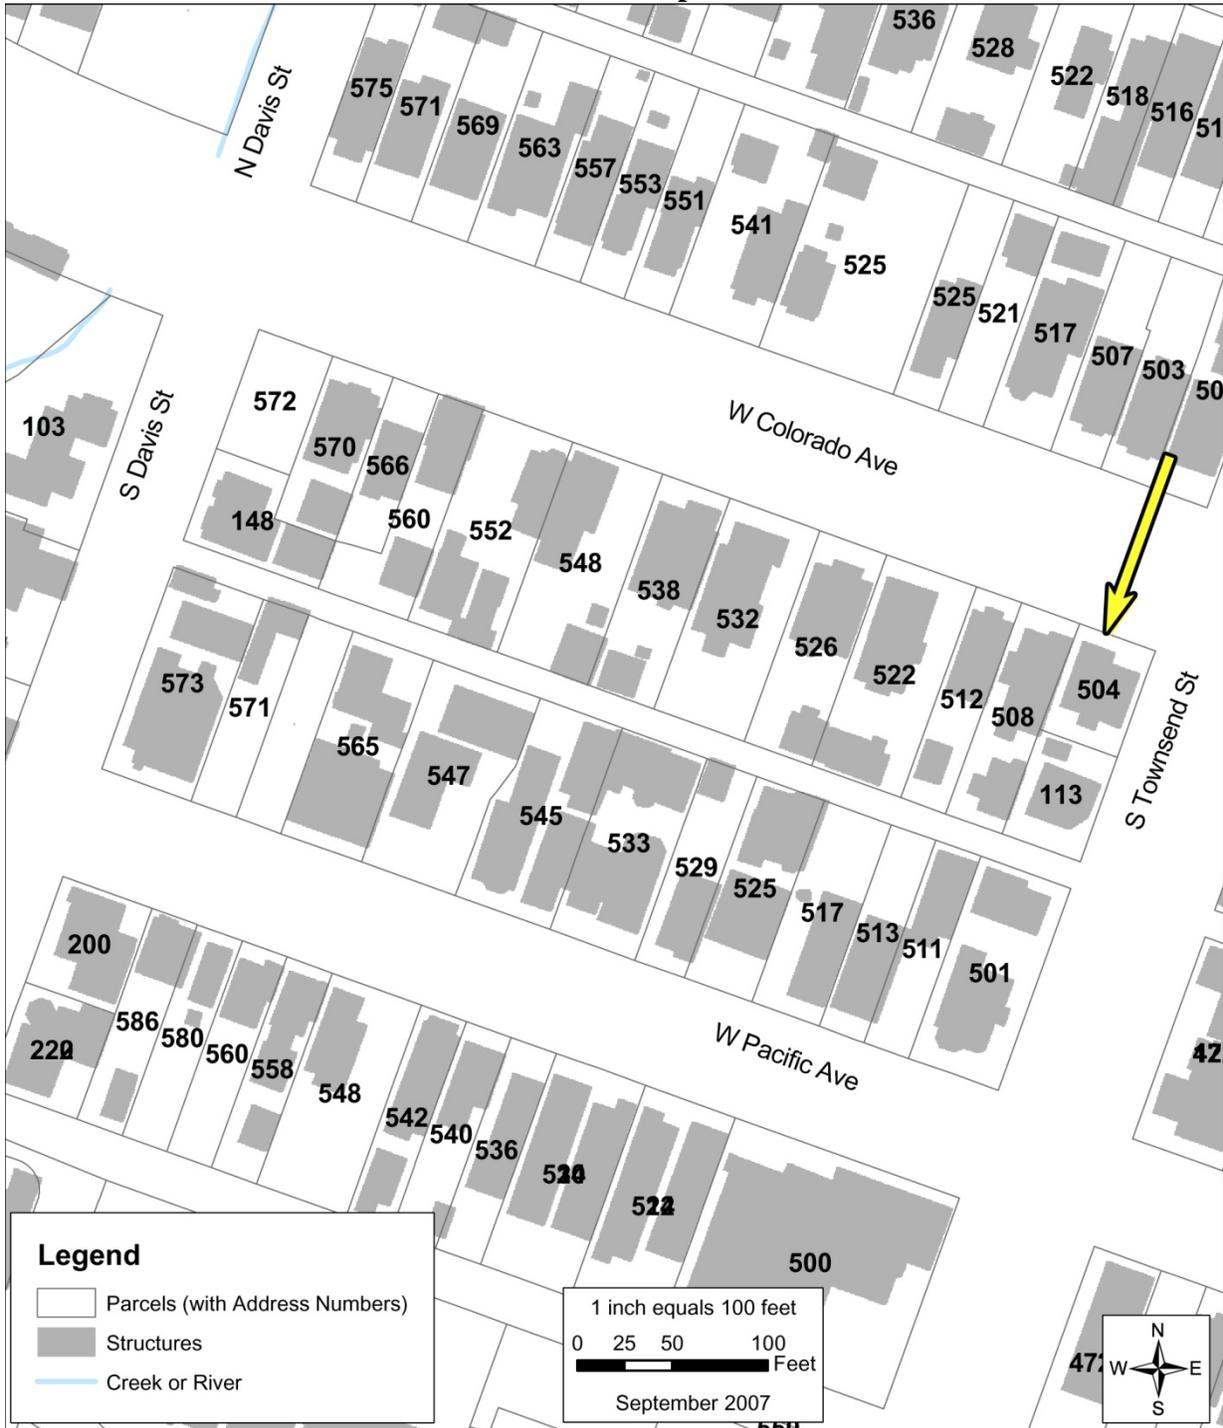
Sketch Map

23. Landscape or special setting features: **This property is located at the southwest corner of West Colorado Avenue and Townsend Street, near the west end of the Telluride National Historic Landmark District.**
