COLORADO CULTURAL RESOURCE SURVEY

Architectural Inventory Form

- 1. Resource number: **5SM.1572/THAS198**
- 2. Temporary resource number: **N/A**
- 3. County: **San Miguel**
- 4. City: **Telluride**
- 5. Historic Building Name: **Unknown**
- 6. Current Building Name: **Fruen Properties LLC House**
- 7. Building Address: **512 W. Colorado Avenue**
- 8. Owner Name and Address: **Fruen Properties LLC
P. O. Box 2706
Telluride, CO 814352706**

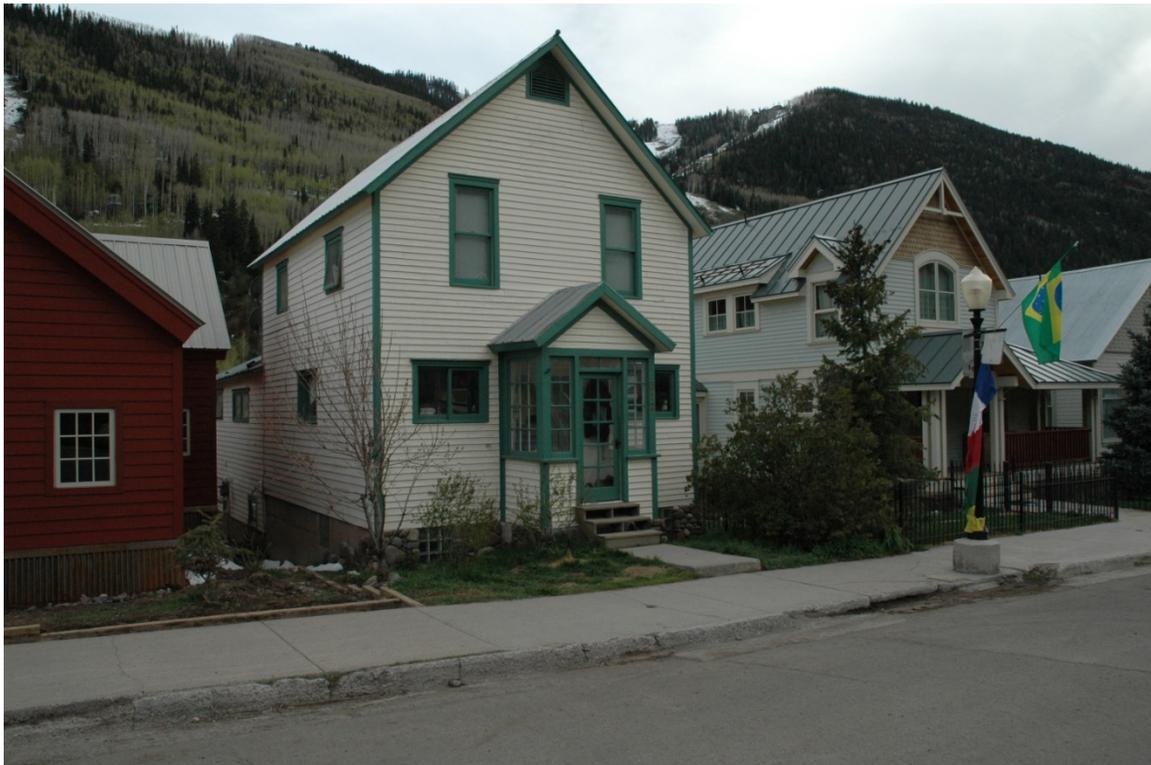
21. General architectural description:
This is a rectangular-shaped wood frame dwelling which consists of an original two-story, 24.5' N-S by 20' E-W, front-gabled section, and a 1.5-story, 20' by 20', saltbox addition to the south (rear) elevation. This addition appears to incorporate an original extension to the west end of the south elevation, however. The house is supported by a non-historic concrete foundation, which is faced with river rock on the façade (north elevation) and on the west elevation. Glass block windows penetrate the foundation wall on the west, north and east elevations. The dwelling's exterior walls are clad with painted yellow horizontal wood siding, with painted green 1" by 4" corner boards. The main front gabled roof, and the saltbox roof over the addition, are both covered with corrugated metal roofing material, and the eaves are boxed with painted green and yellow wood trim. A finial is located at the front apex of the gable roof. The symmetrical façade is set back a short distance from the concrete sidewalk paralleling Colorado Avenue on the north elevation. Here, three wood steps lead to a 4' by 7' enclosed front porch with a gable roof. A painted green, 10-light, glass-in-wood-frame door, with a transom light and flanking sidelights, enters the porch from a concrete sidewalk. A painted white glass-in-wood-frame door leads from within the porch into the interior of the house. The entry porch is flanked on either side by a 1x1 horizontal-sliding window which penetrate the façade wall. Two 1/1 double-hung sash windows penetrate the second story wall on the façade. Fenestration on the east and west elevations includes 1x1 horizontal sliding windows, single-light awning windows, and 1/1 double-hung sash windows. All of the dwelling's windows feature painted green wood frames and surrounds. A short flight of wooden steps at the east end of the south elevation lead to a 4' by 20' rear deck above an enclosed walkout basement-level storage area. The rear entry door opens onto the deck at the east end of the south elevation.
