COLORADO CULTURAL RESOURCE SURVEY

Architectural Inventory Form

I. IDENTIFICATION

- 1. Resource number: **5SM.1588**
- 2. Temporary resource number: **N/A**
- 3. County: **San Miguel**
- 4. City: **Telluride**
- 5. Historic Building Name: **Unknown**
- 6. Current Building Name: **Schroedl House**
- 7. Building Address: **517 W. Colorado Avenue**
- 8. Owner Name and Address: **Thomas E. and Elaine B. Schroedl  
P.O. Box 356  
Telluride, CO 81435-0356**

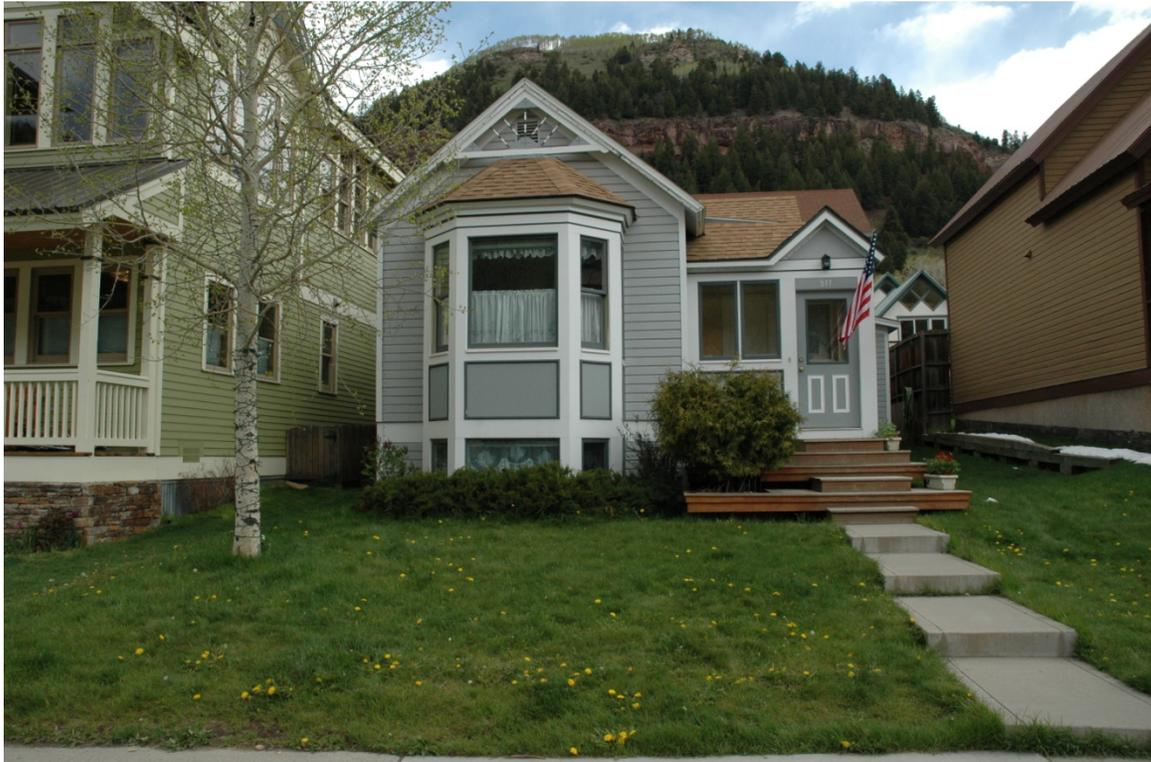
**Window/Glass Block**
21. General architectural description:  
**The extant building at 517 W. Colorado Avenue consists of a historic (circa 1896) wood frame dwelling, and a very large, two-story, (circa 2000) addition to the original north (rear) elevation. The modest original dwelling featured a cross-gable plan. The building's exterior walls are clad with painted pale grey horizontal weatherboard siding, with painted white 1" by 4" corner boards. The roof is covered with brown asphalt shingles, and the eaves are boxed with painted white wood trim. A modern basement has been excavated beneath the historic house, and the new foundation walls are penetrated by glass block windows. A non-historic, enclosed, front porch forms the east end of the façade. (The front porch was historically open.) A large, non-historic, five-sided, bay window projects from the façade wall to the west of the porch. A historic, rectangular, bay window on the east elevation is penetrated by a single-light fixed-pane window.**
