COLORADO CULTURAL RESOURCE SURVEY

Architectural Inventory Form

- 1. Resource number: **5SM.1574**
- 2. Temporary resource number: **N/A**
- 3. County: **San Miguel**
- 4. City: **Telluride**
- 5. Historic Building Name: **Unknown**
- 6. Current Building Name: **Myers House**
- 7. Building Address: **532 W. Colorado Avenue**
- 8. Owner Name and Address: **Christopher R. Myers
PO BOX 3253
Telluride, CO 81435**

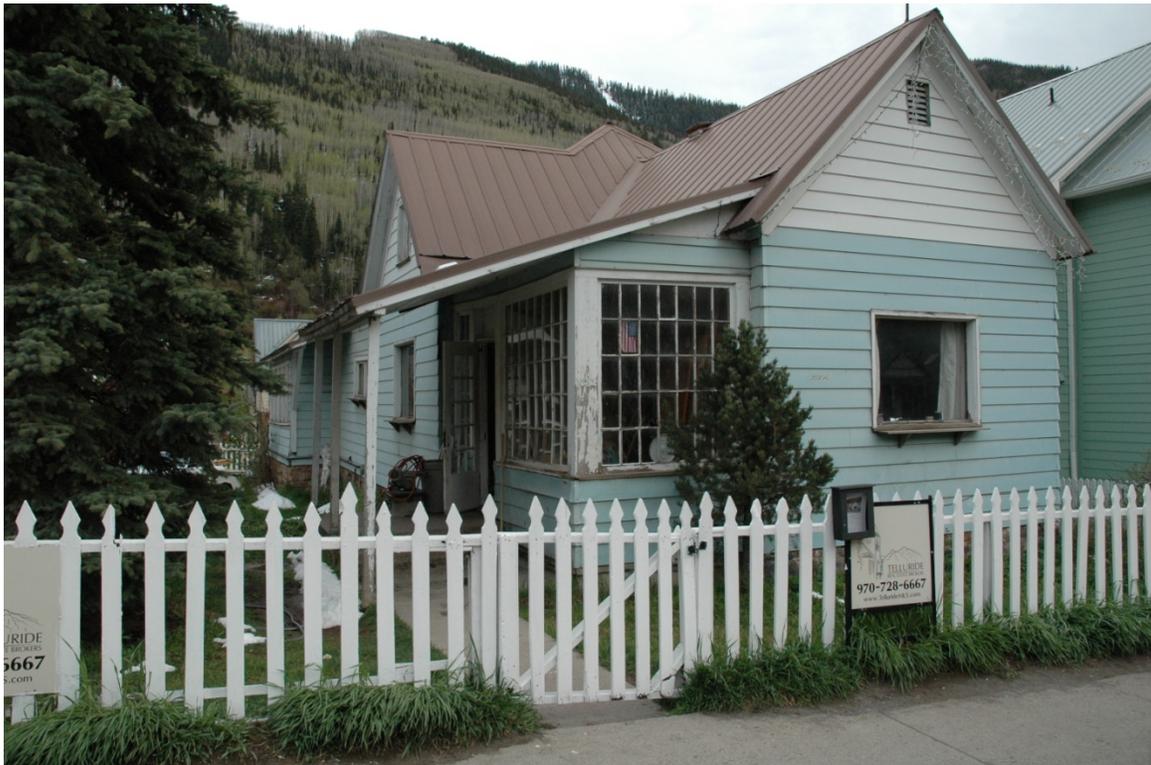
18. Roof configuration: **Gabled Roof/Cross Gabled Roof**
19. Primary external roof material: **Metal Roof**
20. Special features: **Porch**
Chimney
Fence
21. General architectural description:
This is a 1½-story wood frame dwelling with an original cross gabled-T shaped plan, and with gabled and shed roof additions to the south (rear) elevation. The original house is supported by a coursed dark sandstone foundation, which is substantial enough in height (4' above grade) to provide for a partial basement below the main level (as evidenced by a screened window opening in the foundation wall on the lower west elevation). The house's exterior walls are clad with non-historic pale blue and white horizontal aluminum siding, though there appears to be original wood siding on the front entry porch. The cross-gable roof over the original house features a centered hipped peak, and the entire roof is covered with brown metal roofing material. A brown brick chimney was once located on the roof ridge; however, only the base of chimney now slightly protrudes at the ridge. An enclosed, shed-roofed, front entry porch, which measures 12' N-S by 7' E-W, comprises the north (front) end of the east (side) elevation. A 2-step concrete stoop leads to a painted white, 15-light, glass-in-wood-frame door (with a single horizontal glass transom window above), which enters the porch. The porch wall is also penetrated by a 40-light fixed-pane window (at the north end of the east elevation, north of the entry door), a 35-light fixed-pane window (on the north elevation), and a 10-light fixed-pane window (on the east elevation south of the entry door). An enclosed rear entry porch is located at the south end of the east elevation. A band of five 6/6 double-hung windows penetrate the east wall of this porch, while two 6/6 double-hung window penetrate the south (rear) wall. Windows elsewhere are primarily single-light fixed-panes, with one original 1/1 double-hung sash window which is north-facing on the west elevation, and one original fixed-pane window in the attic gable end on the east elevation. Most of the windows feature painted white wood frames and surrounds. A flight of ten

wooden stairs lead to an open wood porch at the end of the south (rear) elevation. A painted blue wood-paneled door enters the rear of the building from this porch. A small, 10' by 10', gable-roofed shed is attached to the basement level of the south elevation. This shed is of wood frame construction, with asbestos shingle exterior siding. It is covered by a gable roof with brown metal roofing material the same or similar to that on the house. A set of paired, painted white, vertical wood plank doors penetrate the storage shed's south elevation. An old plank door to the west of this shed accesses the coal chute / storage area beneath the house.

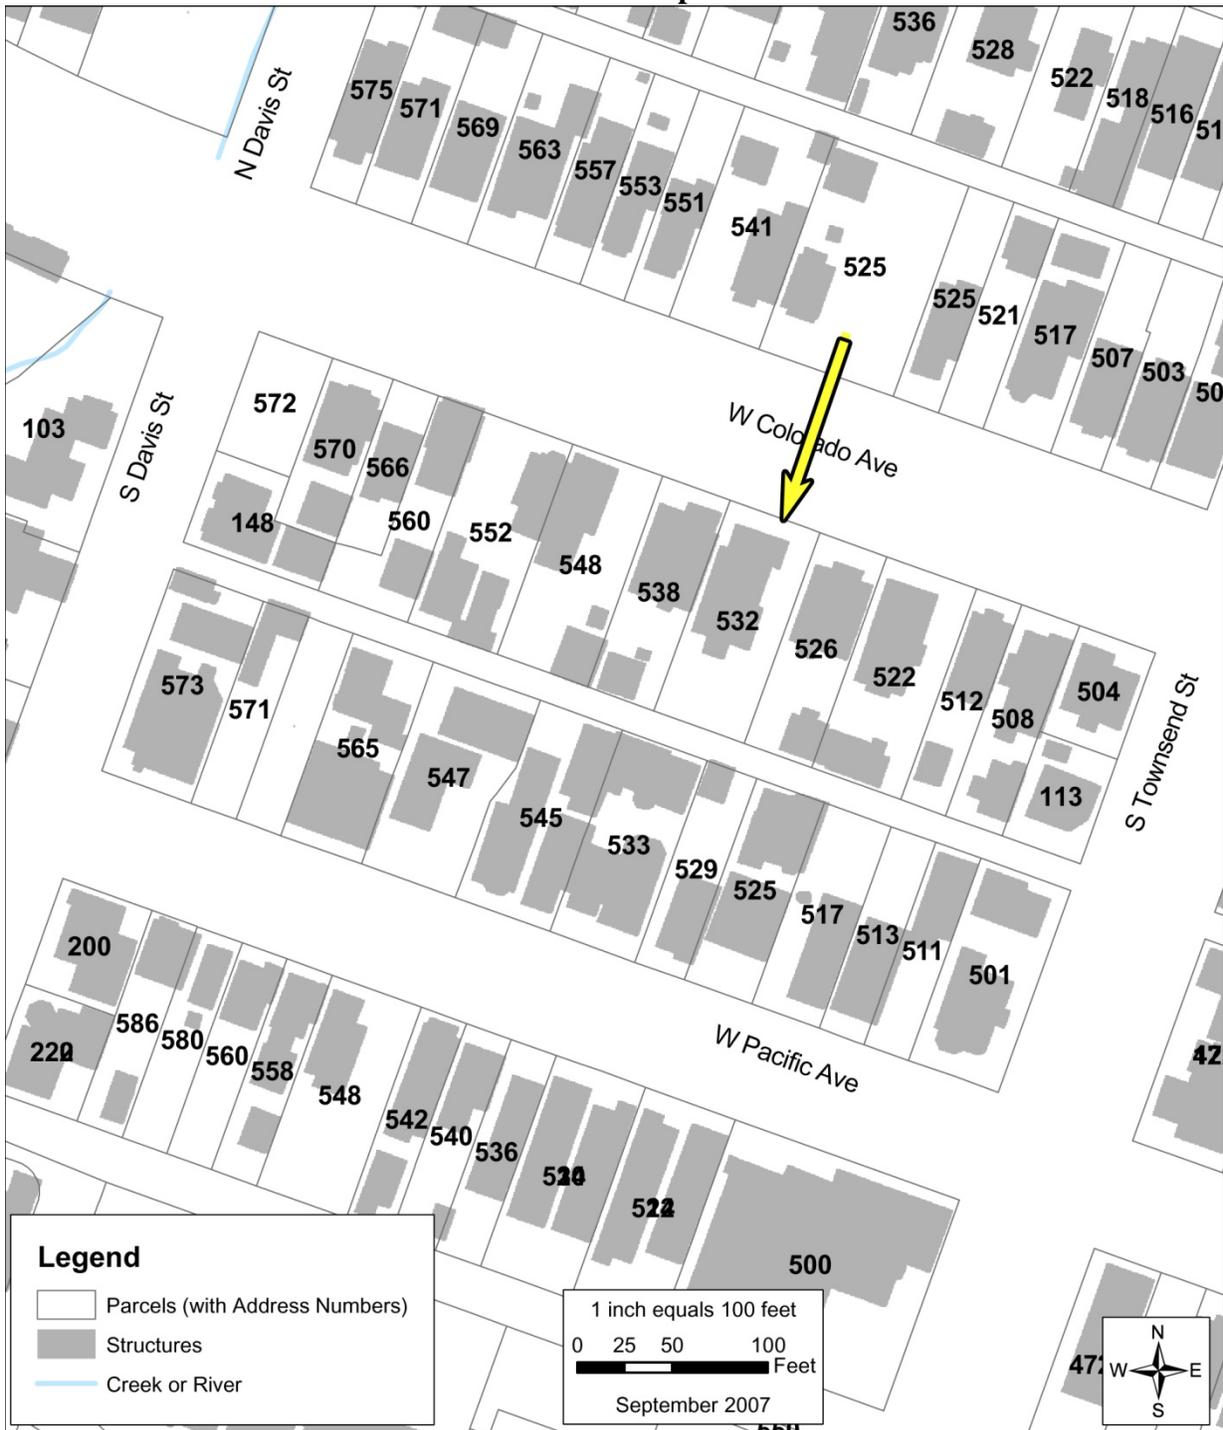
Sketch Map

23. Landscape or special setting features:
This property is located on the south side of West Colorado Avenue in the block between Townsend and Davis Streets, near the west end of the Telluride National Historic Landmark district. The house sits on a double lot with several well-established lilacs and is partially enclosed by a painted white picket fence. Per Sanborn Insurance maps and historic photos, the house's relationship relative to the lot and overall site appears intact.
