COLORADO CULTURAL RESOURCE SURVEY

Architectural Inventory Form

- 1. Resource number: **5SM.1575/THAS.194**
- 2. Temporary resource number: **N/A**
- 3. County: **San Miguel**
- 4. City: **Telluride**
- 5. Historic Building Name: **N/A**
- 6. Current Building Name: **San Miguel County Daycare Preschool Assoc. Bldg.**
- 7. Building Address: **538 W. Colorado Avenue**
- 8. Owner Name and Address: **San Miguel County Daycare Preschool Association Inc.  
P. O. Box 1583  
Telluride, CO 814351583**

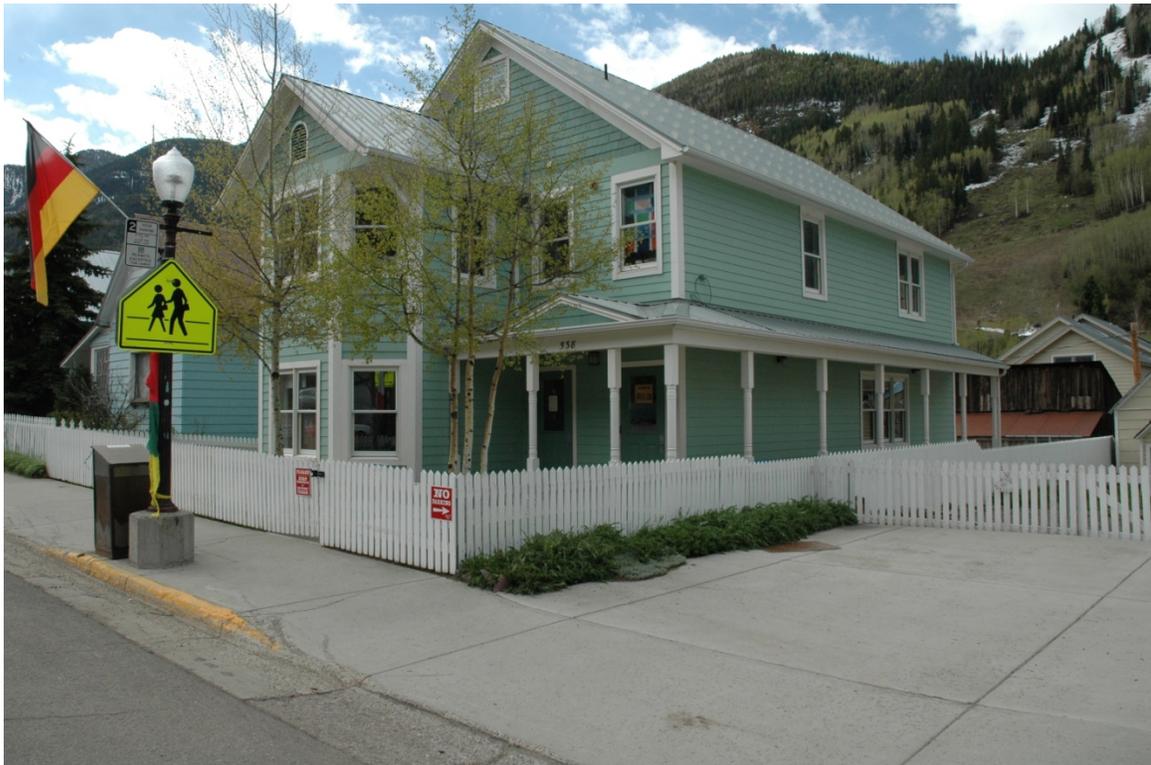
**This is a large, 2.5-story, wood frame building. It is supported by a low concrete foundation, and its exterior walls are clad with painted green horizontal wood siding, with painted white 1" by 6" corner boards. Painted green square-cut wood shingles appear in the upper gable ends on the south and north elevations, however. The front gable roof is moderately-pitched, and is covered with corrugated metal roofing material. The eaves are boxed, with painted white wood trim. The building's asymmetrical façade faces toward Colorado Avenue on the north elevation. Two green metal-paneled doors, each with one upper sash light, enter the west end of the façade from a front porch which wraps around to cover all of the west (side) elevation. This porch features a concrete floor, painted white turned columns, and a low-pitched hip roof with an intersecting gable over the entry. A large two-story canted bay, with multiple 1/1 double-hung sash windows, and covered by a gable roof, dominates the façade to the east of the entry porch. The west elevation is penetrated by a band of three 1/1 double-hung sash first story windows, which look out onto the porch, and by one set of paired and one single second story windows, which overlook the porch roof. There are no doors or windows on the east (side) elevation. A metal staircase ascends to doors entering the first and second stories on the south (rear) elevation. The south elevation is also penetrated by a set of paired 6-light casement first story windows, and by two sets of paired 1/1 double-hung sash second story windows. A 6-light window is located in the south elevation's upper gable end.**

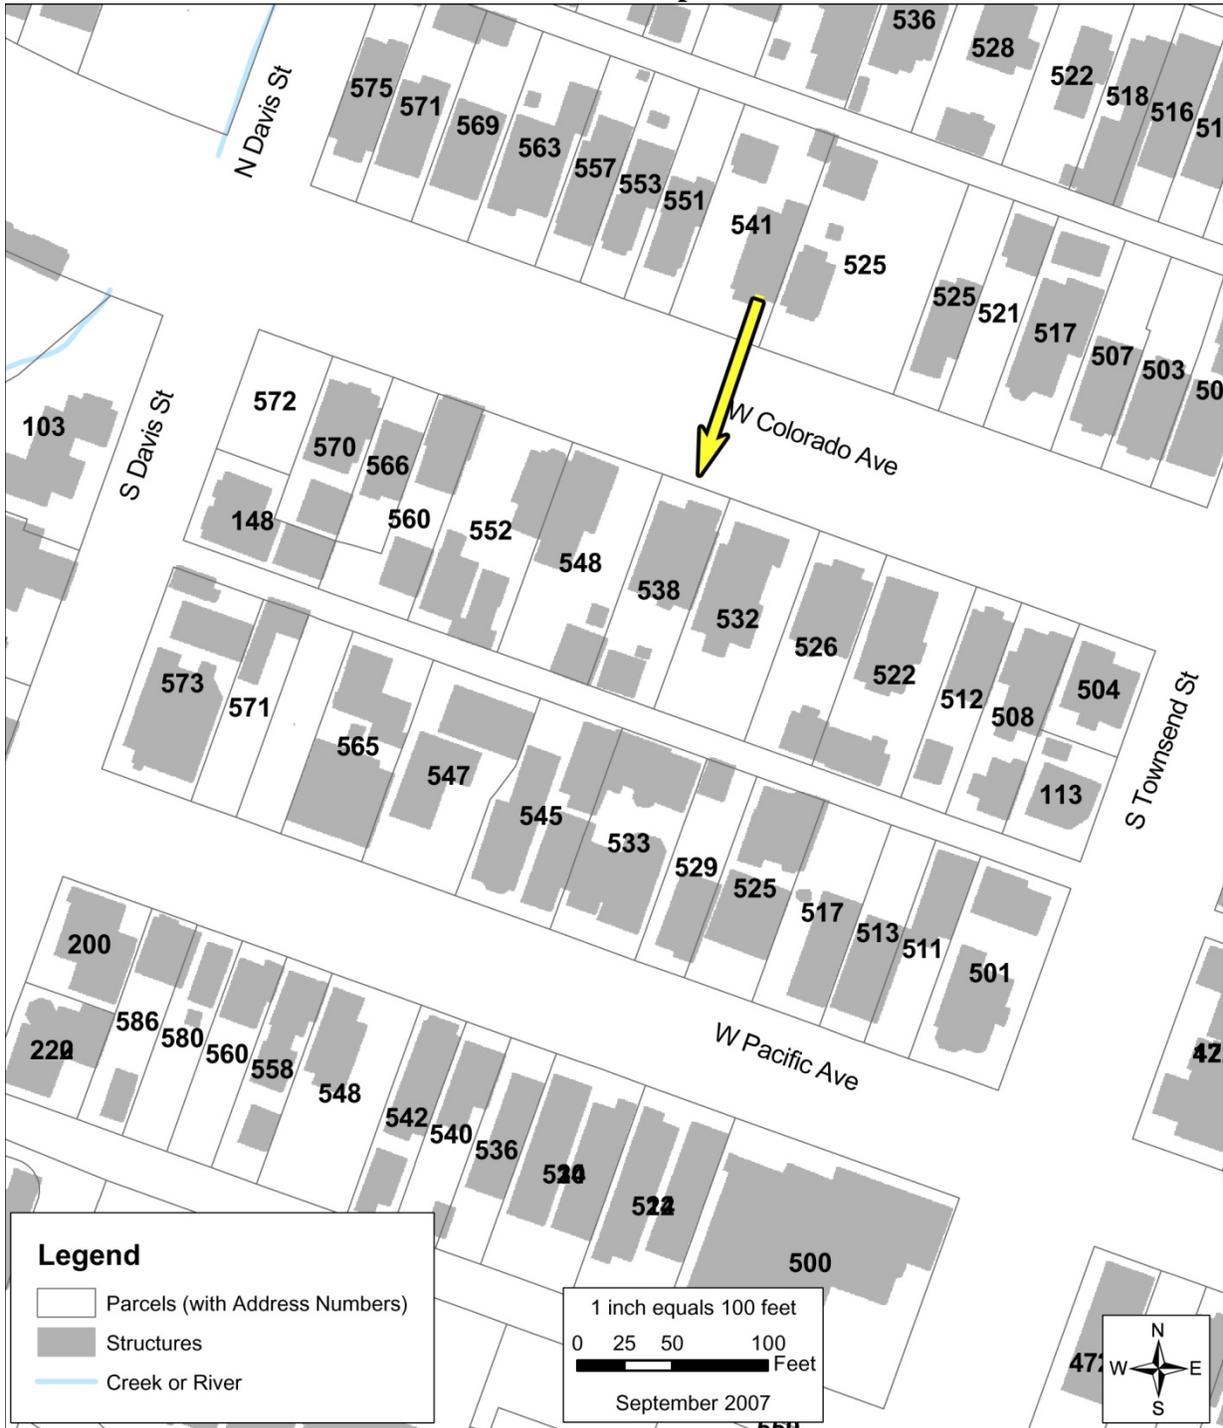
## Sketch Map

**This property is located on the south side of West Colorado Avenue, in the block between Townsend and Davis Streets, near the west end of the Telluride National Historic Landmark district. This property is enclosed by a painted white picket fence.**

<b>Garage/Shed (THAS #194)</b>
<p><b>A historic garage/shed is located near the rear southwest corner of the property. This structure, overall, measures approximately 14' N-S by 20' E-W, and is composed of a tall shed-roofed garage portion, with a lower shed-roofed extension to its north elevation. It features a non-historic concrete slab floor, and a low concrete perimeter walls foundation. The garage/shed's exterior walls are made of unpainted vertical wood planks, and board-and-batten. The roof is covered with corrugated metal, laid over plywood decking and 2x wood rafters. A rusted corrugated-metal-clad, roll-away, garage door opens toward the alley on the south elevation.</b></p>
