COLORADO CULTURAL RESOURCE SURVEY

Architectural Inventory Form

- 1. Resource number: **5SM.1585**
- 2. Temporary resource number: **N/A**
- 3. County: **San Miguel**
- 4. City: **Telluride**
- 5. Historic Building Name: **Unknown**
- 6. Current Building Name: **Bleak House**
- 7. Building Address: **551 W Colorado Avenue**
- 8. Owner Name and Address: **Louise Jamail
1612 Haver Street
Houston TX 77006**

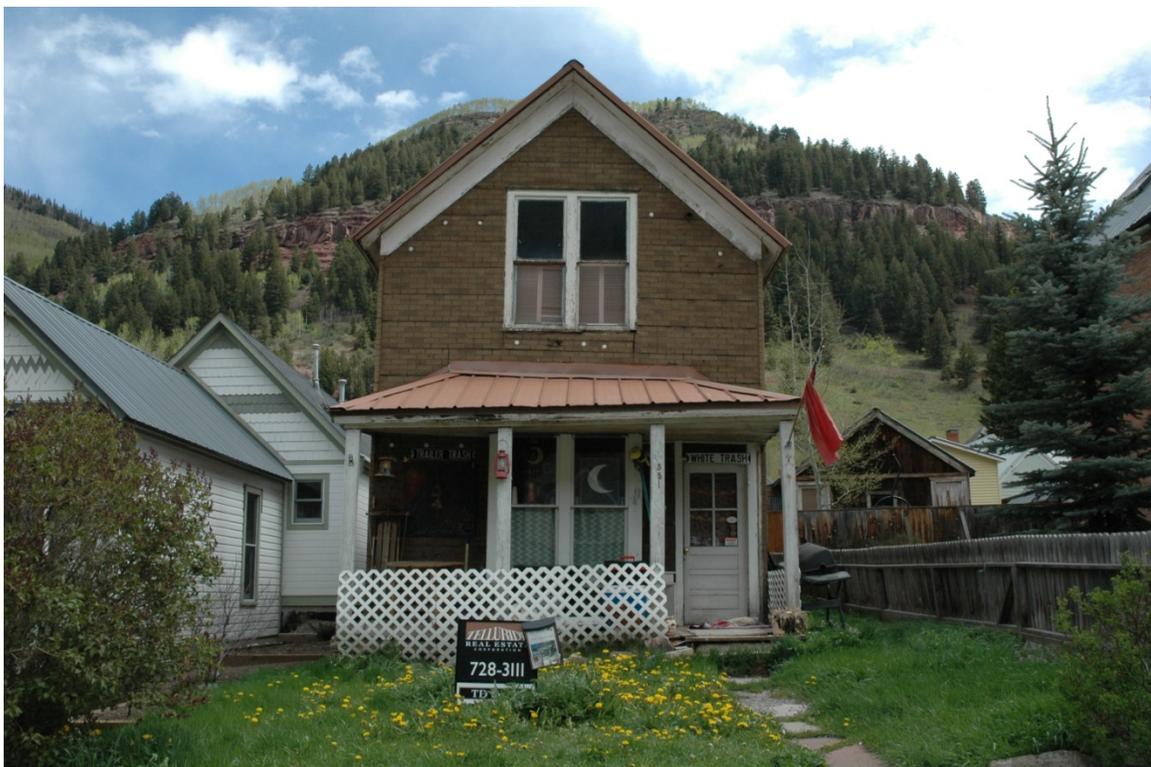
18. Roof configuration: **Gabled Roof/Front Gabled Roof**
19. Primary external roof material: **Metal Roof**
20. Special features: **Porch**
Chimney
21. General architectural description:
This 1890s-era wood frame dwelling consists of a main 1.5-story front gabled section, which measures 16' N-S (across) by 24' E-W (deep), and a one-story shed-roofed extension to the north (rear) elevation, which measures 18.5' N-S by 20'5' E-W. Overall, the building measures approximately 42.5' N-S by 20.5' E-W. Its foundation probably consists of stone piers, and its exterior walls are clad with rolled brown asphalt siding exhibiting a faux brick pattern. The front gable roof over main 1.5-story section is steeply-pitched, and is covered with brown metal roofing material. The eaves are boxed with painted white wood trim, and a red brick chimney is located on the roof ridge. The house's façade faces toward Colorado Avenue on the south elevation. A painted white wood-paneled door, with four upper sash lights and a transom light, enters the east end of the façade from a full-width front porch. This porch features a tongue-in-groove wood floor, painted white square wood posts, and a low-pitched hip roof. A boxed bay, with four 1/1 double-hung sash windows, projects out onto the porch to the west of the entry door. A set of paired 1/1 double-hung sash windows are located in the façade's upper gable end, overlooking the porch roof. Two 1/1 double-hung sash windows, with painted white wood frames and surrounds, penetrate the west elevation. Two historic (but perhaps not original) single-light windows, with painted white wood frames and surrounds, penetrate the east elevation. One 1/1 double-hung sash window, penetrates the upper gable end on the north (rear) elevation. A rear entry door enters the shed-roofed extension from beneath a 4' by 8' lean-to near the east end of the north elevation.

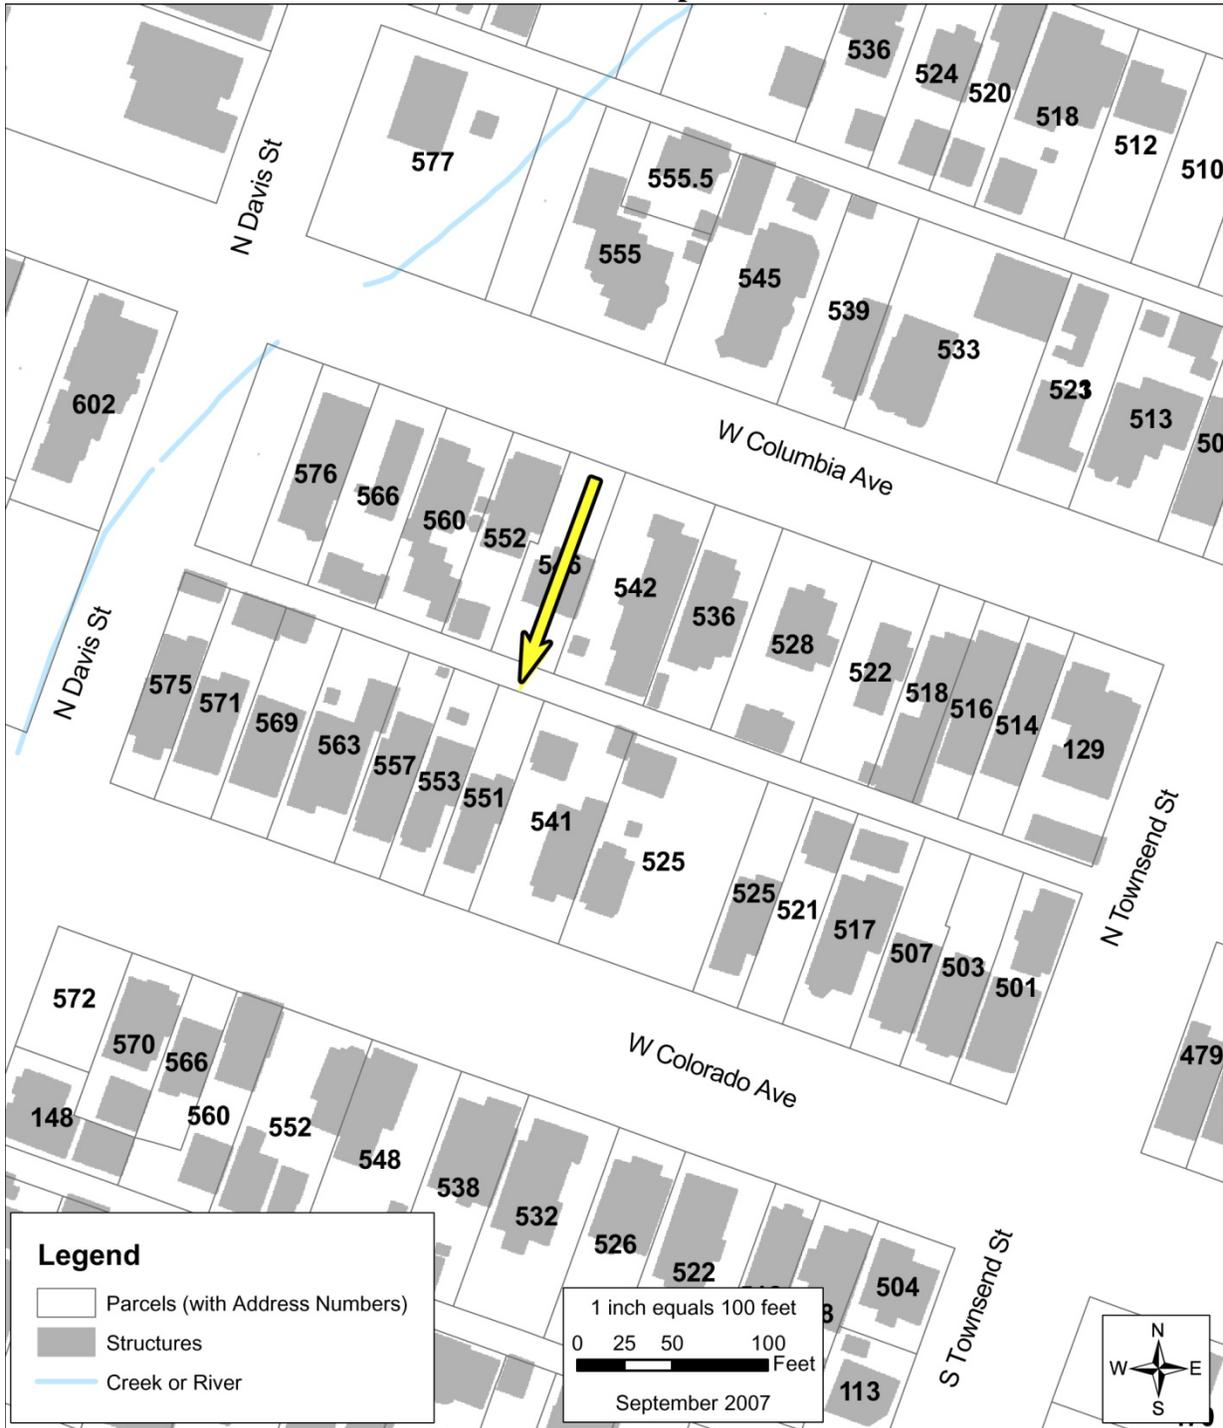
Sketch Map

This property is located on the north side of Colorado Avenue in the block between Townsend and Davis Streets, near the west end of the Telluride National Historic Landmark District.
