COLORADO CULTURAL RESOURCE SURVEY

**Architectural Inventory Form**

- 1. Resource number: **5SM.1577/THAS.191**
- 2. Temporary resource number: **N/A**
- 3. County: **San Miguel**
- 4. City: **Telluride**
- 5. Historic Building Name: **Backman House; Ranta House**
- 6. Current Building Name: **Ranta House**
- 7. Building Address: **552 W. Colorado Avenue**
- 8. Owner Name and Address: **Allan Ranta  
P. O. Box 1505  
Telluride, CO 814351505**

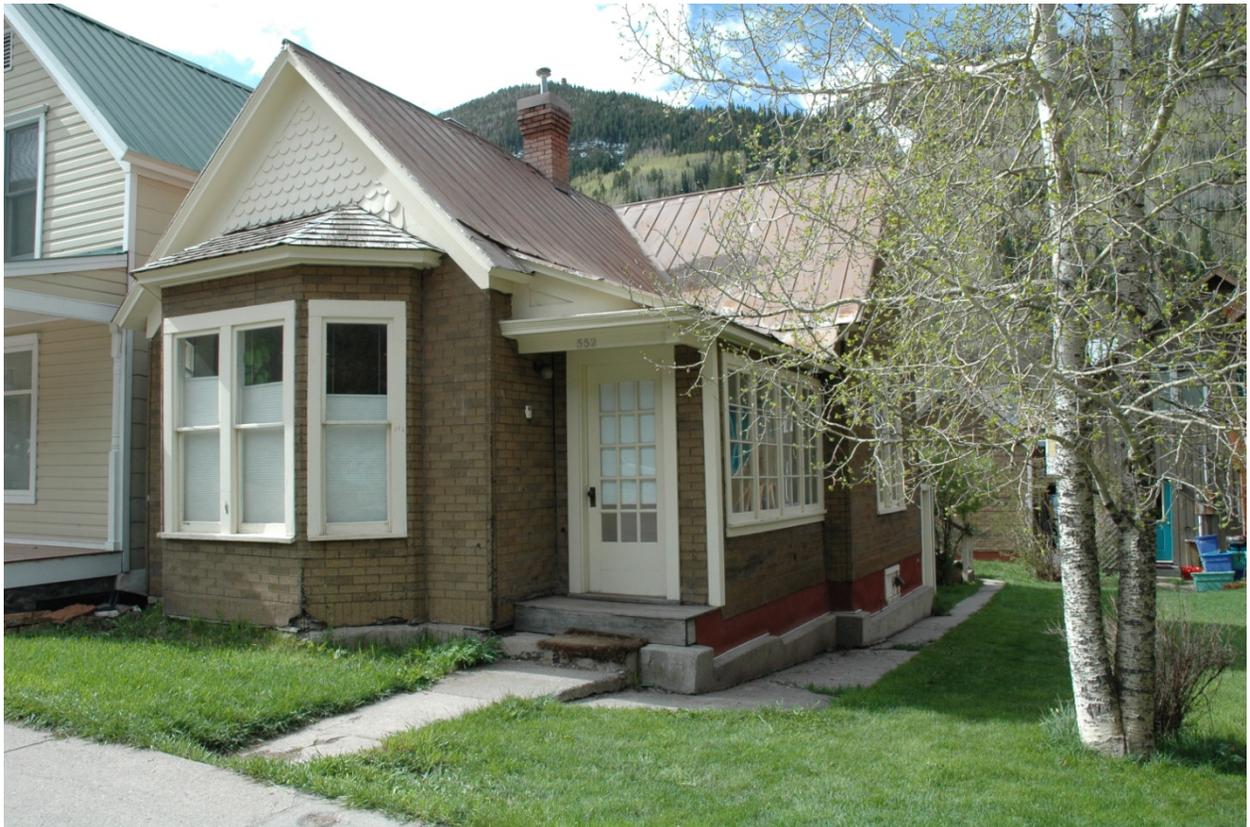
**Ornamentation/Decorative Shingles**
21. General architectural description:  
**This single-story, wood-frame dwelling appears to consist of an original gabled-L section, and an early gabled addition to the south (rear) elevation. The house is supported by a low concrete foundation, and its exterior walls are covered with rolled brown asphalt with a faux brick pattern, Painted cream white fishscale shingles appear in the upper gable end on the façade (north elevation), however. The house is covered by a cross gable roof, with brown metal roofing material, and with painted cream white boxed eaves. A red brick chimney with a corbelled cap is located on the roof ridge. A painted cream white, 15-light, glass-in-wood-frame door enters an enclosed, 11' by 5', shed-roofed porch which forms the north end of the west elevation. The enclosed porch is approached by a 2-step wood and concrete stoop, and its wall is penetrated by a band of four 8-light fixed-pane windows. The façade wall, to the east of the entry porch, is dominated by a hip-roofed bay, with four 1/1 double-hung sash windows. The west elevation is also penetrated by a set of paired 1/1 double-hung sash windows. All of the home's windows feature painted cream white wood frames and surrounds. A painted cream white wood-paneled door, with one upper sash light, and with a transom light, enters the west end of the south elevation from an elevated wood deck.**

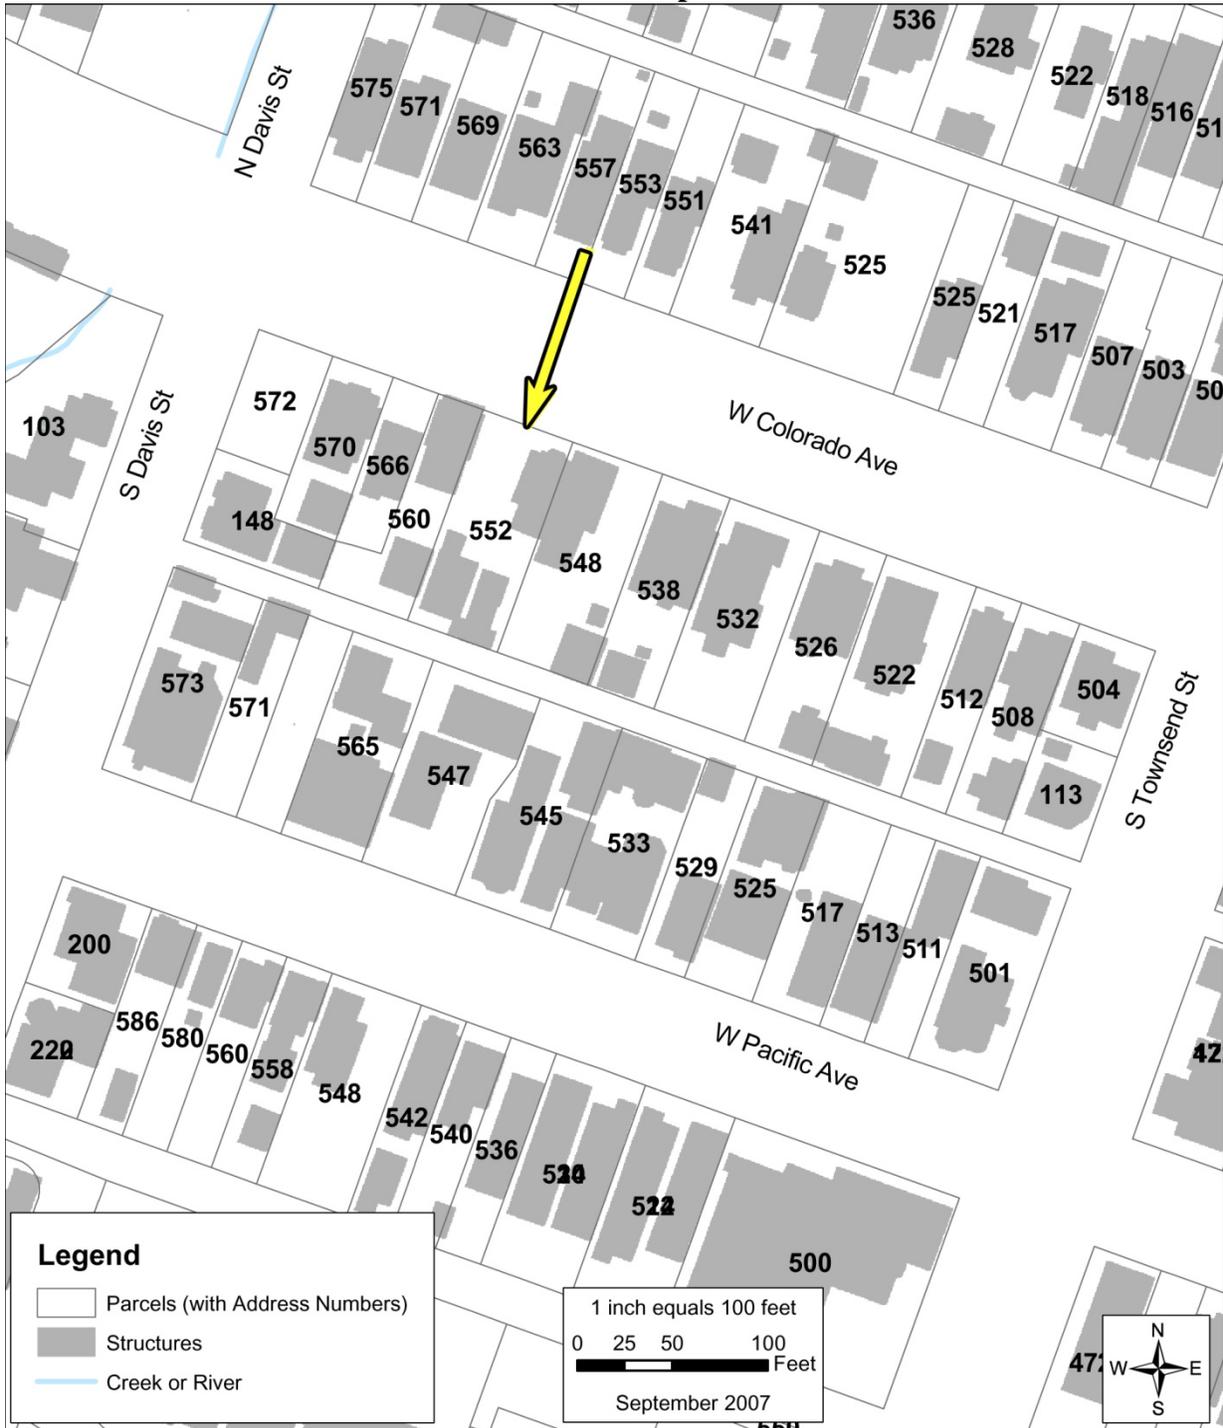
## Sketch Map

**This property is located on the south side of West Colorado Avenue, in the block between Townsend and Davis Streets, near the west end of the Telluride National Historic Landmark district.**

**This historic building located near the rear (south end) of the property actually consists of three separate abutting structures - a secondary residence, and two sheds. Overall, the three structures measure 36' N-S by 16.5' E-W.**
