COLORADO CULTURAL RESOURCE SURVEY

Architectural Inventory Form

- 1. Resource number: **5SM.1584/THAS28**
- 2. Temporary resource number: **N/A**
- 3. County: **San Miguel**
- 4. City: **Telluride**
- 5. Historic Building Name: **Unknown**
- 6. Current Building Name: **Frankmann House**
- 7. Building Address: **553 W Colorado Ave**
- 8. Owner Name and Address: **Mark Frankmann
P. O. Box 330
Telluride, CO 81435-0330**

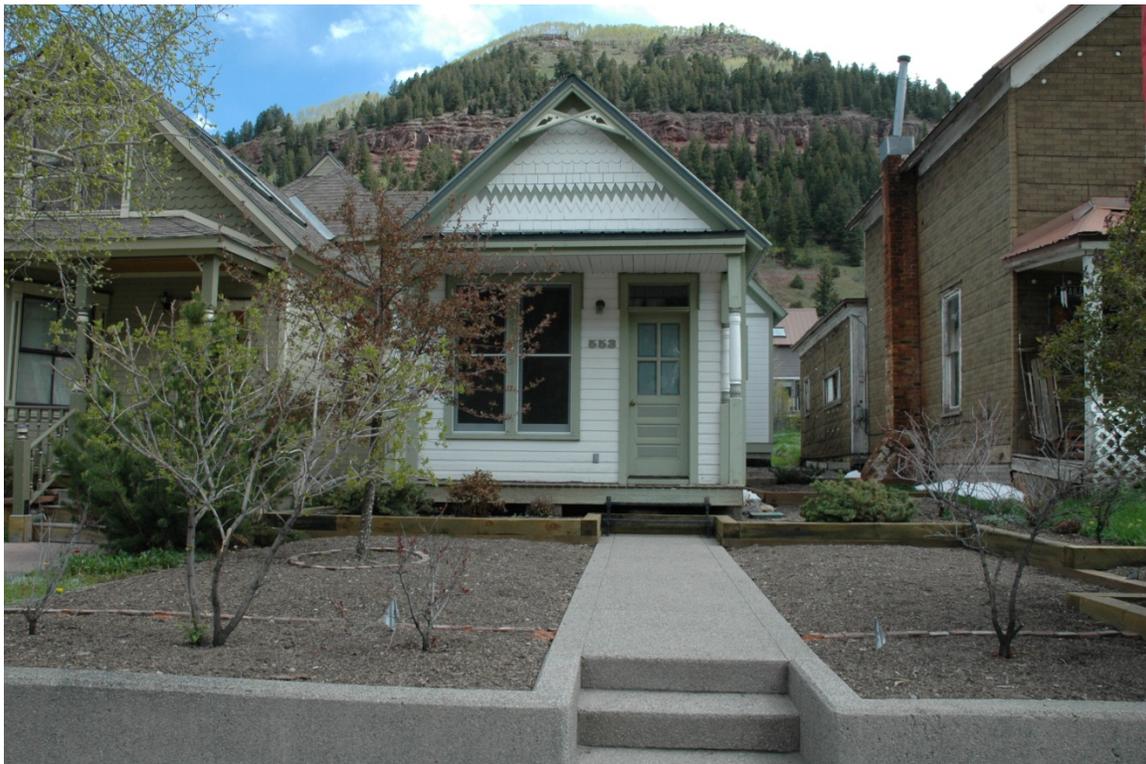
21. General architectural description:
The building at 553 W. Colorado Avenue consists of a small, circa 1894, rectangular-shaped wood frame dwelling, with a 1989 addition to the north (rear) elevation. The original dwelling measures only 24' N-S (deep) by 14.5' E-W (across); the 1989 addition measures 30' N-S by 18' E-W. The exterior walls of the original house are clad with painted white horizontal weatherboard siding, with painted green 1" by 4" corner boards. Painted green and white variegated wood shingles, and a gable ornament appear in the façade's upper gable end. The front gable roof is steeply-pitched, and is covered with metal roofing material. The eaves are boxed with painted green wood trim. The house's façade faces toward W. Colorado Avenue on the south elevation. A painted green wood-paneled front door, with four upper sash lights and a transom light, enters the east end of the façade from a full-width front porch. The 4' by 14.5' front porch is approached by two metal (iron?) steps, and features a wood plank floor, painted green and white turned columns and engaged columns, and a low-pitched hip roof. Two 1/1 double-hung sash windows, with painted green wood surrounds, overlook the front porch to the west of the entry door. 1/1 double-hung sash windows also penetrate the original dwelling's east and west (side) elevations.

- The 1989 addition is supported by a concrete foundation, and its exterior walls are also clad with painted white horizontal weatherboard siding, with painted green 1" by 4" corner boards. The addition is covered by a gable roof, with black asphalt composition shingles and with boxed eaves. A painted green wood-paneled door, with one upper sash light, enters the east end of the addition's north elevation. Like the original dwelling, the addition's windows are also primarily 1/1 double-hung sash with painted wood surrounds.**
