COLORADO CULTURAL RESOURCE SURVEY

Architectural Inventory Form

- 1. Resource number: **5SM.1582/THAS.31**
- 2. Temporary resource number: **N/A**
- 3. County: **San Miguel**
- 4. City: **Telluride**
- 5. Historic Building Name: **Wilson House**
- 6. Current Building Name: **Triple J of Telluride House**
- 7. Building Address: **563 W. Colorado Avenue**
- 8. Owner Name and Address: **Triple J of Telluride Limited Partnership
5519 SW Campbell Pl.
Seattle, WA 98116**

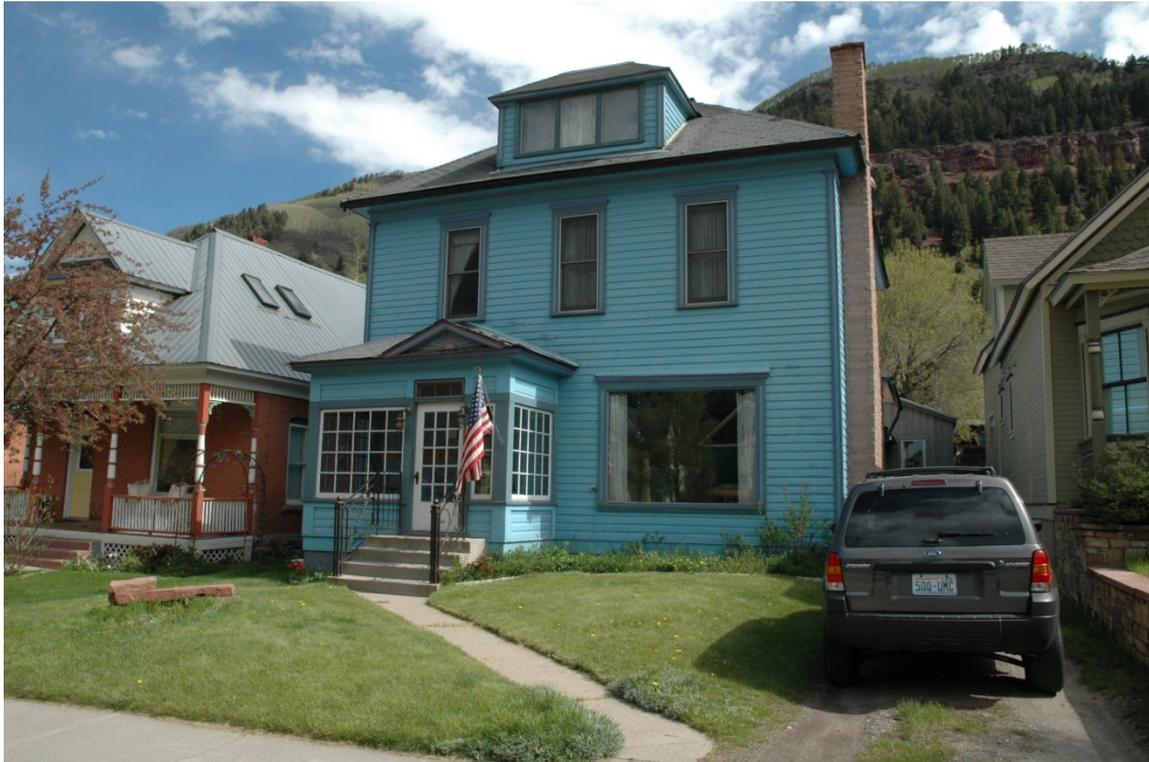
21. General architectural description:
This is a 2.5-story, hip-roofed, wood frame dwelling, with a single-story hip-roofed extension to the north (rear) elevation. The main 2-story portion of the house measures 30' N-S (deep) by 28' E-W (across); the single-story extension measures 12.5' N-S by 23' E-W. The house is supported by a low stone foundation, covered with concrete pargeting. The exterior walls are clad with painted light blue horizontal weatherboard siding, with painted dark blue 1" by 4" corner boards. The hip roof over the two story portion is truncated, and is covered with black asphalt composition shingles. The eaves are boxed with painted light blue wood trim. A non-historic masonry fireplace chimney is located near the south end of the east elevation. A hip-roofed dormer, with a band of three (probably non-historic) windows, overlooks the façade on the south-facing roof slope. An enclosed hip-roofed front porch, which measures 6' N-S by 12' E-W, covers the west end of the façade (south elevation). The porch is approached by a 4-step concrete stoop flanked by distinctive wrought iron railings. A painted white, 15-light, glass-in-wood-frame door, with a sidelight and transom light, leads from the stoop into the porch. A low intersecting gable, with a sunburst motif, is positioned above the entry door. The porch walls are also penetrated by three 20-light fixed-pane windows. A non-historic single-light fixed-pane window penetrates the façade wall to the east of the porch. A bowed bay on the east elevation presently features multiple glass block windows. Windows elsewhere, including those on the second story, are primarily 1/1 double-hung sash with painted wood frames and surrounds.
