COLORADO CULTURAL RESOURCE SURVEY

Architectural Inventory Form

- 1. Resource number: **5SM.1581/THAS32**
- 2. Temporary resource number: **N/A**
- 3. County: **San Miguel**
- 4. City: **Telluride**
- 5. Historic Building Name: **Unknown**
- 6. Current Building Name: **Schmeltz House**
- 7. Building Address: **569 W. Colorado Avenue**
- 8. Owner Name and Address: **Schmeltz Family Trust  
P.O. Box 3857  
Telluride, CO 81435**

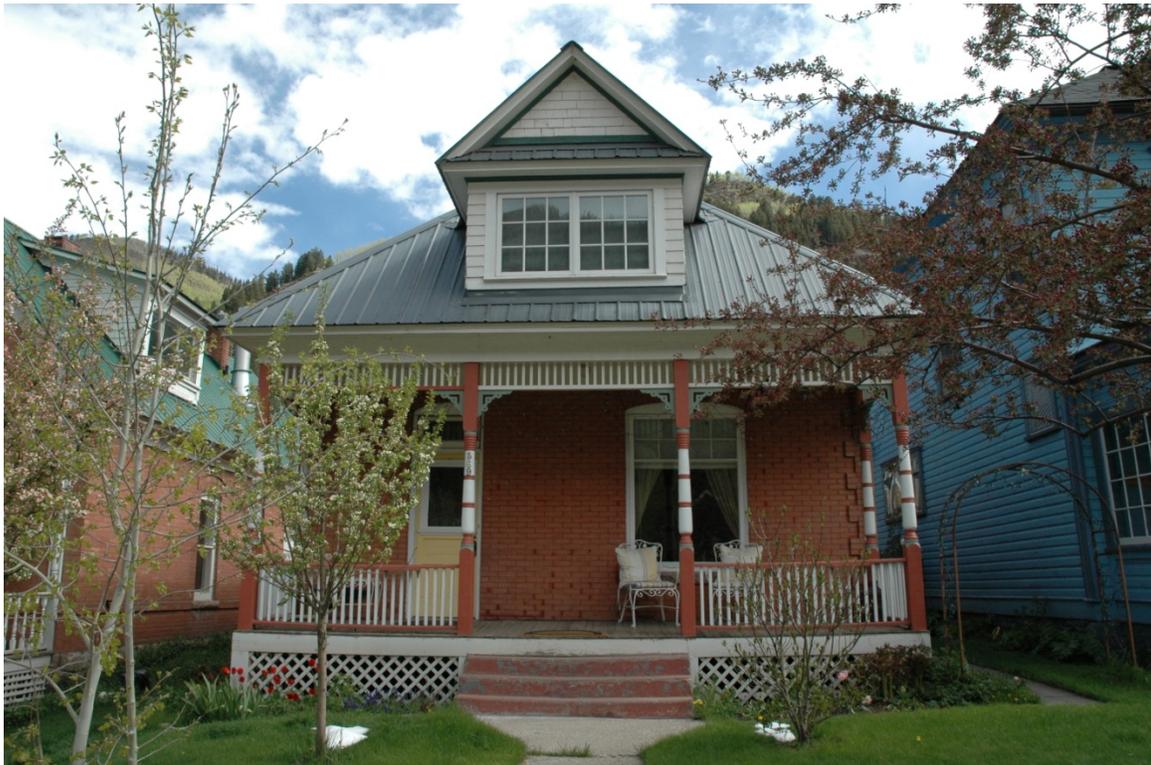
**Window/Segmental Arch**
21. General architectural description:  
**This 1.5-story, rectangular-shaped, brick masonry dwelling measures 45.5' N-S (deep) by 23' E-W (across). It is supported by a low coursed sandstone foundation, and its solid red brick walls are laid in running bond. The corners feature decorative brickwork, creating a quoining effect. The house is covered by a steeply-pitched hip roof, with metal roofing material, and with painted white boxed eaves. A large gable dormer, with a set of paired 9-light casement windows, overlooks the façade on the south elevation. There are two red brick chimneys: one is located near the rear of the east-facing roof slope; the other is located just below the ridge on the west-facing slope. The front entry door enters the house from the front porch near the west end of the façade. This is a painted yellow with white trim wood-paneled door, with one upper sash light, a transom light, and a segmental brick arch header. The full-width front porch measures 5' N-S by 23' E-W, and is recessed under the front eave of the house's hip roof. The porch is approached by three concrete steps, and features a tongue-in-groove wood floor, an open wood railing, turned columns and engaged columns, decorative brackets, and a wooden frieze. A large single-hung sash window, with a painted white wood frame, a sandstone lugsill, and a segmental brick arch, overlooks the porch to the east of the entry door. Windows elsewhere are predominantly 1/1 double-hung sash, with painted white wood frames, sandstone lugsills, and segmental brick arches. A painted yellow glass-in-wood-frame door, with a transom light and a segmental brick arch, enters the north (rear) elevation from a wood deck.**

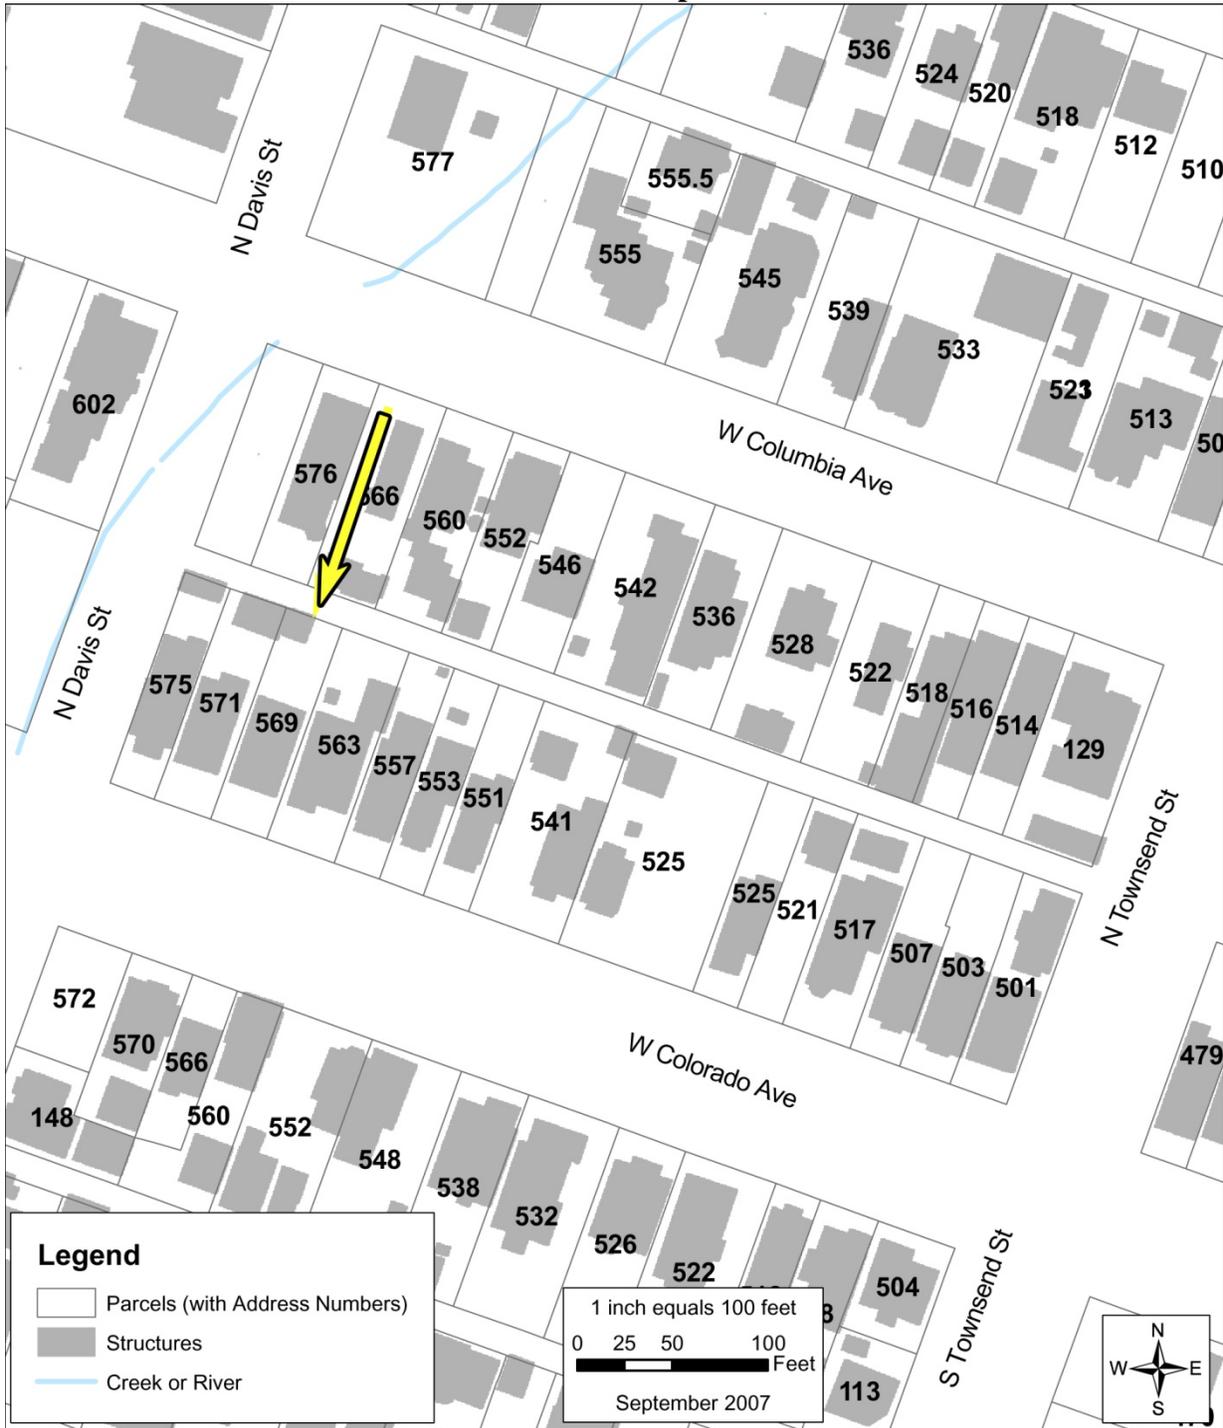
## Sketch Map

**This property is located on the north side of Colorado Avenue in the block between Townsend and Davis Streets, near the west end of the Telluride National Historic Landmark District.**

<b>Shed (THAS #32)</b>
A shed which measures approximately 12' by 10' is located adjacent to the alley at the rear northwest corner of the property. This structure has a high stone-faced foundation, above the foundation, its exterior walls are clad with horizontal wood siding. The shed is covered by an intersecting hip and gable roof, with rolled red asphalt roofing material laid over 1x wood decking and 2x wood rafters. Two plywood or diagonal wood plank doors are located on the east elevation. A single-light fixed-pane window penetrates the south elevation. A shuttered window opening is located on the north elevation.
