COLORADO CULTURAL RESOURCE SURVEY

Architectural Inventory Form

- 1. Resource number: **5SM.1579/THAS.35**
- 2. Temporary resource number: **N/A**
- 3. County: **San Miguel**
- 4. City: **Telluride**
- 5. Historic Building Name: **Unknown**
- 6. Current Building Name: **Perpar Residence**
- 7. Building Address: **575 W. Colorado Avenue**
- 8. Owner Name and Address: **Kristine Perpar  
P.O. Box 3206  
Telluride, CO 81435**

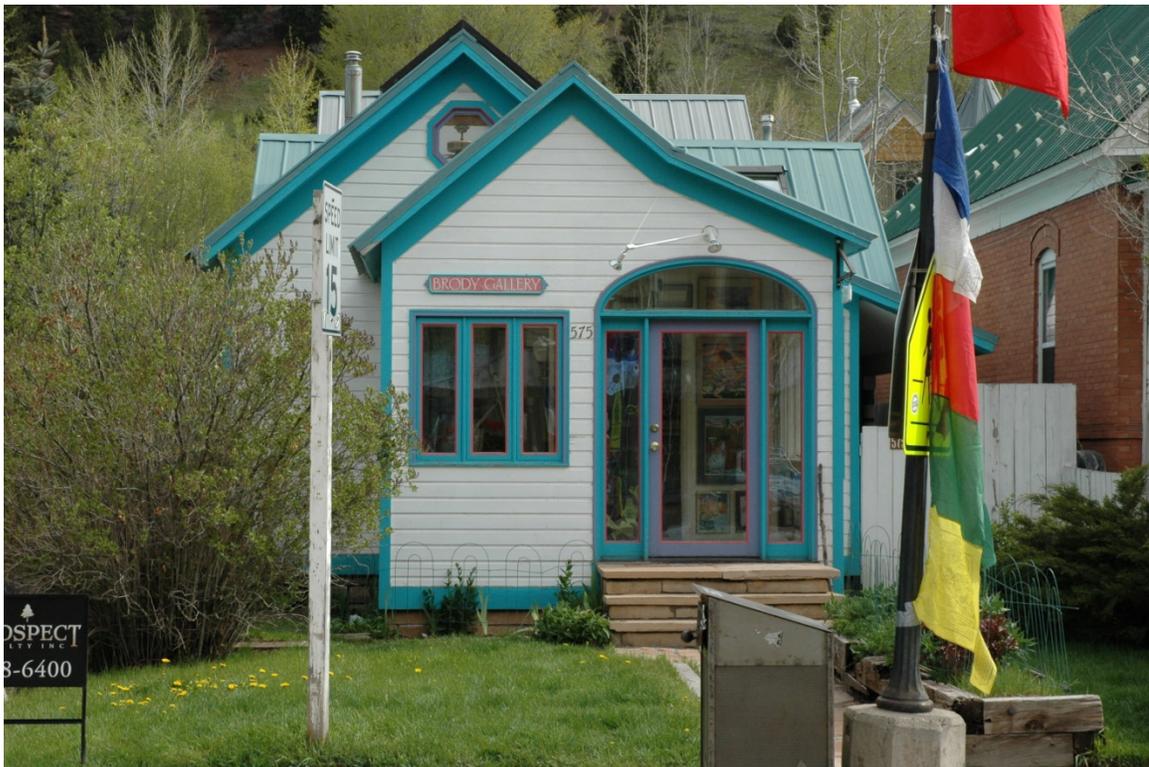
**This 1.5-story wood frame building is presently used as a residence and as an art gallery. Overall, it measures 48' N-S (deep) by 20' E-W (across). Included in these dimensions is a tall, angular, 1.5-story, cross-gabled addition to the north (rear) elevation which measures 12.5' by 20'. The dwelling/art gallery is supported by a low coursed sandstone foundation, and its exterior walls are clad with painted cream white horizontal weatherboard siding, with painted turquoise 1" by 4" corner boards. The cross gable roof is covered with metal roofing material, and the eaves are boxed with painted turquoise wood trim. Non-historic (but pre-1986) skylights are located on the south and east facing roof slopes. The front entry porch, at the east end of the façade (south elevation) has been altered since 1986. The porch now features a painted purple glass-in-wood-frame door, with sidelights, and a segmental transom light, which enters the enclosed porch from a 3-step flagstone stoop. The enclosed porch is covered by a shed-roof extension of a front-gabled addition at the front of the building. A band of three, non-historic, casement windows penetrate the façade wall to the west of the porch. A set of paired glass-in-wood-frame doors, covered by a gable hood, enters the building's west elevation.**

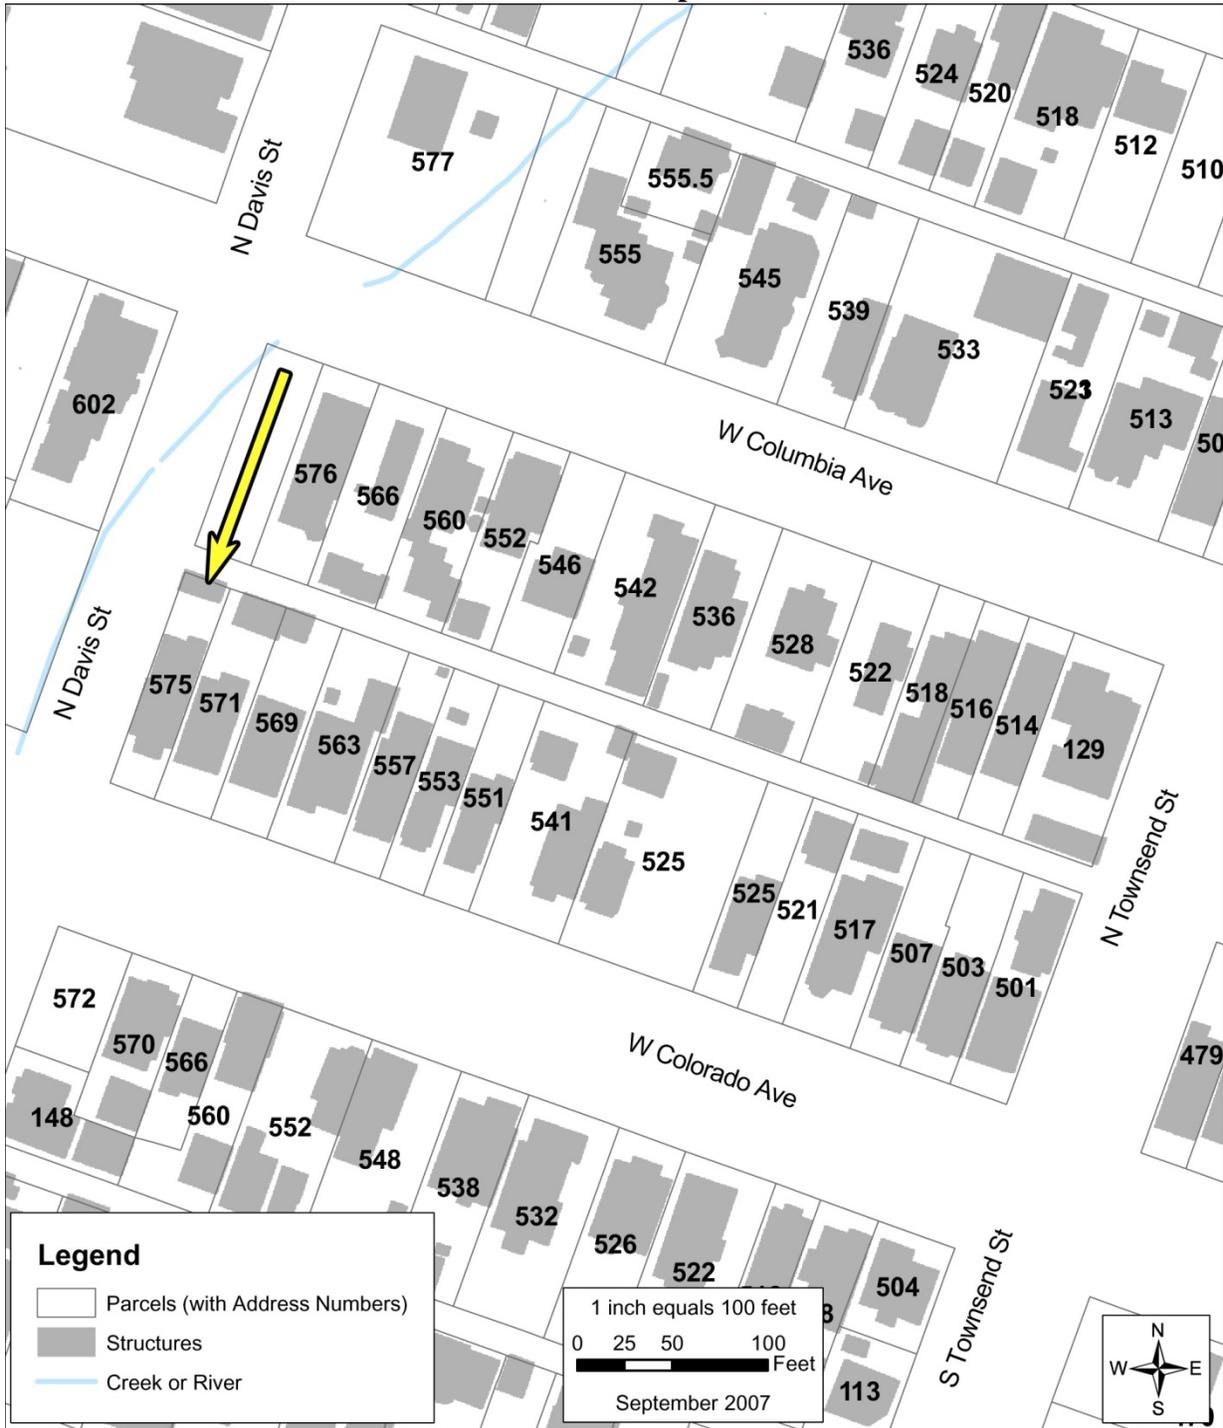
## Sketch Map

**This property is located at the northeast corner of W. Colorado Avenue and Davis Street, at the west end of the Telluride National Historic Landmark District. A wood privacy fence paralleling Davis Street on the west property line is adorned with multiple three-dimensional artistic items. Cornet Creek flows generally north-to-south, just to the west of this property.**

<b>Shed (THAS #35)</b>
<b>A shed is located at the rear northwest corner of the property. This wood frame building measures 11' N-S by 22' E-W, and is supported by a wood timbers on grade foundation. It has board-and-batten exterior walls, and a shed roof with corrugated metal roofing material. Two horizontal and diagonal wood plank doors, both side-hinged with metal strap hinges, are located on the south elevation. A 1/1 double-hung sash window, and a single-light fixed-pane window, penetrate the shed's north elevation.</b>
