COLORADO CULTURAL RESOURCE SURVEY

Architectural Inventory Form

- 1. Resource number: **5SM.1829**
- 2. Temporary resource number: **N/A**
- 3. County: **San Miguel**
- 4. City: **Telluride**
- 5. Historic Building Name: **Unknown**
- 6. Current Building Name: **Decastro House**
- 7. Building Address: **627 E. Colorado Avenue**
- 8. Owner Name and Address: **Vicente M. III, and Nancy Scott Decastro
PO Box 3119
Telluride, CO 814353119**

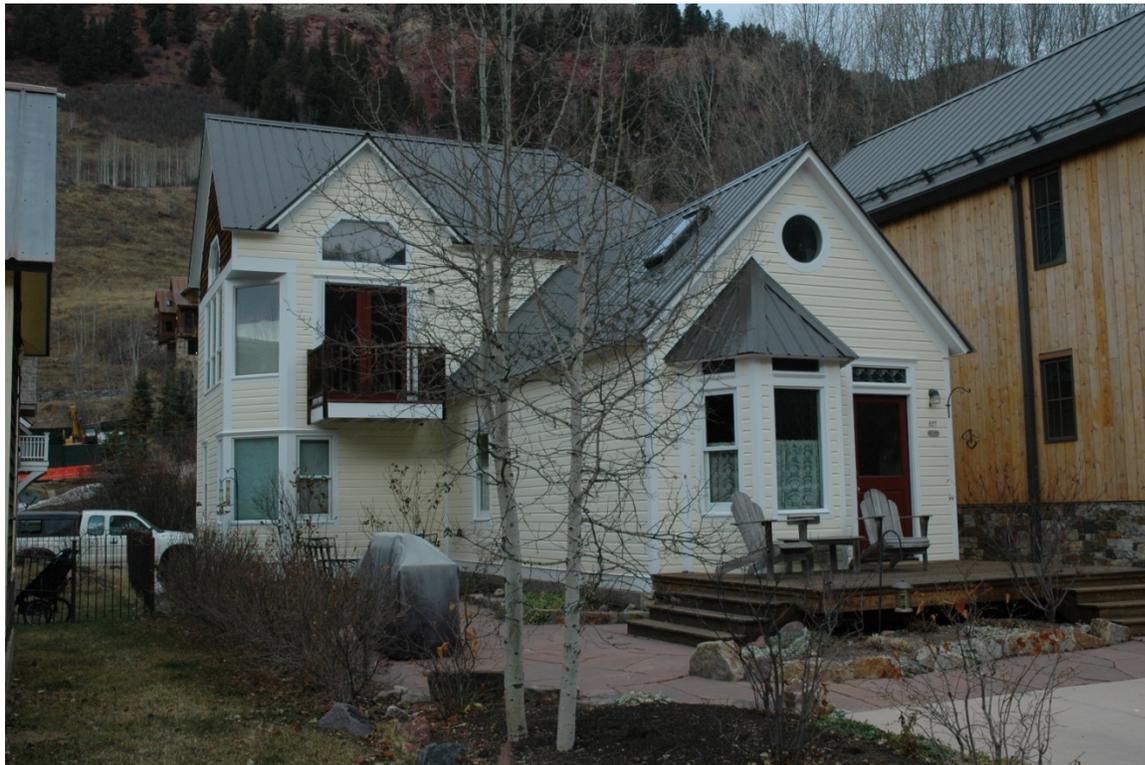
18. Roof configuration: **Gabled Roof / Front Gabled Roof**
19. Primary external roof material: **Metal Roof**
20. Special features: **Porch**
21. General architectural description:
This residence consists of a small historic front gabled dwelling, reportedly moved to this location in 1978, together with a large 2½-story gabled addition to the north (rear) elevation. The house rests on a poured concrete foundation, faced with a stone veneer. The exterior walls are clad with painted yellow horizontal weatherboard siding, with painted white 1" by 4" corner boards. The gable roof over the original dwelling and the gable roof over the addition are both covered with metal roofing material, and the eaves are boxed with painted white wood trim. The building's asymmetrical facade faces Colorado Avenue on the south elevation. A painted burgundy wood-paneled front door, with one upper sash light and a transom light, enters the east half of the facade from an uncovered 4-step wood porch/deck. A painted burgundy wood-paneled door, with nine upper sash lights, enters an enclosed shed-roofed rear porch at the north end of the east elevation. A non-historic oculus window penetrates the facade's upper gable end. A non-historic canted bay is located on the facade west of the front door. Other windows on the original dwelling are 1/1 double-hung sash and single-light fixed-panes.

This building displays a below average standard of physical integrity, relative to the seven aspects of integrity as defined by the National Park Service and the Colorado Historical Society, Office of Archaeology and Historic Preservation - setting, location, design, materials, workmanship, feeling and association. The small historic front gabled dwelling lost its integrity of setting and location when it was reportedly moved to this location in 1978. At this site, the small building's physical integrity was further compromised by the construction of a large rear addition, and by the installation of a new bay window and an oculus window on the facade.

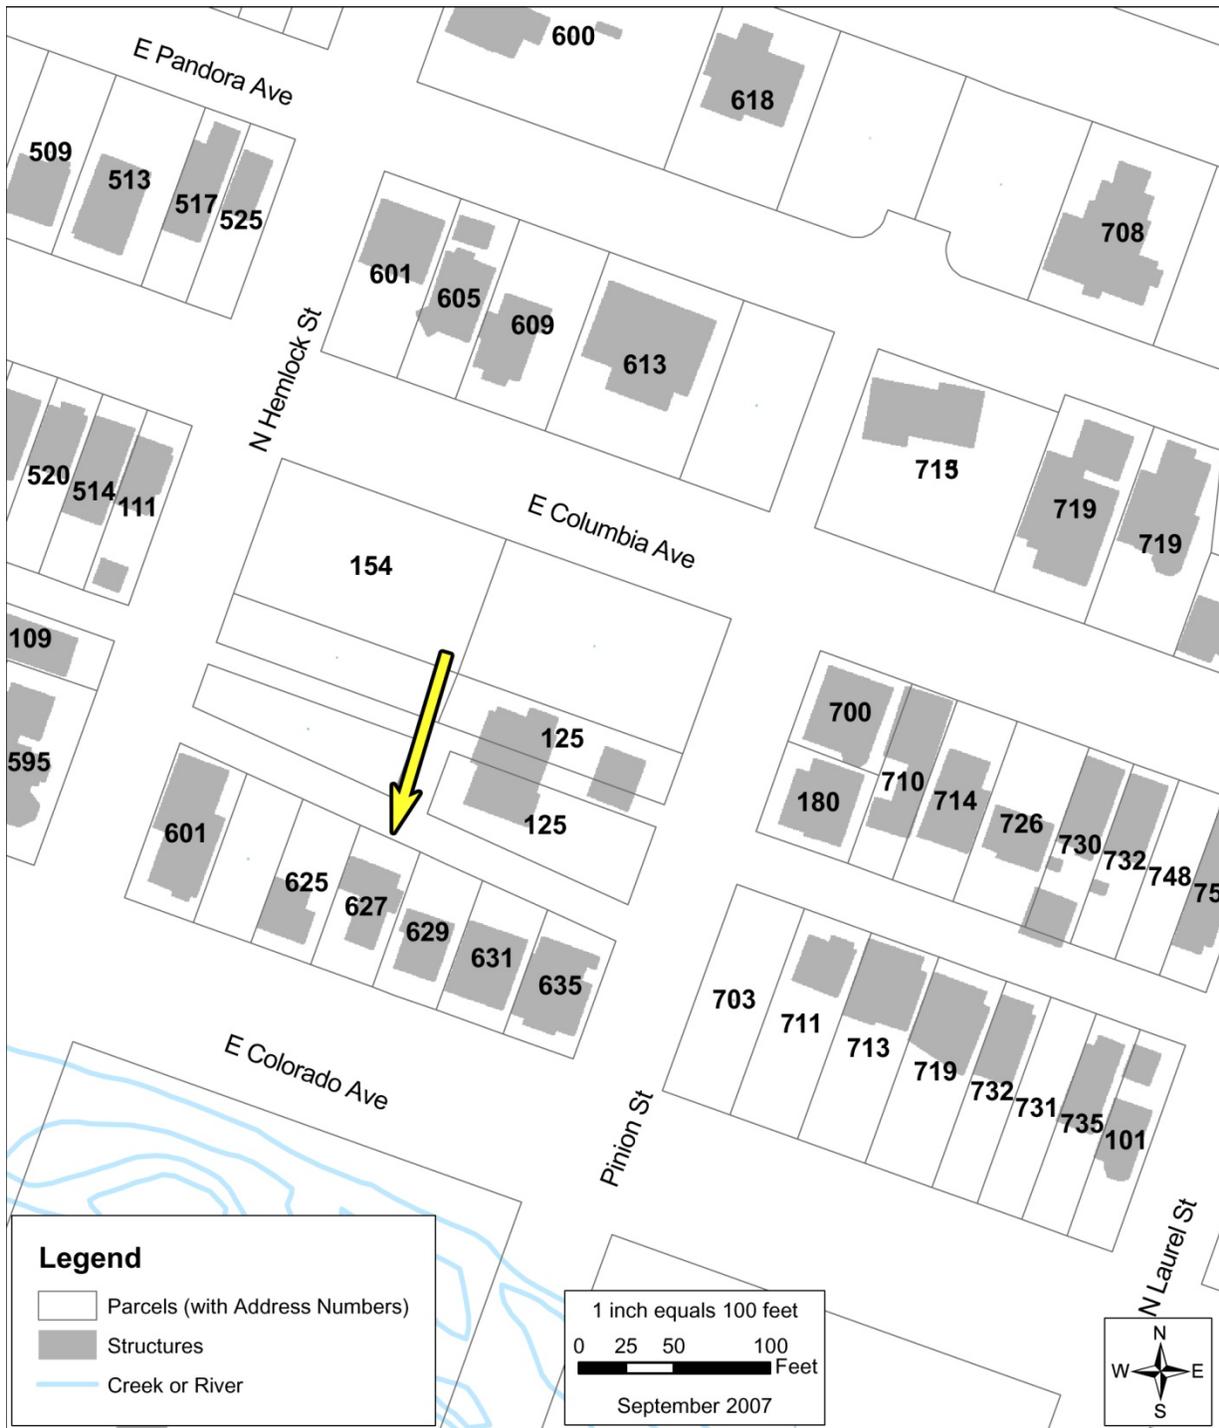
Sketch Map

22. Architectural style: **Modern Movements**
 Building type:
23. Landscape or special setting features:
This property is located on the north side of E. Colorado Avenue in the block east of Hemlock Street. A concrete parking pad comprises the west half of the front yard, while the remainder of the front yard is paved with flagstone, landscaped with low native plants and flowers.
