COLORADO CULTURAL RESOURCE SURVEY

Architectural Inventory Form

- 1. Resource number: **5SM.1834** Parcel number(s): **456536416006**
- 2. Temporary resource no: **N/A** **456536416007**
- 3. County: **San Miguel** **456536416005**
- 4. City: **Telluride** **456536416008**
- 5. Historic Building Name: **Unknown** **477901118003**
- 6. Current Building Name: **Columbia LLC Building**
- 7. Building Address: **116 W. Columbia Avenue**
- 8. Owner Name and Address: **Columbia LLC , P. O. Box 1105, Telluride, CO 81435**
Robert H. Savath Trust, PO Box 606, Telluride, CO 81435
Lucy Boody Melzer , P.O. Box 3518, Telluride, CO 814353518

| 48. Report title: | Town of Telluride Re-Survey of Historic Structures | | Planning and Building

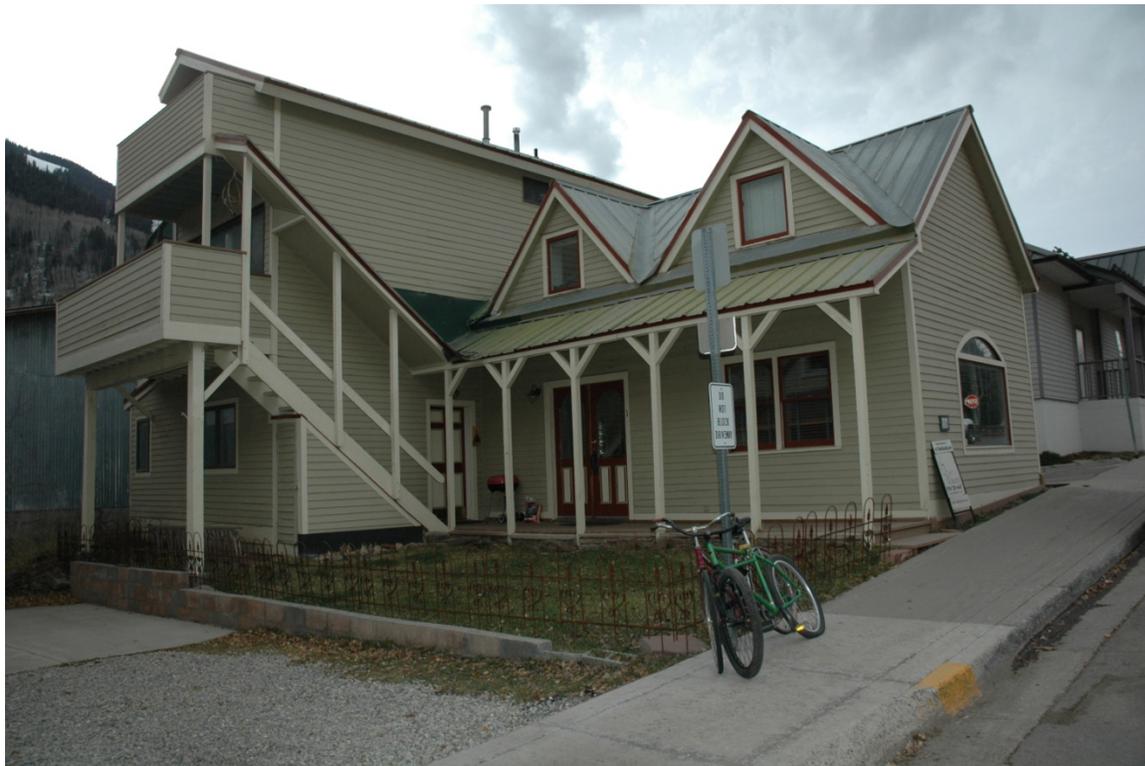
THLD RATING:	Noncontributing Without Qualifications
---------------------	---

18. Roof configuration: **Gabled Roof**
19. Primary external roof material: **Metal Roof**
20. Special features: **Porch**
21. General architectural description:
This building consists of a single-story gabled section to the north, with a taller 2½-story gabled extension to the south. The building rests on a low stone or poured concrete foundation, while its exterior walls are clad with painted beige horizontal wood siding with painted cream white 1" by 4" corner boards. The roof is covered with metal roofing material, and the eaves are boxed with painted beige and white wood trim. A gabled dormer, with a single-light casement window, is on the west-facing roof slope. Two non-historic bubble skylights are on the west-facing roof slope. Two gabled dormers, each with a single-light casement window, are on the east-facing roof slope. A set of paired wood-paneled doors, with rounded upper sash lights, enter the east elevation from an open porch. This porch features a wood plank floor, painted cream white square wood posts, brackets, and a shed roof. A set of paired 1/1 double-hung sash windows overlook the porch north of the entry door. A non-historic single-light window, with a segmental transom light, penetrates the north elevation, facing Columbia Avenue. A wooden staircase at the east end of the north elevation leads to a second story porch, as well as to a smaller porch in the upper half story of the rear 2½-story portion of the building. A painted buff red and cream white wood-paneled door enters the main level of the 2½-story section on the north elevation.

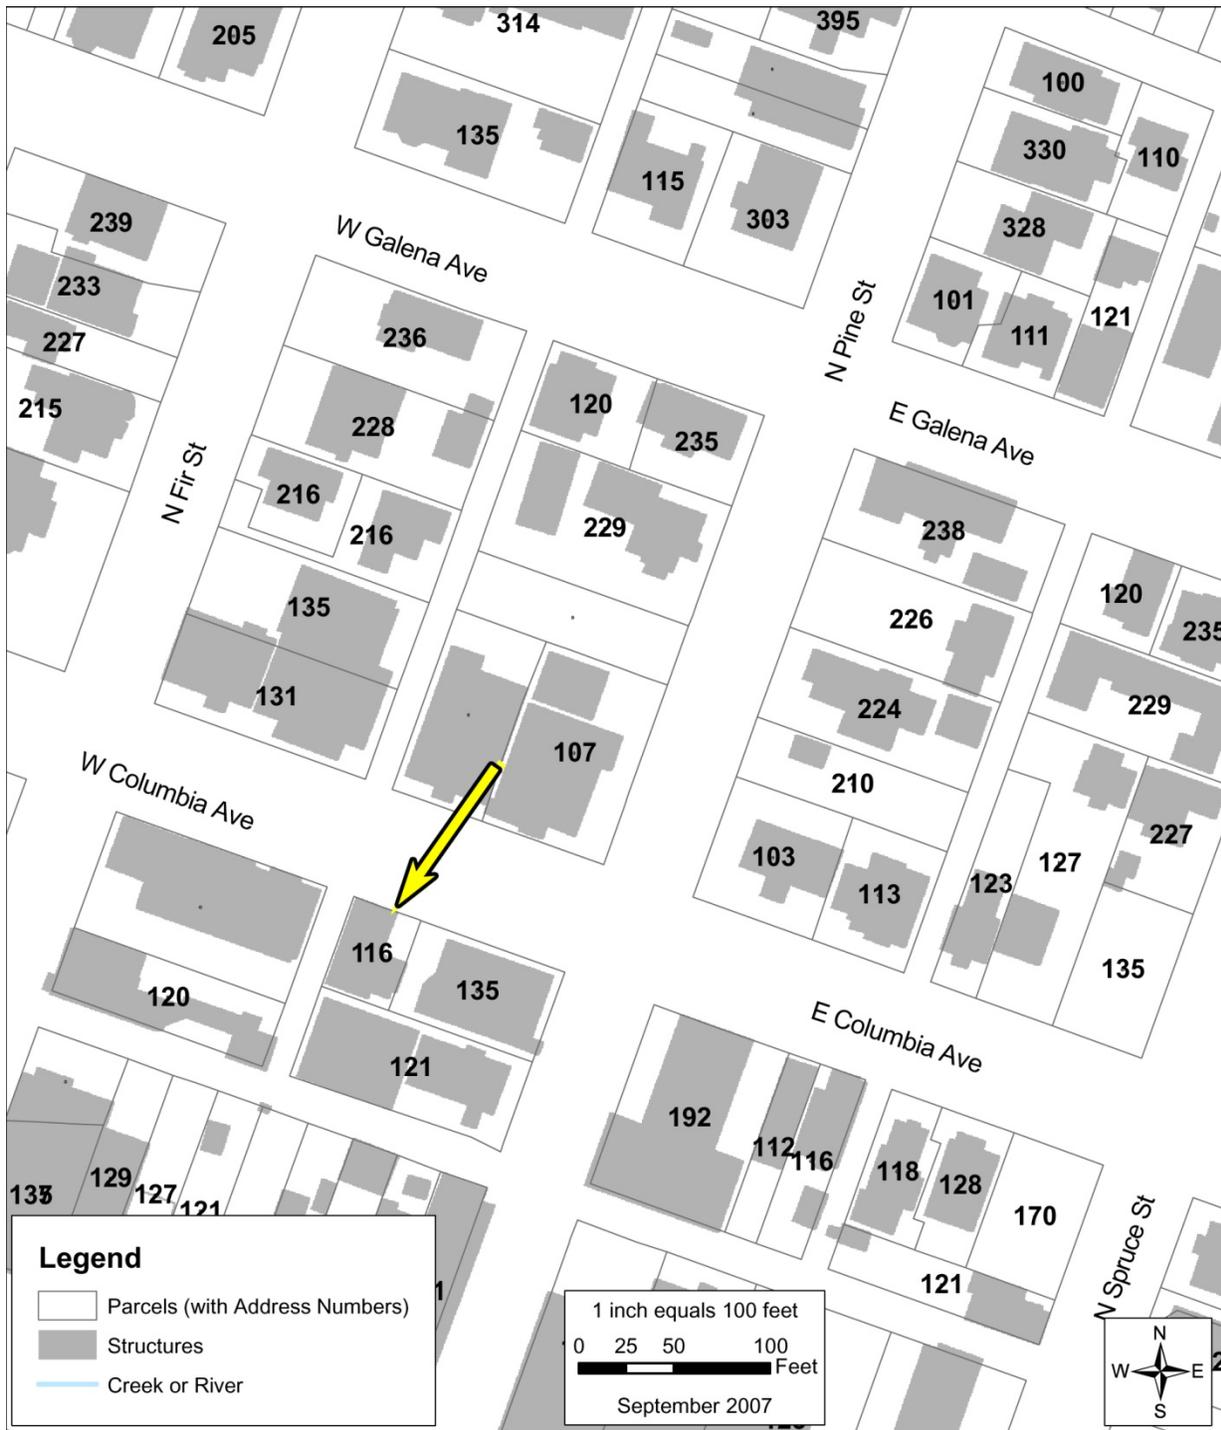
Sketch Map

This building is located on the south side of Columbia Avenue in the block between Fir and Pine Streets. The alley between the two streets is just to the west of this property.
