COLORADO CULTURAL RESOURCE SURVEY

Architectural Inventory Form

- 1. Resource number: **5SM.1763**
- 2. Temporary resource number: **N/A**
- 3. County: **San Miguel**
- 4. City: **Telluride**
- 5. Historic Building Name: **Unknown**
- 6. Current Building Name: **Sante House**
- 7. Building Address: **123 E. Columbia Avenue**
- 8. Owner Name and Address: **Peter & Molly Sante
P.O. Box 61
Telluride, CO 81435**

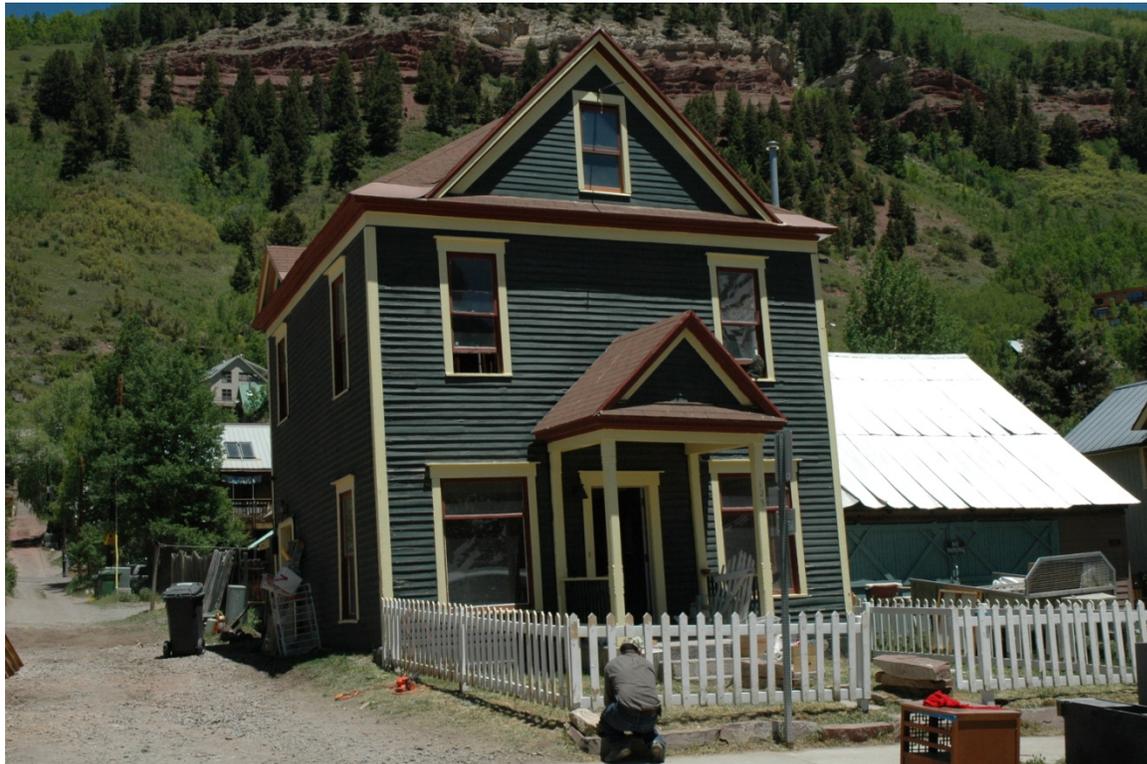
THLD RATING:	Contributing to District
---------------------	---------------------------------

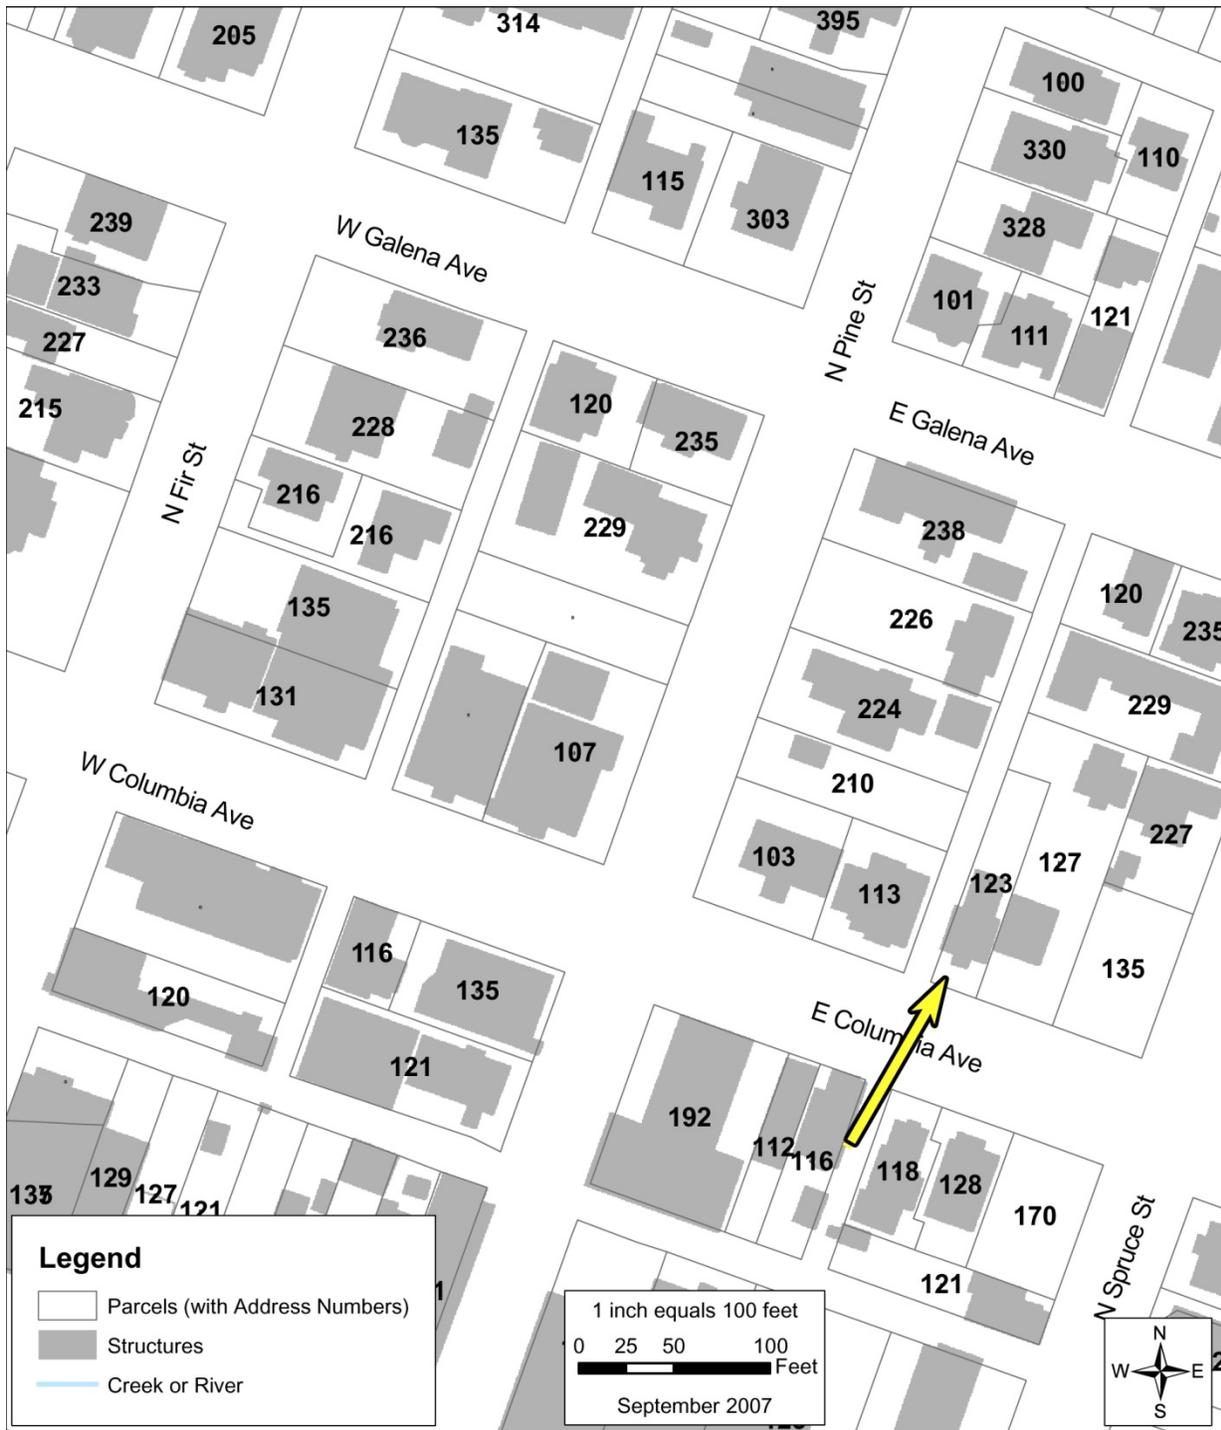
Sketch Map

This property is located on the north side of Columbia Avenue, just east of the alley between Pine and Spruce Streets. A painted white picket fence encloses a small front yard, while the backyard is enclosed by an older wood privacy fence. A narrow grass strip is located between the front sidewalk and the curb along Columbia Avenue. A north-south trending alley runs along the west side of the property.
