COLORADO CULTURAL RESOURCE SURVEY

Architectural Inventory Form

- 1. Resource number: **5SM.1764** Parcel number(s): **477901118025**
- 2. Temporary resource number: **N/A**
- 3. County: **San Miguel**
- 4. City: **Telluride**
- 5. Historic Building Name: **Unknown**
- 6. Current Building Name: **Boukouzis House**
- 7. Building Address: **128 E. Columbia Avenue (formerly 135 N. Spruce St.)**
- 8. Owner Name and Address: **Peter Boukouzis
6350 Auden St
Houston, TX 77005**

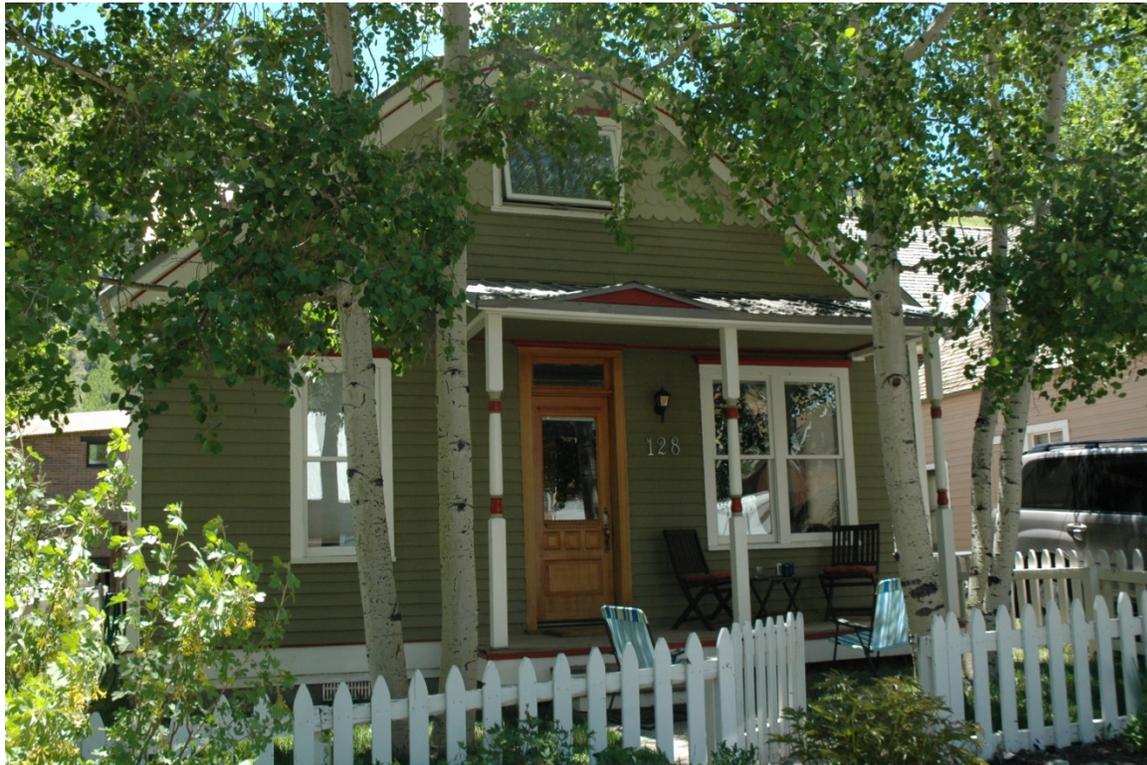
18. Roof configuration: **Gambrel Roof**
19. Primary external roof material: **Metal Roof**
20. Special features: **Porch, Chimney, Fence**
21. General architectural description:
This 1½-story wood frame dwelling rests on an unpainted poured concrete foundation. Its exterior walls are clad with painted light brown horizontal wood siding with painted white 1" by 4" corner boards, and with fish scale shingles in the facade's upper gambrel end. The home's gambrel roof is covered with metal roofing material and the eaves are boxed with painted white wood trim. A metal-capped red brick chimney is on the ridge. Windows are predominantly single and paired 1/1 double-hung sash with painted white and red wood frames and surrounds. The facade faces Columbia Avenue on the north elevation. A non-historic stained brown wood-paneled door, with one upper sash light and a transom light, enters the facade from an open front porch. This porch measures approximately 4' N-S by 15' E-W, and features a wood plank floor, turned columns, and a shed roof with an intersecting gable. A 2½-story gabled addition extends from the building's south (rear) elevation. The addition is supported by a poured concrete foundation, and its exterior walls are clad with painted light brown horizontal weatherboard siding with painted white 1" by 4" corner boards. The addition is covered by a steeply-pitched cross gabled roof with wood shingles and painted white boxed eaves. Windows in the addition are primarily 1/1 double-hung sash.
