COLORADO CULTURAL RESOURCE SURVEY

Architectural Inventory Form

- 1. Resource number: **5SM.1785**
- 2. Temporary resource number: **N/A**
- 3. County: **San Miguel**
- 4. City: **Telluride**
- 5. Historic Building Name: **Mitchel House**
- 6. Current Building Name: **Halle House**
- 7. Building Address: **220 E. Columbia Avenue**
- 8. Owner Name and Address: **James S. Halle
P. O. Box 167
Stevenson, MD 211530167**

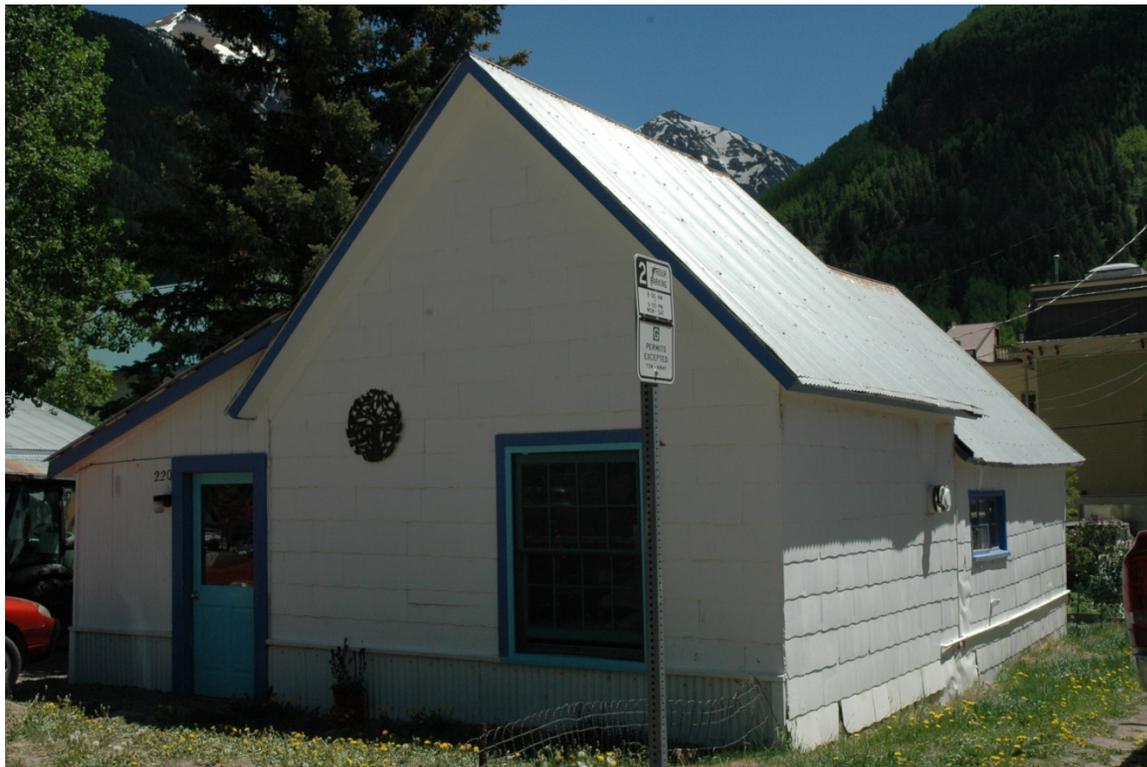
18. Roof configuration: **Gabled Roof / Front Gabled Roof**
19. Primary external roof material: **Metal Roof**
20. Special features: **Fence**
21. General architectural description:
This single-story wood frame residence is composed of a three sections: a main front gabled section, to the north (front), which measures sixteen feet square, a slightly lower gabled section to the south (rear), which also measures sixteen feet square, and a shed-roofed extension along the east elevation, which measures 28' N-S by 8' E-W. The dwelling is supported by a poured concrete foundation covered by corrugated metal skirting above grade. The exterior walls of the gabled sections are primarily clad with white, undulated, asphalt shingle siding, while the exterior walls of the shed-roofed section are clad with painted white vertical wood siding. Portions of the south (rear) elevation are clad with painted white plywood, however. The roof is covered with corrugated metal roofing material, and the eaves are boxed with painted blue and white wood trim. A painted light blue wood-paneled door, with one upper sash light and a painted dark blue wood frame, enters an enclosed front porch, in the shed-roofed extension, at the east end of the north elevation (facade). A painted white wood-paneled door enters shed-roofed extension at the south end of the east elevation. The home's windows primarily feature painted blue wood frames and surrounds. A 15-light fixed-pane window penetrates the facade wall west of the entry door. The west elevation is penetrated by a 4x4 horizontal sliding window. Two single-light fixed-pane windows and a 1x1 horizontal sliding window penetrate the east elevation. The south elevation is penetrated by a 1/1 double-hung sash window, with a painted white wood frame and painted blue wood surrounds.

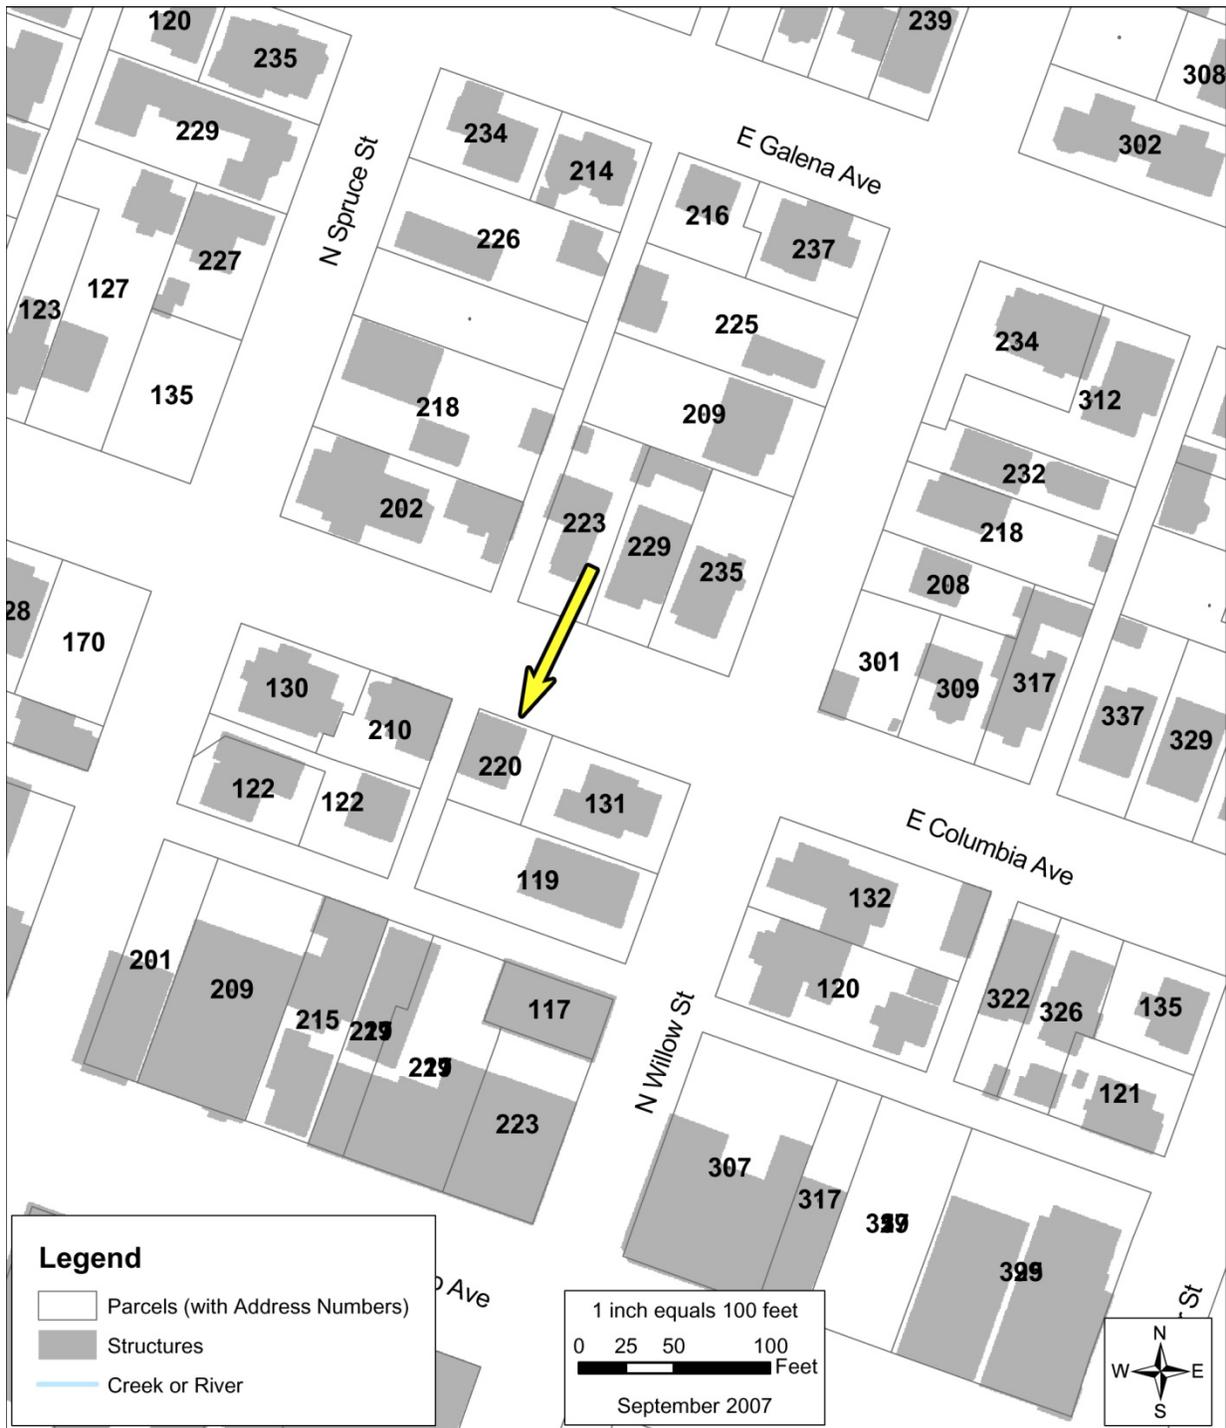
Sketch Map

This property is located on the south side of Columbia Avenue, the second house west of Willow Street. A small planted grass front yard is partially enclosed by a low woven wire fence. A short gravel driveway extends from Columbia Avenue to near the front northeast corner of the house. A fir tree is in the side yard east of the house.
