COLORADO CULTURAL RESOURCE SURVEY

Architectural Inventory Form

- 1. Resource number: **5SM.1782/THAS127**
- 2. Temporary resource number: **N/A**
- 3. County: **San Miguel**
- 4. City: **Telluride**
- 5. Historic Building Name: **Pugh House, Vigars House**
- 6. Current Building Name: **McTigue House**
- 7. Building Address: **223 E. Columbia Avenue**
- 8. Owner Name and Address: **Beverley G. McTigue, Jacob McTigue  
P. O. Box 1837  
Telluride, CO 814351837**

| 48. Report title: | <b>Town of Telluride Re-Survey of Historic Structures</b> | | <b>Planning and Building<br/>Department</b> |

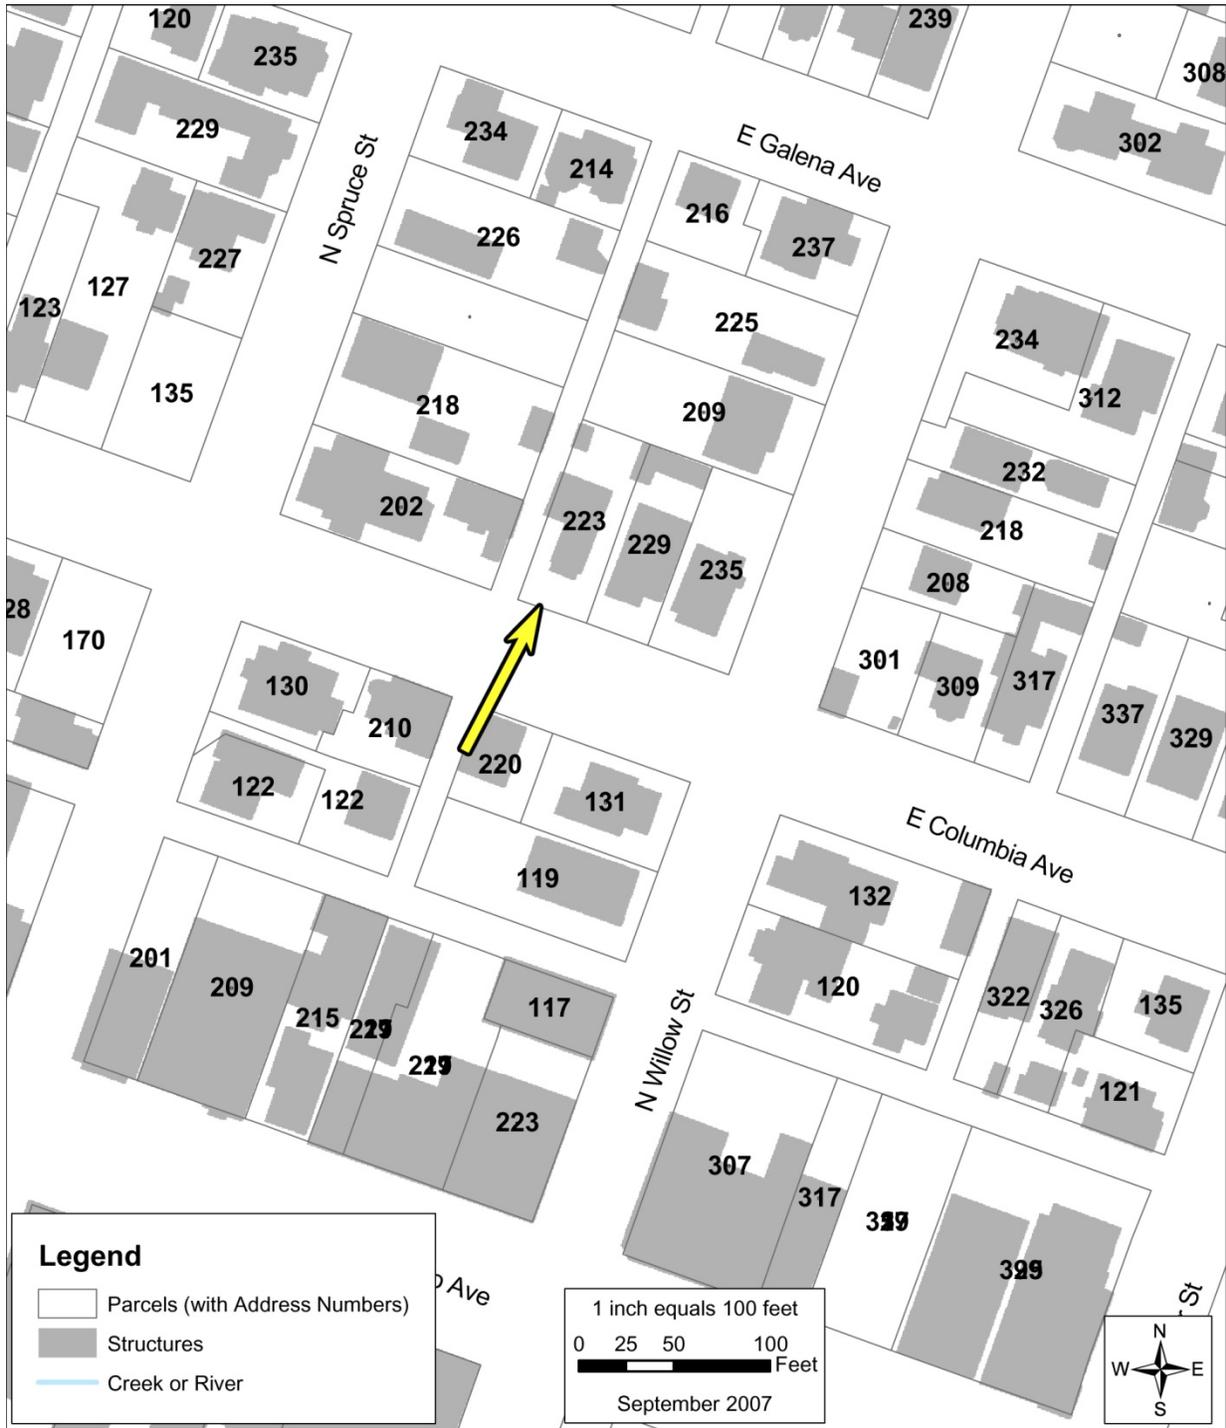
## Sketch Map

**This property is located on the north side of Columbia Avenue in the block between Spruce and Willow Streets. A small front yard is enclosed by a low picket fence. An alley is to the west.**

**A historic shed is located near the alley toward the rear northwest corner of the property. This small utilitarian structure features a rectangular shape, with board-and-batten clad exterior walls, and with a shed roof. The entry door is on the east elevation, opening into the backyard. Per the current owner, the shed features newer 2" by 4" dimensional lumber framing and a metal roof over plywood decking.**
