COLORADO CULTURAL RESOURCE SURVEY

Architectural Inventory Form

- 1. Resource number: **5SM.1784**
- 2. Temporary resource number: **N/A**
- 3. County: **San Miguel**
- 4. City: **Telluride**
- 5. Historic Building Name: **Armstrong House**
- 6. Current Building Name: **235 E. Columbia, LLC House**
- 7. Building Address: **235 E. Columbia Avenue**
- 8. Owner Name and Address: **235 E. Columbia, LLC
11 Indian Creek Village
Miami Beach, FL 33154**

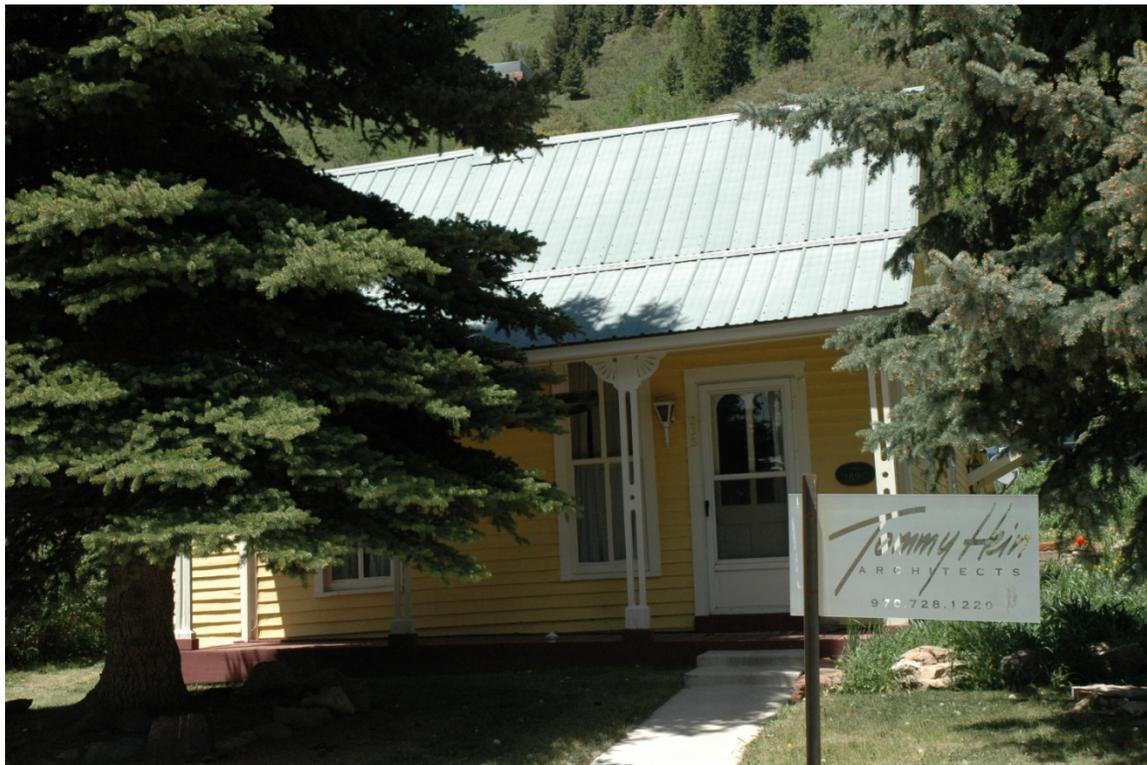
18. Roof configuration: **Gabled Roof / Cross Gabled Roof**
19. Primary external roof material: **Metal Roof**
20. Special features: **Porch, Chimneys**
21. General architectural description:
This building consists of the following elements: an original cross gabled section, which measures approximately 30' N-S (deep) by 24½' E-W (across); a narrow shed-roofed extension along the west elevation, a small, low, gabled addition at the west end of the north (rear) elevation, and two small, low, low shed-roofed additions at the east end of the north elevation. The building is supported by a painted yellow poured concrete foundation (or possibly painted yellow concrete pargeting over a low stone foundation). The exterior walls are clad with painted yellow horizontal wood siding, with painted white 1" by 4" corner boards. The main cross gabled roof is steeply-pitched, with metal roofing material and painted white boxed eaves. There are two red brick chimneys with corbelled caps, one on the front ridge, and the other on the intersecting rear ridge. The original windows are 2/2 double-hung sash with painted white wood frames and surrounds. The shed roofed extension along the west elevation is penetrated by two 1/1 double-hung sash windows with painted white wood frames and surrounds. The asymmetrical facade faces Columbia Avenue on the south elevation. A painted white wood-paneled front door, with two vertically-oriented upper sash lights with rounded tops, enters the east end of the facade from an open front porch. This porch measures 4' N-S by 20' E-W, and features a wood plank floor, painted white pierced wood supports, pierced fan shaped brackets, and a shed roof. Another painted white wood-paneled door, with two vertically-oriented upper sash lights with rounded tops, and with a transom light, enters the north end of the east elevation from a small concrete porch. This porch is covered by a shed roof with knee brace supports. A painted white solid wood door enters a shed roofed extension at the north end of the east elevation.
