COLORADO CULTURAL RESOURCE SURVEY

Architectural Inventory Form

I. IDENTIFICATION

- 1. Resource number: **5SM.1795**
- 2. Temporary resource number: **N/A**
- 3. County: **San Miguel**
- 4. City: **Telluride**
- 5. Historic Building Name: **Unknown**
- 6. Current Building Name: **McCoy House**
- 7. Building Address: **309 E. Columbia Avenue**
- 8. Owner Name and Address: **Jill McCoy
3001 Bridgeway, Ste. K
Sausalito, CA 949651485**

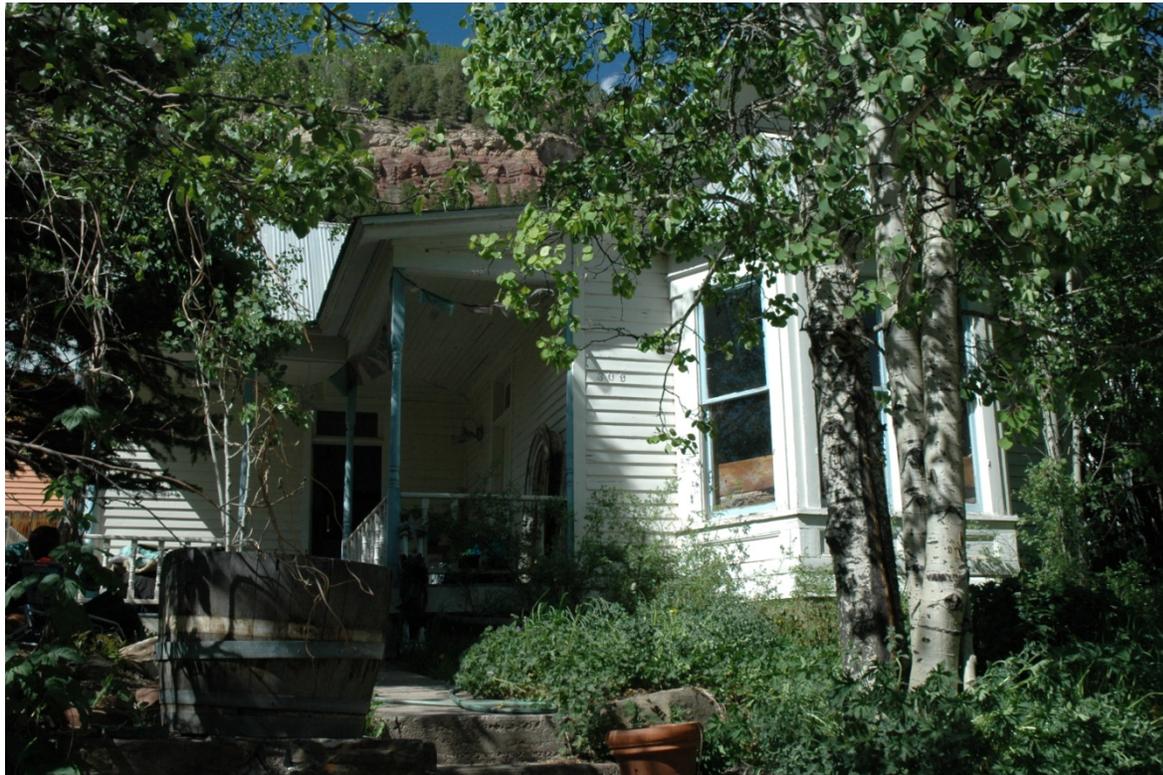
21. General architectural description:
This 1½-story cross-gabled, L-shaped, dwelling is made up of a front gabled east wing, which measures 30' N-S (deep) by 16' E-W (across), and a side gabled west wing, which measures 16' N-S by 14' E-W. The house is supported by an unpainted coursed sandstone foundation, and its exterior walls are clad with painted white horizontal wood siding with 1" by 4" corner boards. The cross gabled roof is steeply-pitched, with corrugated metal roofing material and painted white boxed eaves. A short red brick chimney is on the roof ridge. The dwelling's asymmetrical facade faces Columbia Avenue on the south elevation. Two painted white wood-paneled doors, each with a transom light, enter the west half of the facade from an open L-shaped front porch which fills in the void formed by the house's L-shaped plan. This porch is approached by two wood steps, and features a wood plank floor, a painted white open wood railing with turned balusters, painted blue turned columns, a painted white bead board ceiling, and a shed roof. A prominent hipped-roof canted bay is centered in the front gabled portion of the facade, east of the front porch. The bay contains four 1/1 double-hung sash windows, with painted light blue wood frames and painted white wood surrounds. The home's other windows also all feature painted white wood surrounds. These include: a small 4-light window in the west elevation's upper gable end; a single-light window on the west elevation; a 2-light window in the north elevation's upper gable end; a 2x2 horizontal sliding window, and a single-light fixed-pane window, on the north elevation. Several of these windows appear altered from their original configuration.

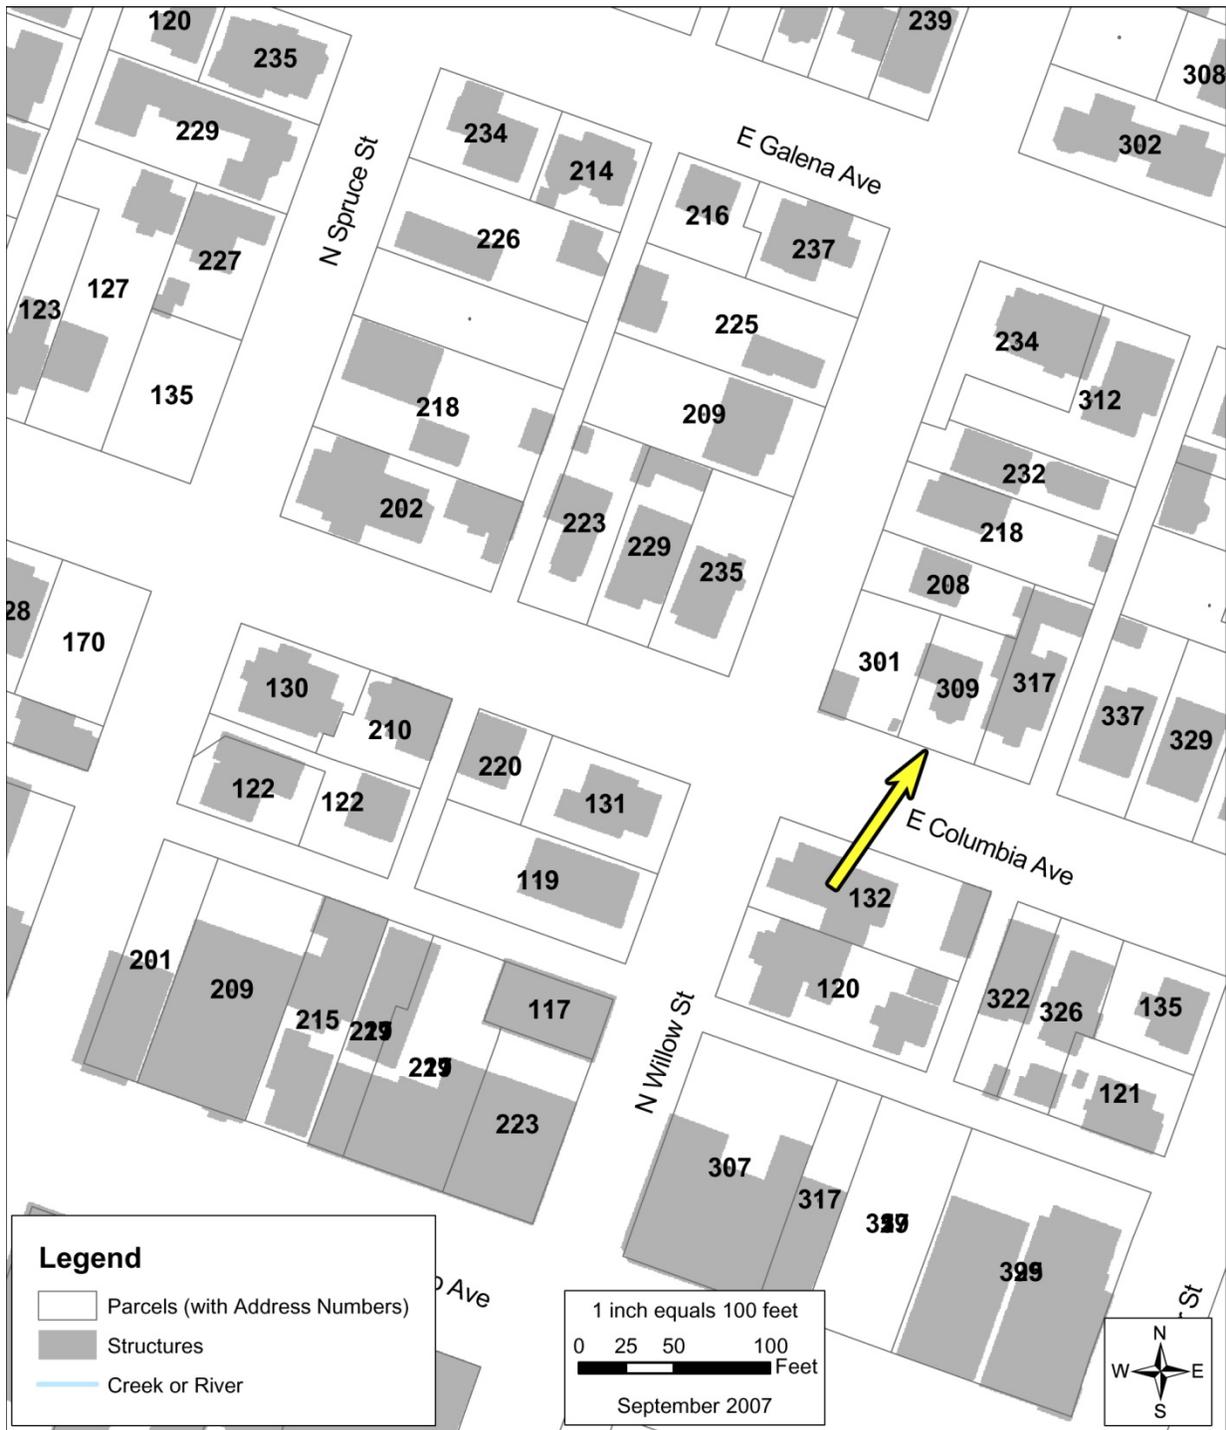
Sketch Map

This is the first house east of Willow Street on the north side of E. Columbia Avenue. A high sandstone retaining wall parallels the front sidewalk along Columbia. Six poured concrete steps lead from the street into the front yard. The planted grass front yard is nicely landscaped with mature low plants and trees. A wood privacy fence extends along the west property line.
