COLORADO CULTURAL RESOURCE SURVEY

Architectural Inventory Form

- 1. Resource number: **5SM.1704**
- 2. Temporary resource number: **N/A**
- 3. County: **San Miguel**
- 4. City: **Telluride**
- 5. Historic Building Name: **Unknown**
- 6. Current Building Name: **Specker House**
- 7. Building Address: **320 W. Columbia Avenue**
- 8. Owner Name and Address: **Pamela A. Specker
P. O. Box 818
Telluride, CO 814350818**

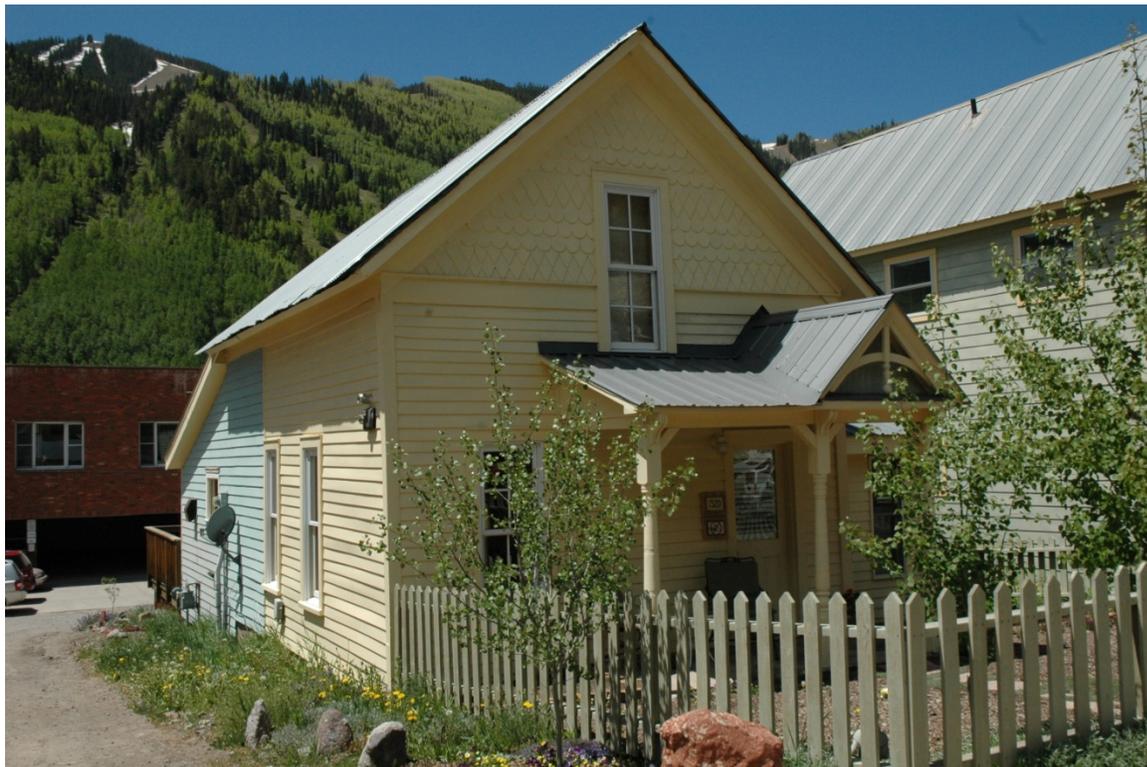
21. General architectural description:
This is a 1½-story, front gabled, wood frame dwelling with a single-story shed-roofed extension to the south (rear) elevation and another single-story addition to the west (side) elevation. The house is supported by a low stone or poured concrete foundation, while its exterior walls are clad with painted yellow horizontal wood siding with 1" by 4" corner boards. Painted yellow variegated wood shingles appear in the facade's upper gable end. The main front gabled roof is steeply-pitched and is covered with metal roofing material. The facade is asymmetrical and faces toward Columbia Avenue on the north elevation. A wood-paneled door with one upper sash light enters the west end of the facade from an open front porch. The porch features a wood floor, bracketed turned columns, and a shed roof with a prominent intersecting gable. A rear door enters the shed-roofed extension from a redwood deck on the north elevation. Windows are primarily 1/1 double-hung sash, although a 4/4 double-hung sash window penetrates the facade's upper gable end.
