COLORADO CULTURAL RESOURCE SURVEY

Architectural Inventory Form

- 1. Resource number: **5SM.1797/THAS136**
- 2. Temporary resource number: **N/A**
- 3. County: **San Miguel**
- 4. City: **Telluride**
- 5. Historic Building Name: **Unknown**
- 6. Current Building Name: **Paris House**
- 7. Building Address: **323 E. Columbia Avenue**
- 8. Owner Name and Address: **Paris, Roger Trust  
171 Ute TR SV  
Carbondale, CO 81623**

47. Photograph number(s):	<b>CD #7, Images 322-325</b>	CDs filed at:	<b>Town of Telluride</b>
48. Report title:	<b>Town of Telluride Re-Survey of Historic Structures</b>		<b>Planning and Building Department</b>
49. Date(s):	<b>August 9, 2011; revised April 11, 2013</b>		<b>113 West Columbia Avenue</b>
50. Recorder(s):	<b>Carl McWilliams Timothy Wilder</b>		<b>Telluride, CO 81435</b>
51. Organization:	<b>Cultural Resource Historians</b>		
52. Address:	<b>Dogwood Court Fort Collins, CO 80525</b>		
53. Phone number(s):	<b>(970) 493-5270</b>

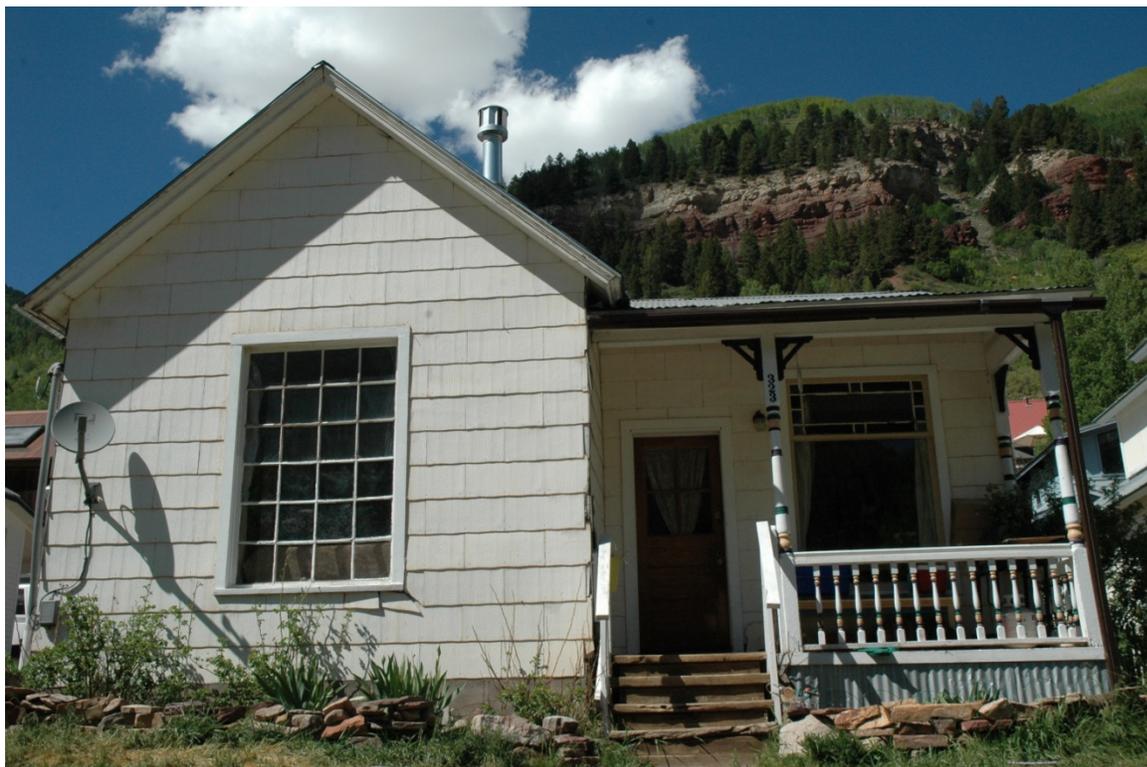
21. General architectural description:  
**Overall, this single-story wood frame residence measures 38½' N-S (deep) by 26' E-W (across). An open front porch, which measures 9' N-S by 12' E-W, and an open rear porch, which measures 6' N-S by 14' E-W, are included within these dimensions. The house is supported by a poured concrete foundation (or possibly concrete pargeting over a stone foundation) covered with asphalt or asbestos shingle skirting. The exterior walls are clad with white undulated asbestos shingle siding. The house is covered by a central hipped roof, with two intersecting north gables, one intersecting east gable, and one intersecting south gable. The roof is covered with corrugated metal roofing material, and the eaves are boxed with painted white wood trim. The asymmetrical facade faces Columbia Avenue on the south elevation. A stained brown wood-paneled door, with four upper sash lights, enters the east half of the facade from the open front porch. The porch is approached by three wood steps, and features a wood plank floor, an open wood railing with turned balusters, bracketed turned columns, and a shed roof. A secondary entry door is covered by a makeshift shed roof near the north end of the east elevation. A single-hung sash window, with stained glass Queen Anne lights, overlooks the front porch east of the front door. A non-original 24-light fixed-pane window penetrates the facade wall west of the front porch. Other windows are primarily 2/2 double-hung sash with painted white wood frames and surrounds.**

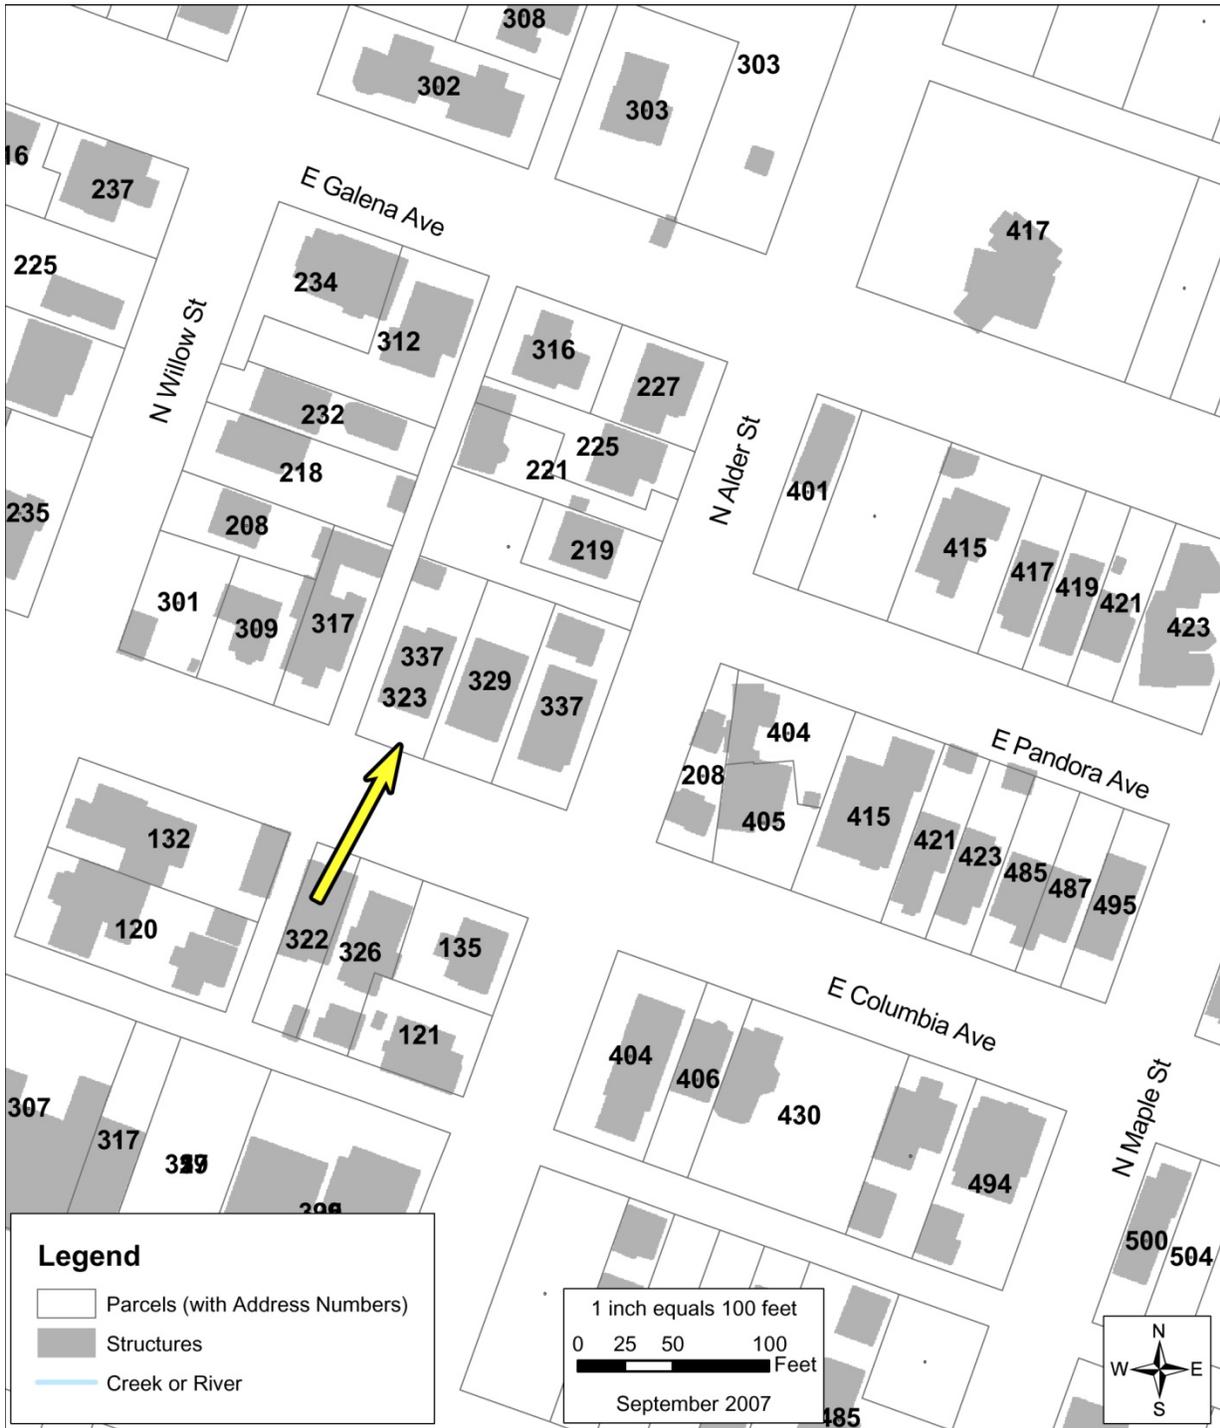
## Sketch Map

**This is the third property west of Alder Street on the north side of E. Columbia Avenue. A sandstone retaining wall parallels Columbia; however, there is no front sidewalk. Five stone steps ascend from near the street to the front yard and house. A planted grass front yard and narrow side yards flank the dwelling.**

**A historic shed (THAS #136) is located adjacent to the alley at the rear northwest corner of the property. This structure measures 14' by 10', and is supported by a wood timbers on grade foundation. The exterior walls are made of unpainted horizontal wood planks, and the roof is a low-pitched gable, covered with green asphalt roofing material laid over 1x wood decking and 2x wood rafters. The rafter ends are exposed beneath the eaves. A painted white wood door and a 2-light window are on the east elevation. The west elevation, facing the alley, is penetrated by two fixed-pane windows. Two more fixed-pane windows penetrate the south elevation.**
