COLORADO CULTURAL RESOURCE SURVEY

Architectural Inventory Form

- 1. Resource number: **5SM.1798**
- 2. Temporary resource number: **N/A**
- 3. County: **San Miguel**
- 4. City: **Telluride**
- 5. Historic Building Name: **Unknown**
- 6. Current Building Name: **Page House**
- 7. Building Address: **329 E. Columbia Avenue**
- 8. Owner Name and Address: **Jennifer Ann Page
P. O. Box 2618
Telluride, CO 814352618**

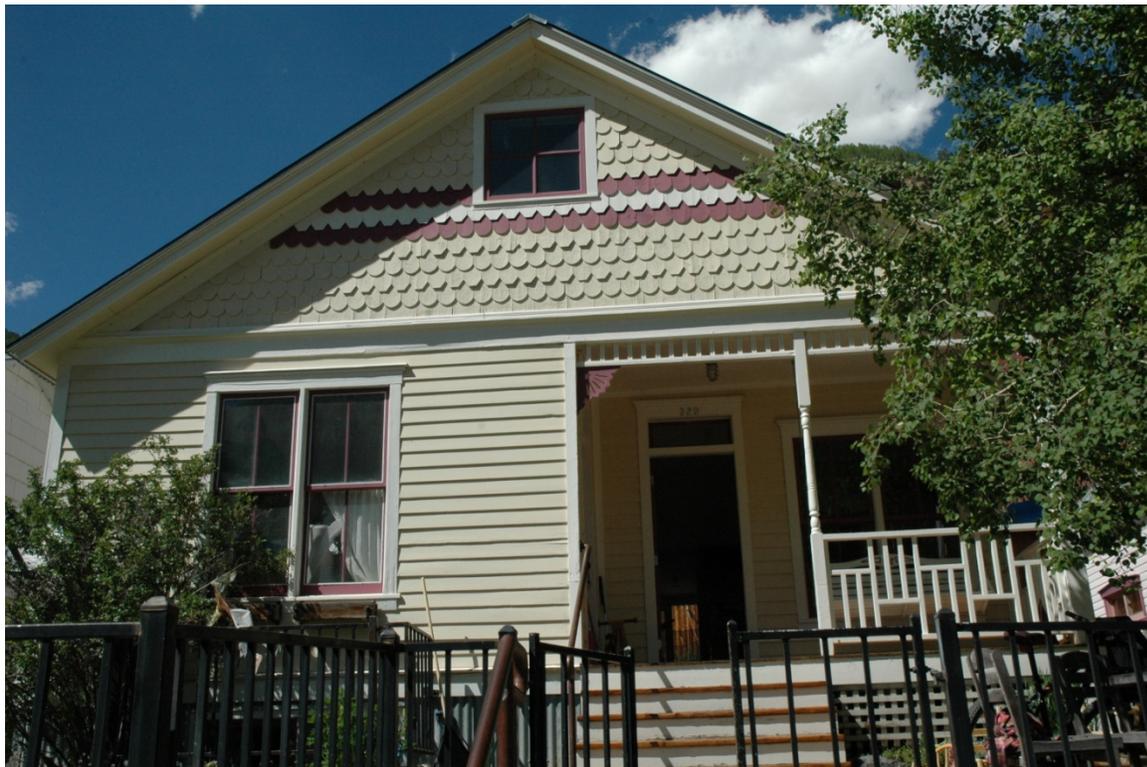
21. General architectural description:
This residence consists of an original (circa 1892) front gabled dwelling, along with its upper half story rear addition and new poured concrete foundation and basement level which were completed in 1995-1996. The foundation walls above grade are covered with corrugated metal skirting, while the exterior walls are clad with painted beige horizontal wood siding with 1" by 4" corner boards. A painted white 1x board with a water table separates the siding from the metal skirting. Painted beige, purple, and white variegated wood shingles appear in the upper gable end on the south elevation. The home's facade faces Columbia Avenue on the south elevation. Two painted purple wood-paneled doors, each with an upper sash light and a transom light, enter the east half of the facade from a recessed open front porch. This porch measures 6' N-S by 12' E-W, and is approached by one poured concrete step and four wood steps. The porch features a wood plank floor, a painted white open wood railing, painted white turned columns with pierced brackets, an open wood frieze. The home's windows are predominantly 1/1 and 2/2 double-hung sash with painted purple wood frames and painted white wood surrounds. The upper half story and rear addition incorporates a gabled dormer on the east elevation and a shed-roofed dormer on the west elevation. A rear entry door is on the north elevation.
