COLORADO CULTURAL RESOURCE SURVEY

Architectural Inventory Form

- 1. Resource number: **5SM.1799**
- 2. Temporary resource number: **N/A**
- 3. County: **San Miguel**
- 4. City: **Telluride**
- 5. Historic Building Name: **Unknown**
- 6. Current Building Name: **McGovern / Paine House**
- 7. Building Address: **337 E. Columbia Avenue**
- 8. Owner Name and Address: **McGovern, Carol Paine and Paine, Thomas W.  
2445 Hall Street SE  
Grand Rapids, MI 49506**

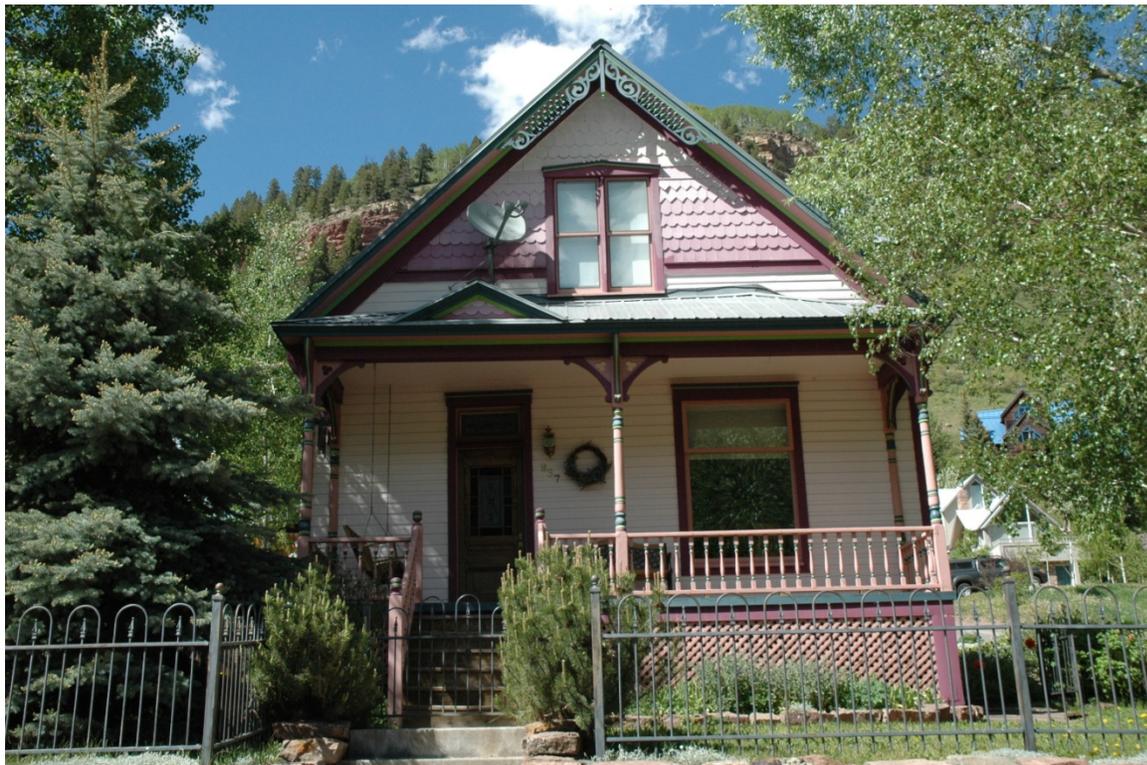
21. General architectural description:  
**This is a 1½-story, rectangular-shaped, wood frame residence which measures 44½' N-S (deep) by 24½' E-W (across). The dwelling is supported by a low, unpainted, coursed sandstone foundation, while the exterior walls are clad with painted beige horizontal weatherboard siding with painted purple 1" by 4' corner boards. A painted purple 1x board with a water table separates the foundation from the siding. The roof is a steeply-pitched front gable, with metal roofing material and painted green and beige boxed eaves. Two large gabled dormers, each with a 1/1 double-hung sash window and with gable ornaments, are on the east-facing roof slope. Two non-historic skylights are on the west-facing roof slope, while one non-historic skylight is on the east-facing roof slope. A distinctive painted green gable ornament, with spindles and a drop pendant, is in the facade's upper gable end on the south elevation. A smaller gable ornament, also with a drop pendant, is in the north elevation's upper gable end. A stained natural brown wood-paneled door, with stained glass Queen Anne lights and a transom light, enters the west half of the facade from a nearly full-width open front porch. The porch is approached by six wood steps, and measures 5' N-S by 21½' E-W. It features a wood plank floor, an open wood railing with turned balusters, turned columns, brackets pierced with trefoil cutouts, newel posts, and a low-pitched hipped roof with a small intersecting gable. Lattice work encloses the space beneath the porch floor. A painted green wood-paneled door, with one upper sash light enters a single-story, 3' by 12' enclosed flat-roofed rear porch at the east end of the north elevation. The roof of the rear porch also serves as a small upper half story porch enclosed by an open wood railing. A painted green wood-paneled door opens onto the small porch from the upper half story. A canted hipped-roof bay, with a single-light fixed-pane window and flanking 1/1 double-hung sash windows, is near the north end of the east elevation. A single-hung sash window overlooks the front porch east of the front**

door. Windows elsewhere are primarily single and paired 1/1 double-hung sash, with painted rose color wood frames and painted purple wood surrounds and with simple wood pediments.

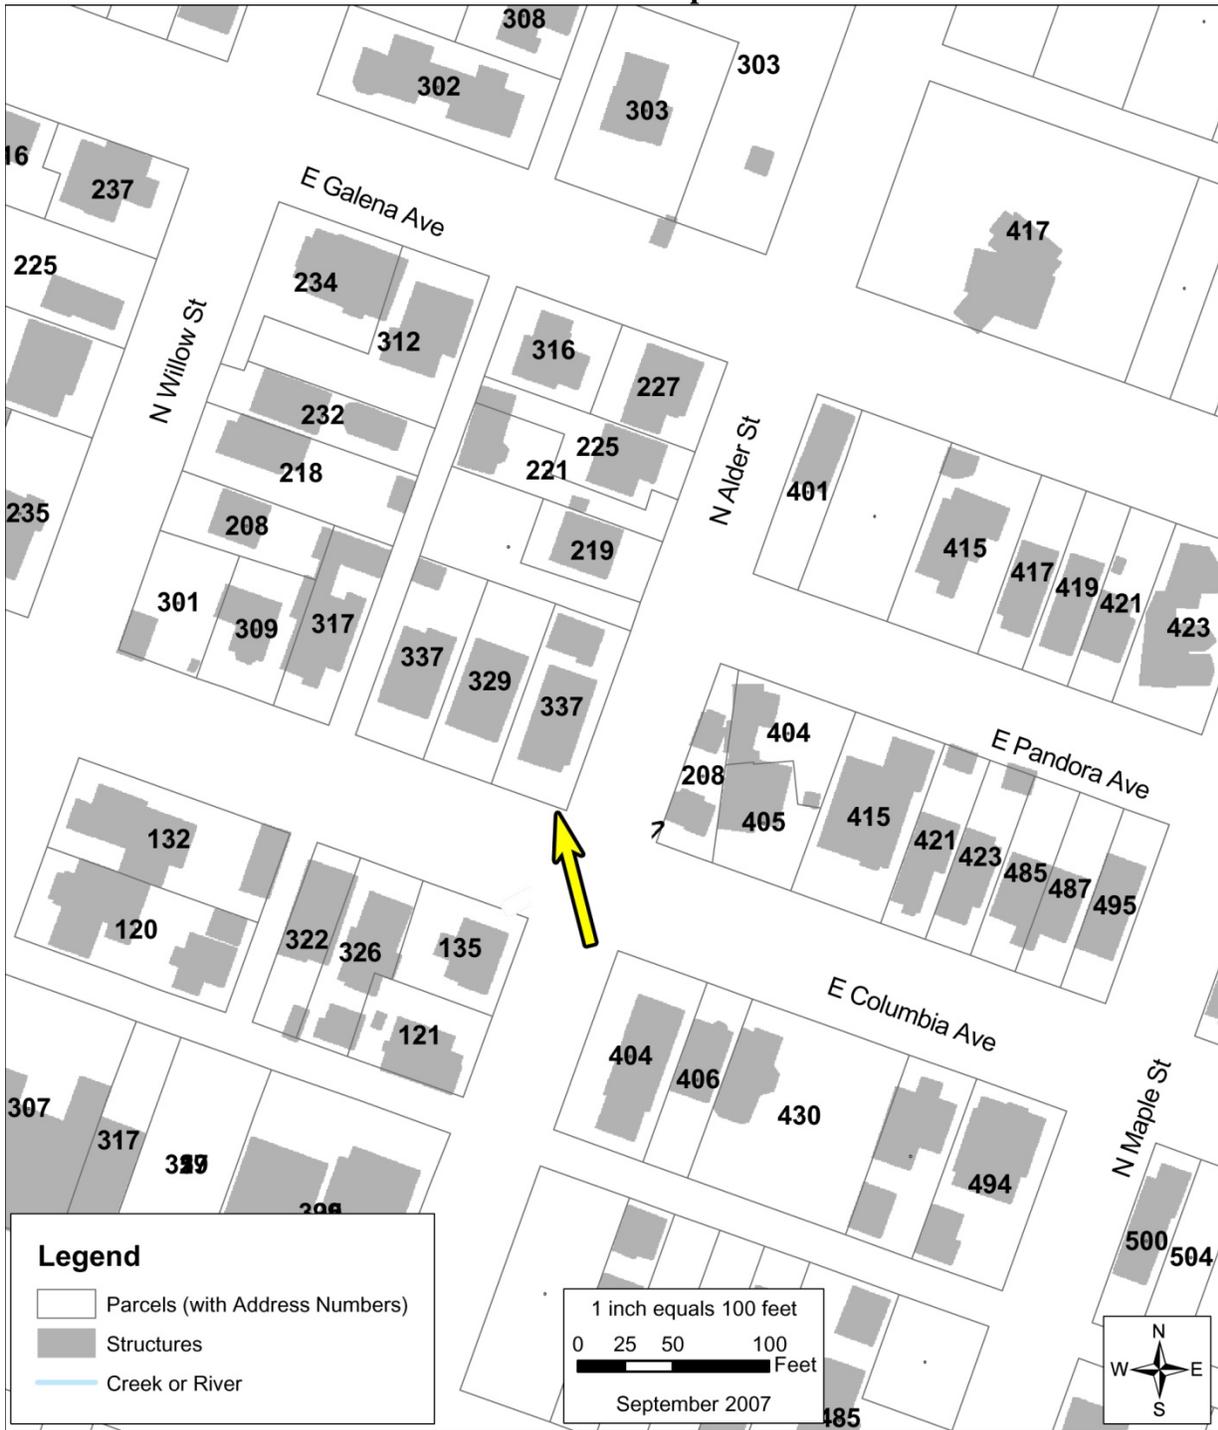
## Sketch Map

**This well-maintained property is located at the northwest corner of Columbia Avenue and Alder Street. A sandstone retaining wall parallels the front sidewalk along Columbia, while a sandstone and wood timbers retaining wall parallels the sidewalk along Alder Street. Six poured concrete steps lead from the front sidewalk to the front yard and house which is sited above street level. The planted grass lawn is nicely landscaped and is enclosed by a black wrought iron fence.**

**A wood frame garage, which measures 14' N-S by 22' E-W, is located at the north end of the property. The garage has a poured concrete slab foundation and floor, stained brown vertical wood plank walls, and a steeply-pitched front gable roof. The roof is covered with corrugated metal roofing material, while stained brown rafter ends and a fascia board are exposed beneath the eaves. A stained brown vertical wood plank overhead garage door on the east elevation opens onto a short gravel driveway which extends to Alder Street. A stained brown wood-paneled door, with one upper sash light, enters the south elevation from a 4-step wood porch covered by a shed roof.**
