COLORADO CULTURAL RESOURCE SURVEY

Architectural Inventory Form

- 1. Resource number: **5SM.1803**
- 2. Temporary resource number: **N/A**
- 3. County: **San Miguel**
- 4. City: **Telluride**
- 5. Historic Building Name: **Unknown**
- 6. Current Building Name: **Measer House**
- 7. Building Address: **405 E. Columbia Avenue**
- 8. Owner Name and Address: **Merle K. Measer
Telluride, CO N/A**

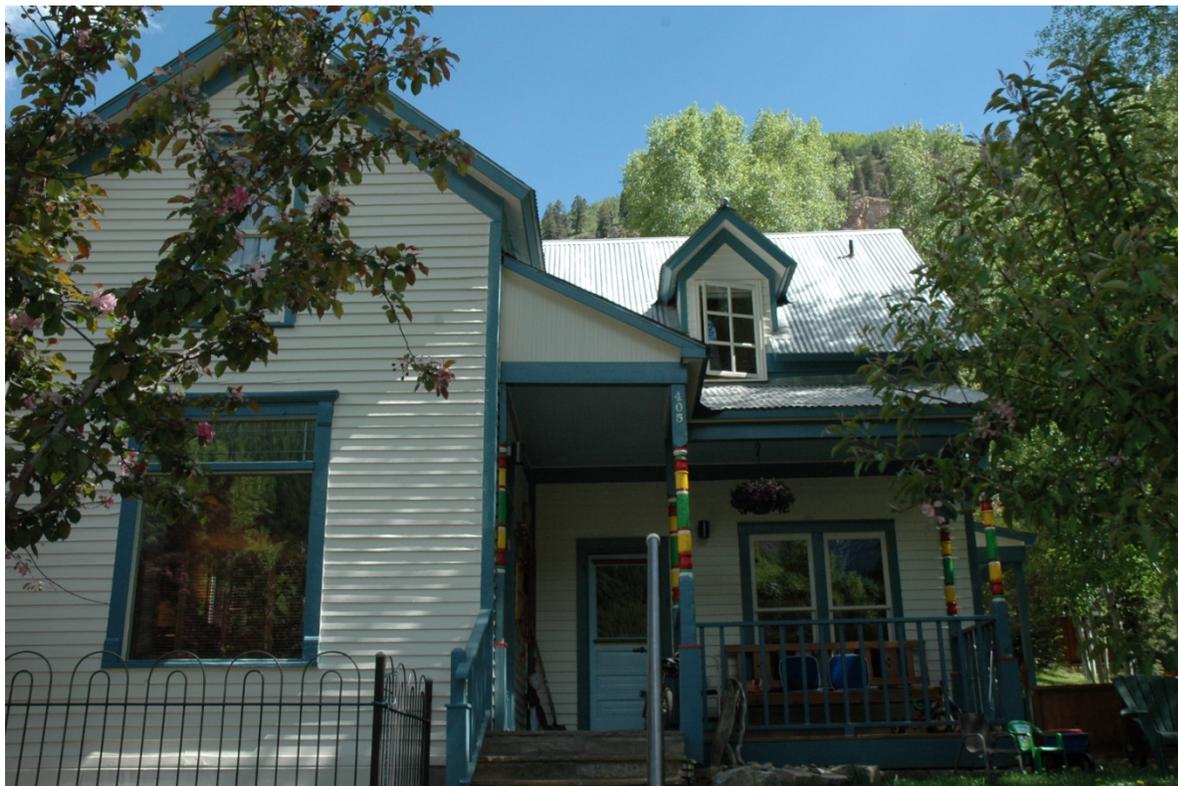
21. General architectural description:
This residence consists of a historic, 1½-story, L-shaped, cross gabled dwelling. The house rests on a poured concrete foundation, faced with sandstone, with a basement level. The exterior walls are clad with painted cream yellow horizontal wood siding, with painted blue 1" by 4" corner boards. The cross-gabled roof is steeply-pitched, with corrugated metal roofing material and painted white boxed eaves. Gabled wall dormers are on the south and west elevations, and a skylight is on the west-facing roof slope. The home's asymmetrical facade faces Columbia Avenue on the south elevation. Two painted white wood-paneled doors, each with an upper sash light, enter the east half of the facade from an L-shaped front porch. The porch is approached by two sandstone steps, and features a wood plank floor, a painted blue open wood railing, multi-colored turned columns, and an L-shaped shed porch roof. A single-hung sash window, with leaded glass Queen Anne lights, penetrates the facade wall west of the front porch. Windows elsewhere are primarily single and paired 1/1 double-hung sash with painted white wood frames and painted blue wood surrounds.
