COLORADO CULTURAL RESOURCE SURVEY

Architectural Inventory Form

- 1. Resource number: **5SM.1806/THAS.142**
- 2. Temporary resource number: **N/A**
- 3. County: **San Miguel**
- 4. City: **Telluride**
- 5. Historic Building Name: **Unknown**
- 6. Current Building Name: **Greene House**
- 7. Building Address: **423 E. Columbia Avenue**
- 8. Owner Name and Address: **Gerald Greene
Box 575
Telluride, CO 814350575**

47. Photograph number(s):	CD #7, Images 366-368	CDs filed at:	Town of Telluride
48. Report title:	Town of Telluride Re-Survey of Historic Structures		Planning and Building Department
49. Date(s):	August 10, 2011		113 West Columbia Avenue
50. Recorder(s):	Carl McWilliams Timothy Wilder		Telluride, CO 81435
51. Organization:	Cultural Resource Historians		
52. Address:	Dogwood Court Fort Collins, CO 80525		
53. Phone number(s):	(970) 493-5270

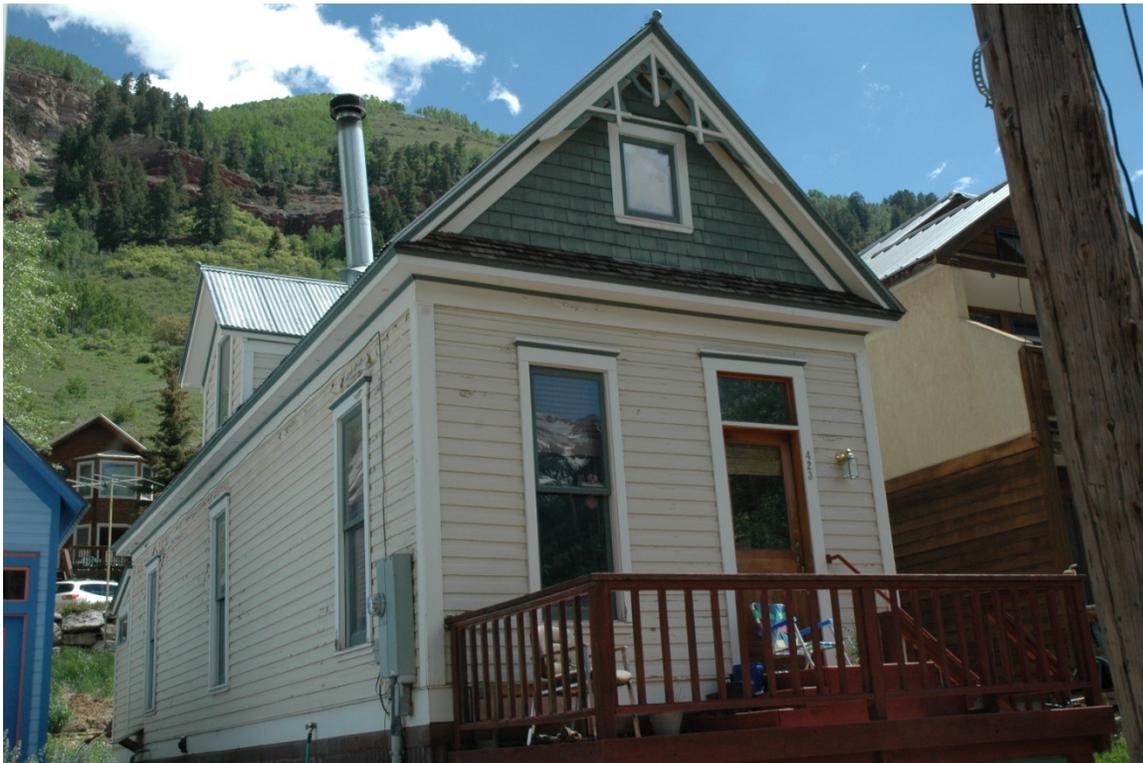
18. Roof configuration: **Gabled Roof / Front Gabled Roof**
19. Primary external roof material: **Metal Roof**
20. Special features: **Porch, Dormers**
21. General architectural description:
This 1½-story, wood frame, front gabled dwelling features a rectangular plan which measures 47' N-S (deep) by 14' E-W (across). There is also a shed-roofed extension near the north end of the east elevation which measures 14' N-S by 4½' E-W, and a shed-roofed extension to the north elevation which measures 5' N-S by 14' E-W.. The house is supported by a poured concrete foundation, covered with rusticated corrugated metal skirting. The foundation and a basement level are relatively new, with the basement extending under the front porch from beneath the house's main gabled section. The exterior walls are clad with painted cream yellow horizontal weatherboard siding, with painted white 1" by 4" corner boards, while painted green square-cut wood shingles appear in the facade's upper gable end on the south elevation. The rear north end of the front gabled roof is hipped, while the entire roof is covered with corrugated metal, and the eaves are boxed with painted white and green wood trim. Gabled dormers, each with a single-light fixed-pane window, are on the east and west roof slopes, while a painted white and green gable ornament is in the facade's upper gable end. A single-light window penetrates the facade's upper gable end just below the gable ornament. Windows elsewhere are primarily 1/1 double-hung sash with painted green wood frames and painted white wood surrounds. A stained brown wood-paneled door, with one upper sash light and with a transom light, enters the east end of the asymmetrical facade from an open front porch. Built above the basement level, this porch is approached by five wood steps, and measures 7' N-S by 12' E-W. The porch has a wood plank floor and an open wood railing. Eight single-light casement windows provide light for the basement level beneath the porch floor. A stained brown wood-paneled door, with one upper sash light, enters the east elevation from a from a 4-step shed-roofed porch.

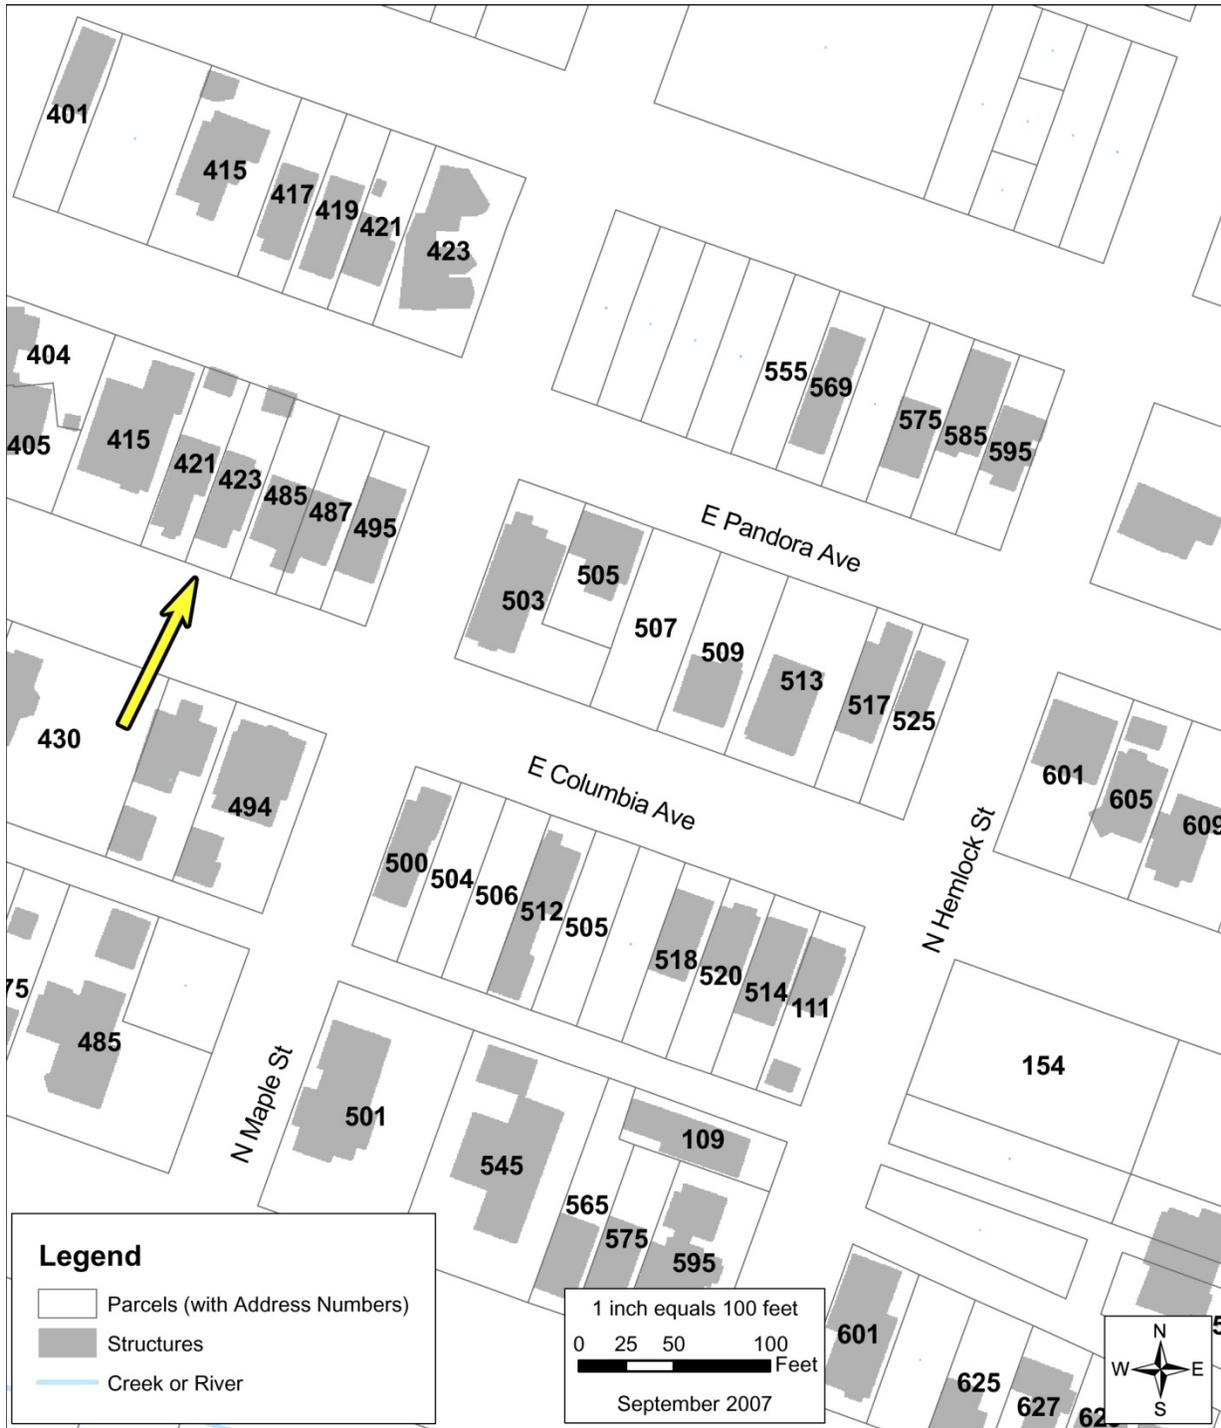
Sketch Map

This property is located on the north side of E. Columbia Avenue in the block between Alder and Maple Streets. The house is flanked by planted grass front and back yards, with narrow side yards between this house and the adjacent dwellings to the east and west. Pandora Street is above the property to the north.

A historic shed (THAS #142) is located near the rear northeast corner of the property. This structure is of log or wood frame construction, and measures 10' by 12'. The east elevation and part of the north elevation are built into the hill slope below Pandora Street. The shed's exterior walls are clad with rusted corrugated metal, and it is covered by a shed roof with rolled black asphalt roofing material laid over 1x wood decking and log rafters. A non-historic window opening penetrates the west elevation. A single-light fixed-pane window is on the south elevation. The entry door is on the south elevation.
