COLORADO CULTURAL RESOURCE SURVEY

Architectural Inventory Form

I. IDENTIFICATION

| 48. Report title: | <b>Town of Telluride Re-Survey of Historic Structures</b> | | <b>Planning and Building<br/>Department</b> |

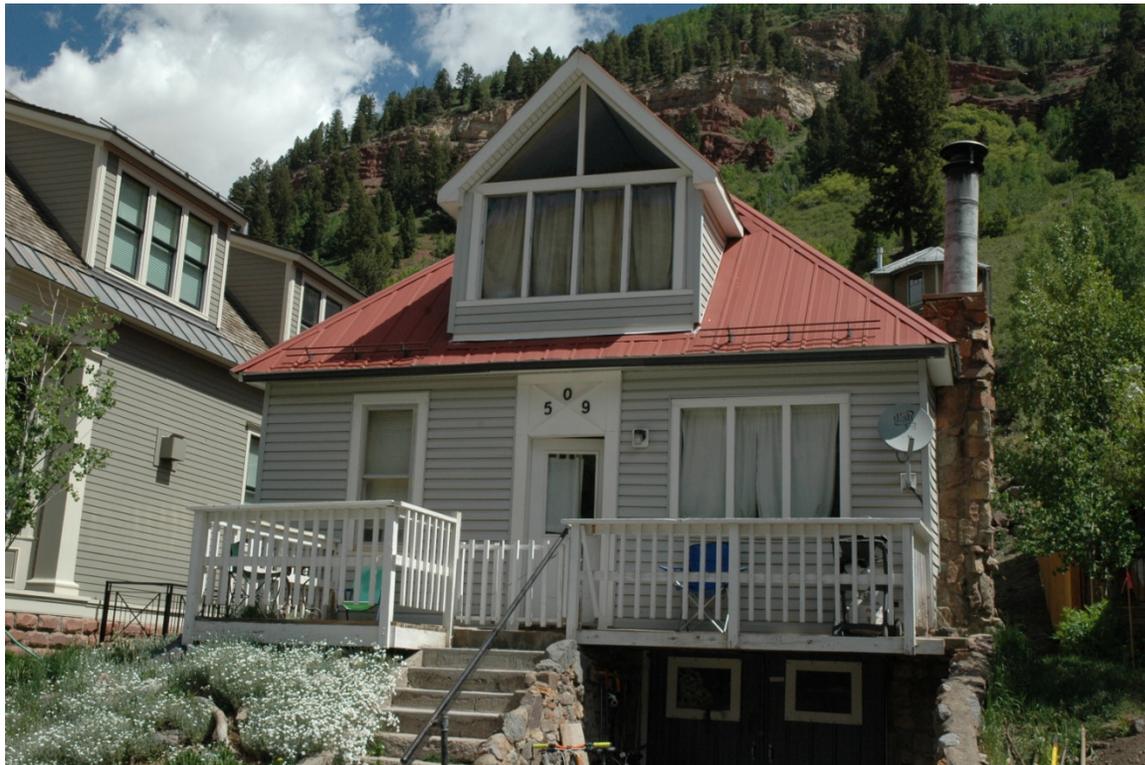
THLD RATING:

Noncontributing Without Qualifications

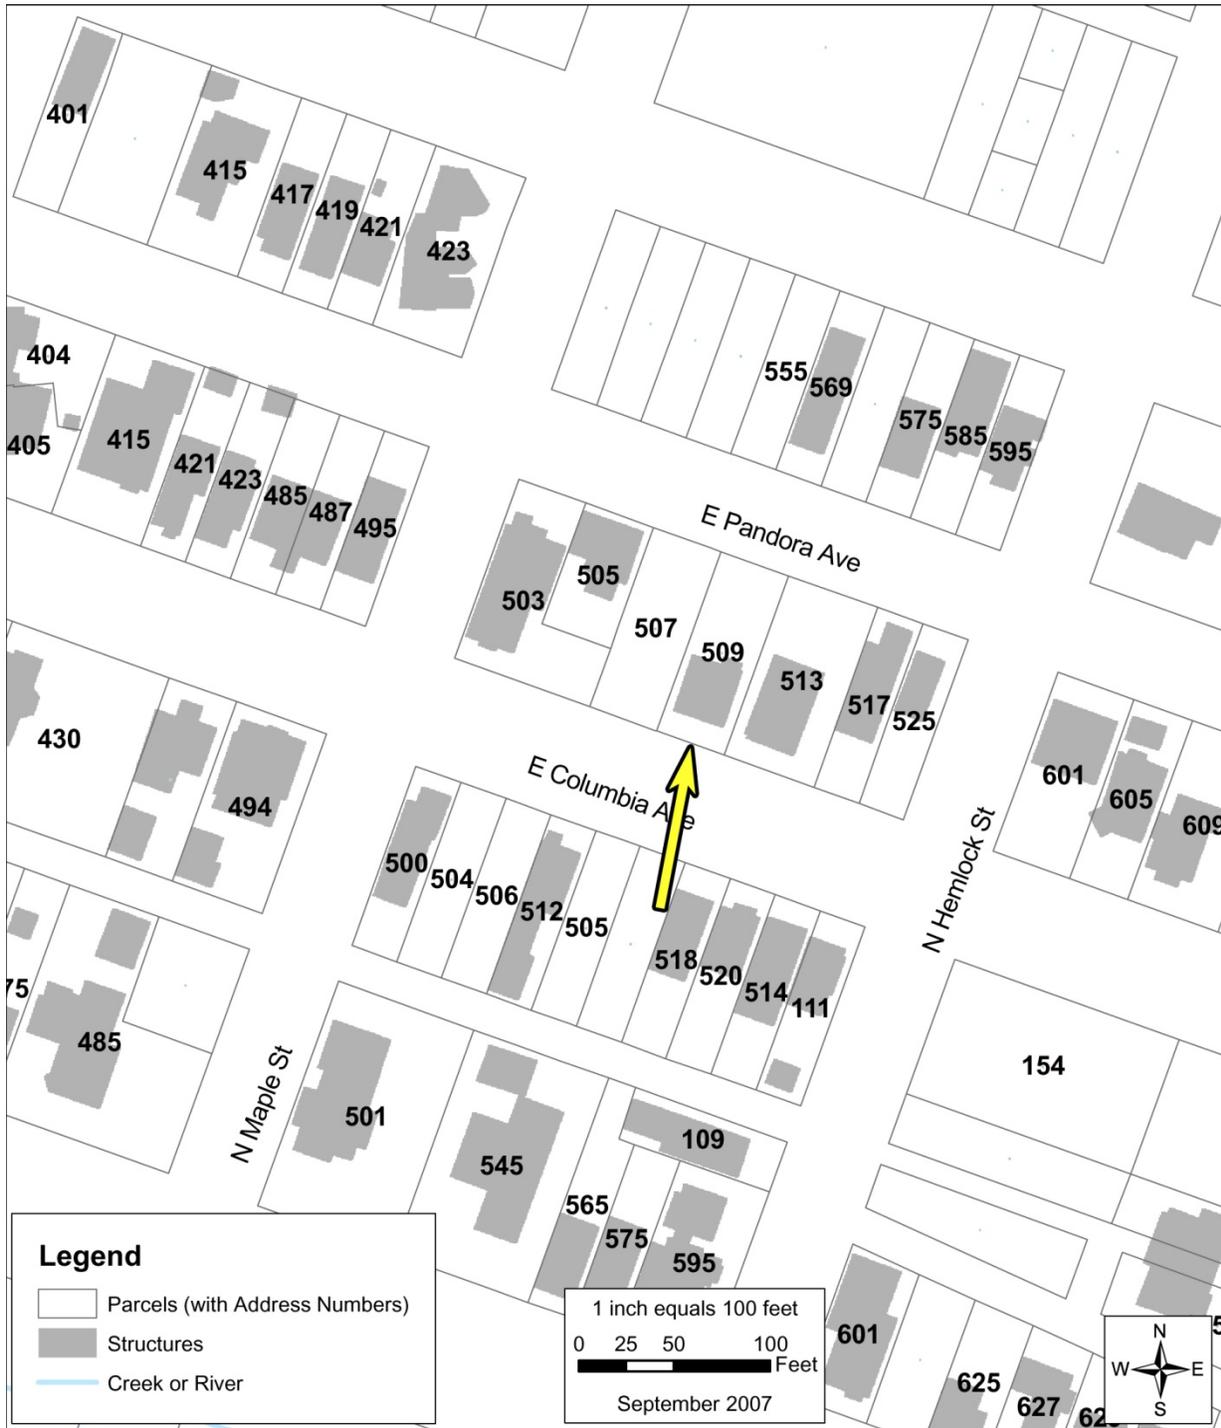
## Sketch Map

**This property is located on the north side of E. Columbia Avenue in the block between Maple and Hemlock Streets, near the east end of the Telluride National Historic Landmark District. A low stone retaining wall parallels the front sidewalk. A painted white picket fence encloses a planted grass lawn. Pandora Street is above the dwelling to the north.**
