COLORADO CULTURAL RESOURCE SURVEY

Architectural Inventory Form

- 1. Resource number: **5SM.1722/THAS.22**
- 2. Temporary resource number: **N/A**
- 3. County: **San Miguel**
- 4. City: **Telluride**
- 5. Historic Building Name: **Unknown**
- 6. Current Building Name: **Loo House**
- 7. Building Address: **528 W Columbia Ave**
- 8. Owner Name and Address: **James Orin Loo  
P. O. Box 1791  
Telluride, CO 814351791**

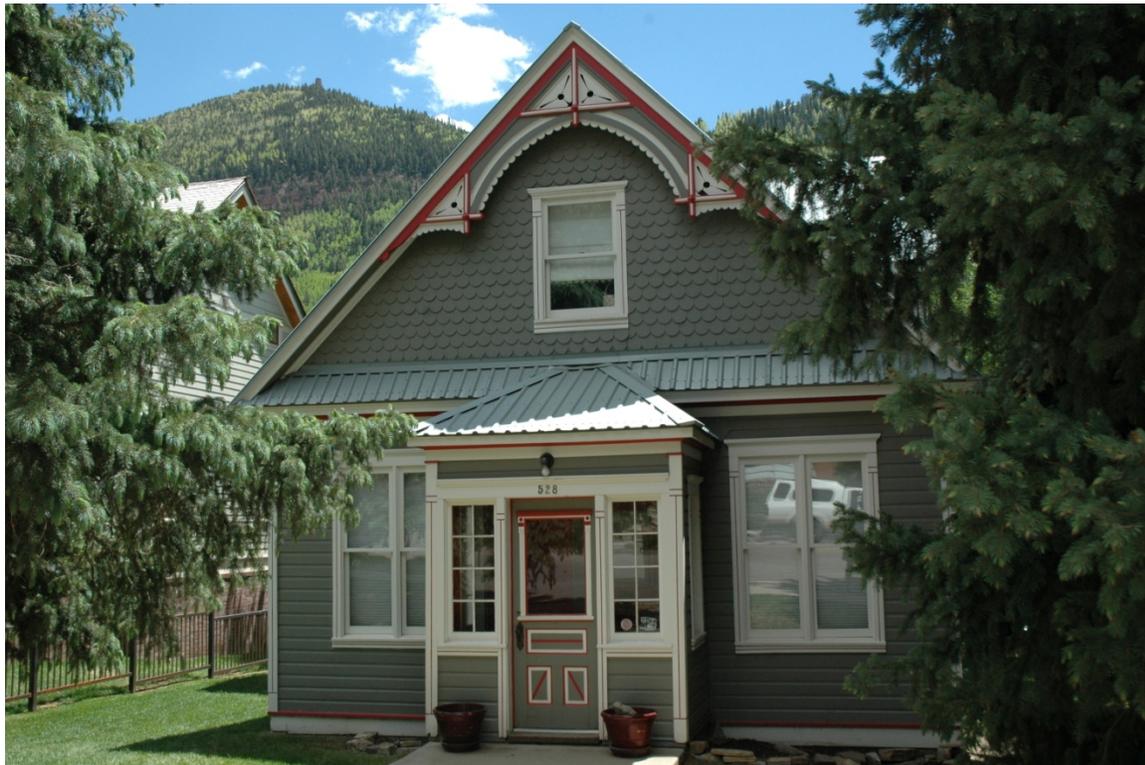
21. General architectural description:  
**This wood frame residence is made up of the following elements: a main 1½-story front gabled section which measures 36' N-S (deep) by 23' E-W (across; an enclosed hipped-roof front porch on the north elevation which measures 5' N-S by 7½ E-W; a gabled extension to the south end of the east elevation which measures 12' N-S by 8' E-W; an enclosed shed-roofed rear porch on the south elevation which measures 6' N-S by 23' E-W. The house is supported by a poured concrete foundation, and its exterior walls are clad with painted grey horizontal weatherboard with painted white and red 1" by 4' corner boards. A distinctive painted red and white pierced gable ornament appears in the façade's upper gable end on the north elevation. Painted grey fish scale shingles also appear in the façade's upper gable end. The roof is covered with metal roofing material, and the eaves are boxed with painted red and white trim. A red brick chimney is on the ridge. A gabled dormer is on the west-facing roof slope. Two non-historic skylights penetrate the east-facing roof slope. A wood-paneled door with one upper sash light enters the enclosed front porch which is centered on the symmetrical facade. A redwood deck extends from the enclosed shed-roofed porch on the south elevation. A large fixed-pane diamond-shaped window penetrates the east elevation. Windows elsewhere are primarily single and paired 1/1 double-hung sash with painted white wood frames and surrounds.**

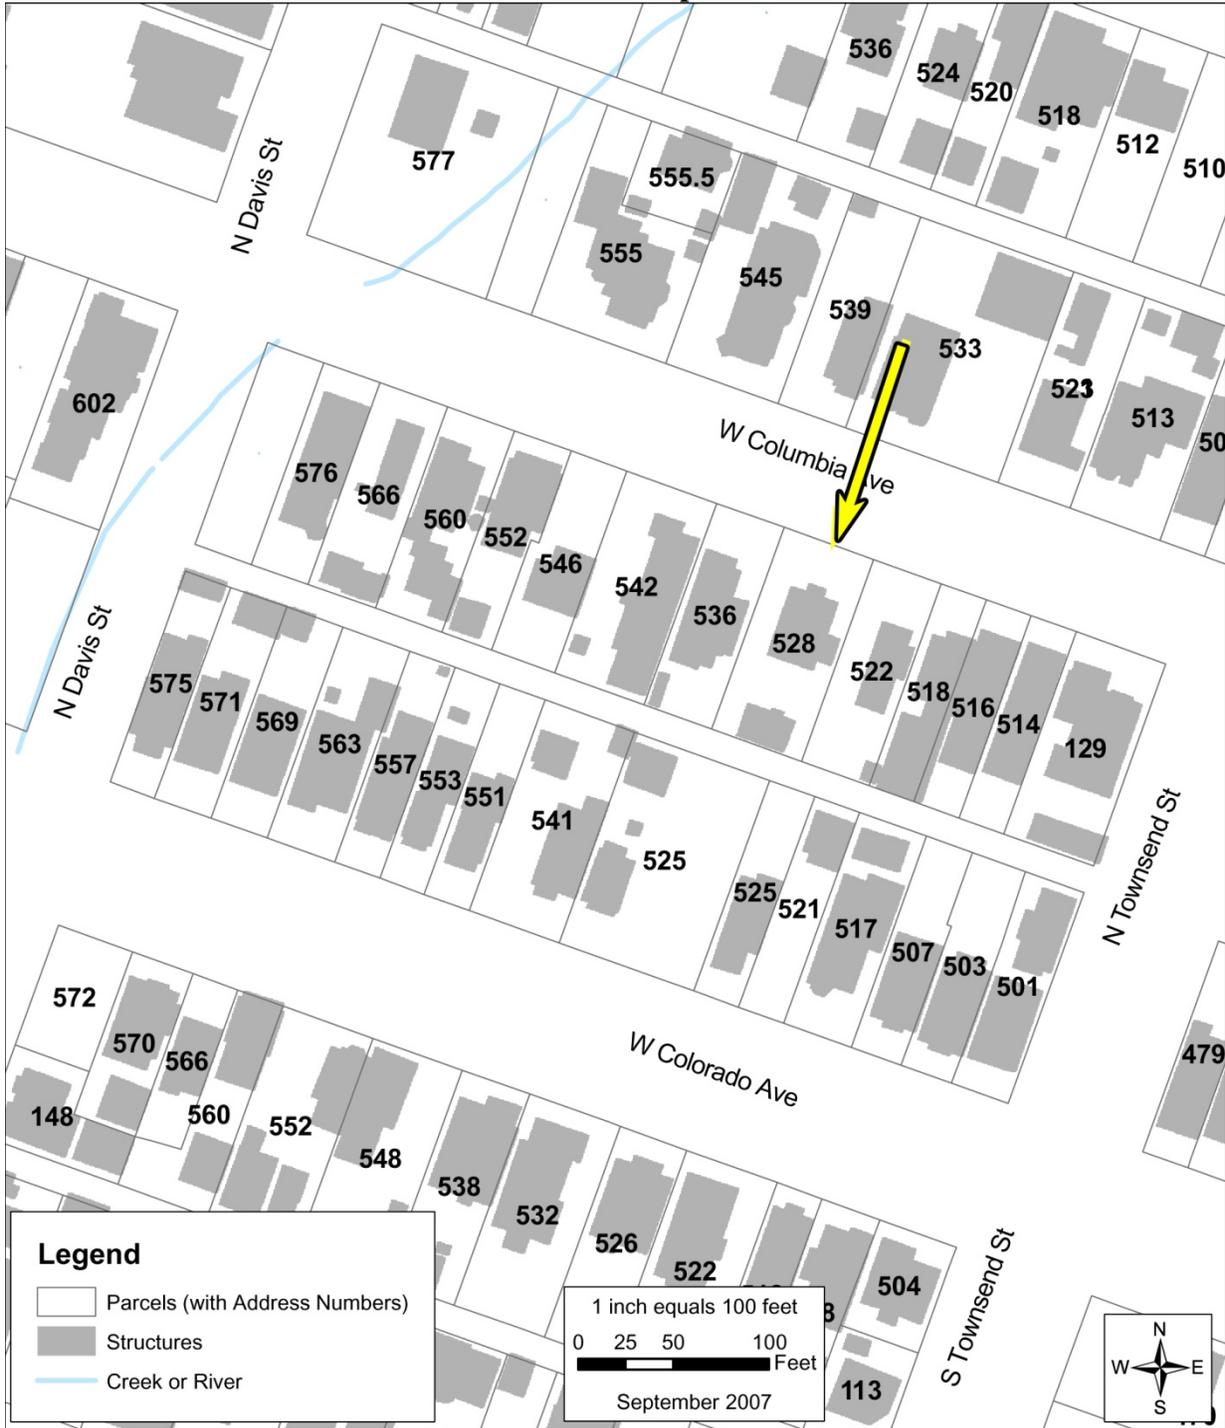
## Sketch Map

**This property is located on the south side of W. Columbia Avenue, the sixth house west of Townsend Street. A planted grass lawn surrounds the house. Two large fir trees are in the front yard.**

**A former garage (THAS #22) has been converted into a secondary residence adjacent to the alley at the rear of the property. This building measures approximately 16' N-S by 24' E-W. It is supported by a poured concrete foundation, and its exterior walls are clad with vertical wood planks. A moderately-pitched gable roof is covered with metal roofing material, and the eaves are boxed with painted white wood trim. Two gabled dormers are on the south elevation; one is a wall dormer with a 12-light window; the other has a 4-light window. A band of three 6-light casement windows and two single-light windows have replaced the garage door on the east elevation. The primary entry door is on the north elevation.**
