COLORADO CULTURAL RESOURCE SURVEY

Architectural Inventory Form

I. IDENTIFICATION

- 1. Resource number: **5SM.1723/THAS.24**
- 2. Temporary resource number: **N/A**
- 3. County: **San Miguel**
- 4. City: **Telluride**
- 5. Historic Building Name: **Unknown**
- 6. Current Building Name: **Sims House**
- 7. Building Address: **536 W. Columbia Avenue**
- 8. Owner Name and Address: **Herbert D. Sims
8880 NE Wordenhill Road
Dundee, OR 97115**

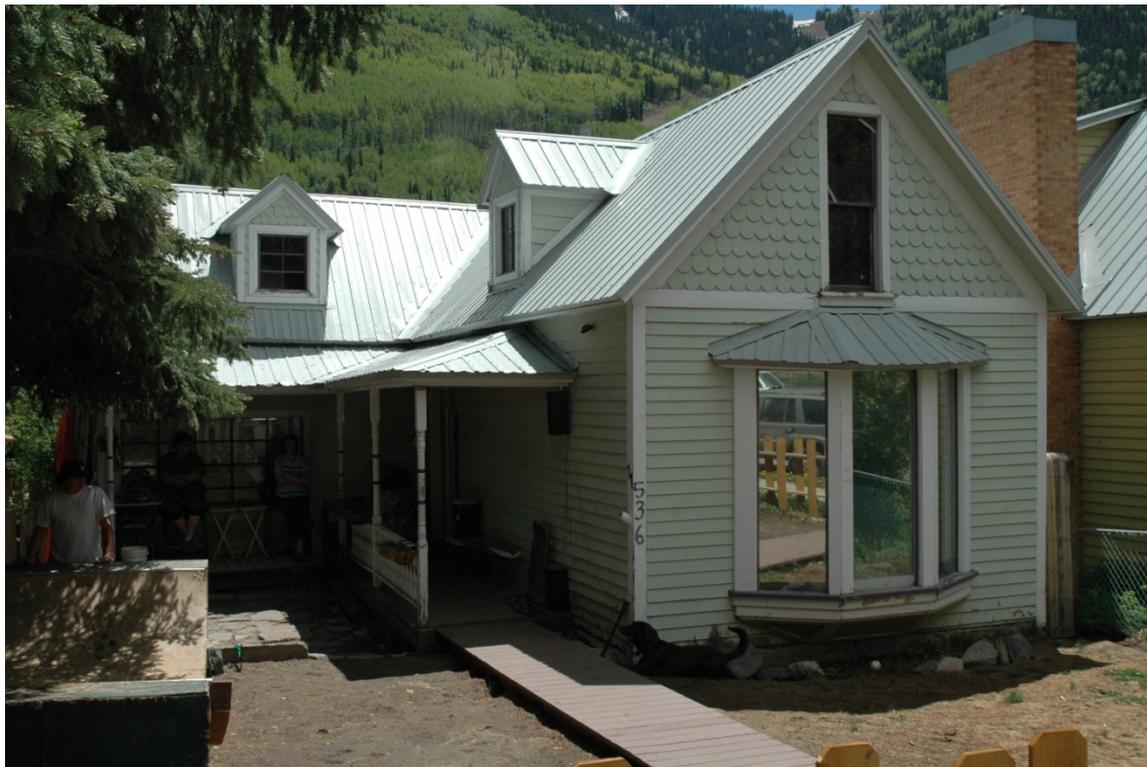
21. General architectural description:
This 1½-story cross gabled dwelling consists of an original front-gabled section, and an intersecting side-gabled addition on the east elevation, which also covers part of the south (rear) elevation. The building is supported by an unpainted poured concrete foundation. Its exterior walls are clad with painted green horizontal Masonite siding with painted white 1" by 4" corner boards. Painted green Masonite fish scale shingles appear in the facade's upper gable end. The roof is covered with modern "Pro-panel" metal roofing material, and the eaves are boxed with painted green and white wood trim. Non-original gabled dormers, each with a 6-light window, are respectively located on the north and east-facing roof slopes. Another gabled dormer is on the west-facing roof slope. A non-historic concrete block chimney is on the east elevation. A painted blue and orange fiberglass-paneled front door enters the house from an L-shaped front porch. The porch features a wood plank floor, a painted white open wood railing with turned balusters, painted white turned columns, and a low-pitched hipped roof. A non-historic (circa 1985) hipped-roof oriel type window, with three single-light fixed-pane windows, penetrates the facade wall west of the entry porch. A large 20-light window overlooks the front porch at the east end of the facade. Windows elsewhere are primarily 1/1 double-hung sash with painted white wood frames and surrounds. A painted white and green wood-paneled door, with one upper sash light, enters the east end of the south elevation from a wood deck which wraps around the house's rear southeast corner.
