# COLORADO CULTURAL RESOURCE SURVEY

# Architectural Inventory Form

1. Resource number: **5SM.1725**
2. Temporary resource number: **N/A**
3. County: **San Miguel**
4. City: **Telluride**
5. Historic Building Name: **Cappis House**
6. Current Building Name: **Miller House**
7. Building Address: **546 W. Columbia Avenue**
8. Owner Name and Address: **Philip S. And Linda J. Miller  
P. O. Box 883  
Telluride, CO 814350883**

| 48. Report title: | <b>Town of Telluride Re-Survey of Historic Structures</b> | | <b>Planning and Building Department</b> |

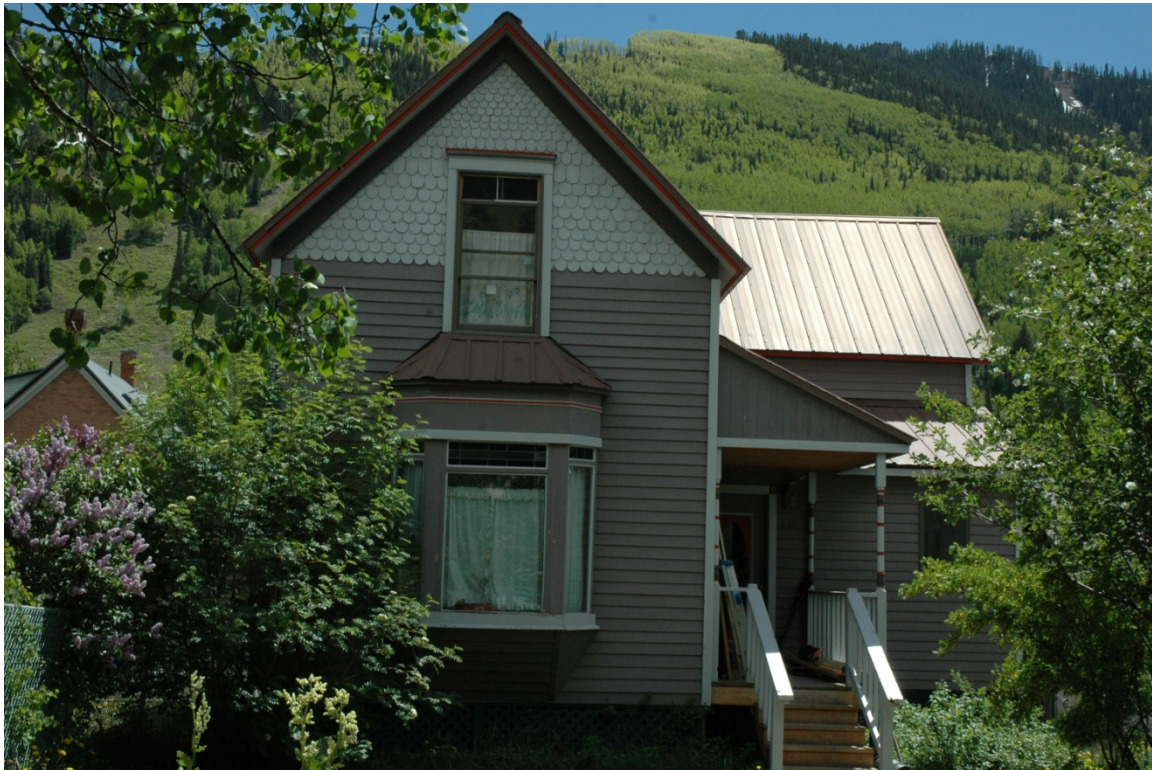
21. General architectural description:  
**This 1½-story wood frame dwelling features an L-shaped cross-gabled plan. It is supported by a concrete block foundation, and its exterior walls are clad with painted beige horizontal wood siding with painted white 1" by 4" corner boards. Painted white fish scale shingles appear in the facade's upper gable end, facing toward Columbia Avenue on the north elevation. The cross-gabled roof is steeply-pitched, with metal roofing material and painted white and red boxed eaves. A short boxed chimney is centered on the roof ridge. Non-historic skylights are on the south-facing roof slope. A wood-paneled front door is painted beige with orange and red trim. This door has a slender oval-shaped light, and enters the facade from an open front porch. This porch is approached by four wood steps, and features a wood plank floor, a painted white open wood railing, and painted beige turned columns with orange and red trim. A painted beige glass-in-wood-frame atrium door enters the east end of the south elevation from an elevated wood porch. This porch is approached by seven wood steps, and has a wood plank floor and an open wood railing. A non-historic hipped roof oriel type window, with three single-light fixed-pane windows, penetrates the facade wall, east of the entry porch. Another hipped-roof oriel window is located on the south elevation. Windows elsewhere are primarily 1/1 double-hung sash with painted white wood frames and surrounds.**

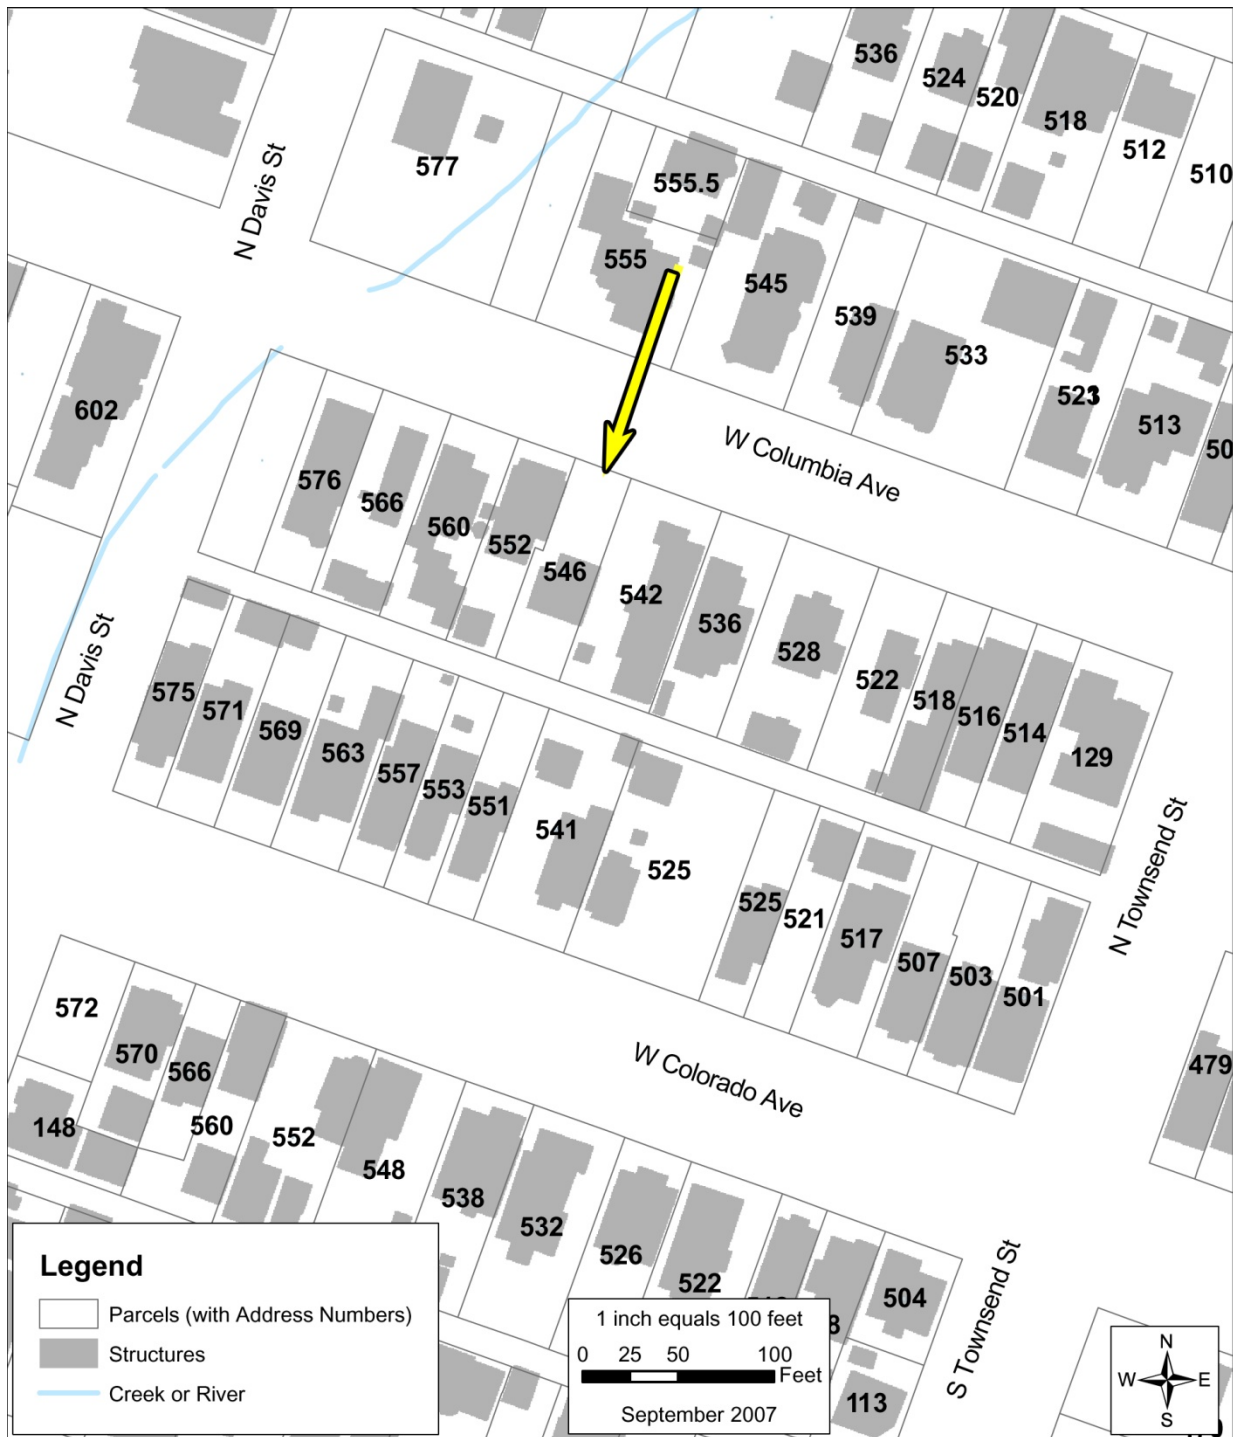
## Sketch Map

**This is the ninth house west of Townsend Street on the south side of W. Columbia Avenue. The dwelling is set well back from the street. The long planted grass front yard and narrow side yards are landscaped with native plants, flowers, and aspen trees. A vegetable and herb garden is also in the front yard.**
