## COLORADO CULTURAL RESOURCE SURVEY

## Architectural Inventory Form

1. Resource number: **5SM.1727/THAS.30**
2. Temporary resource number: **N/A**
3. County: **San Miguel**
4. City: **Telluride**
5. Historic Building Name: **Unknown**
6. Current Building Name: **Tellprop LLC House**
7. Building Address: **560 W. Columbia Avenue**
8. Owner Name and Address: **Tellprop I LLC  
6232 Indian Creek Dr  
Fort Worth, TX 76107**

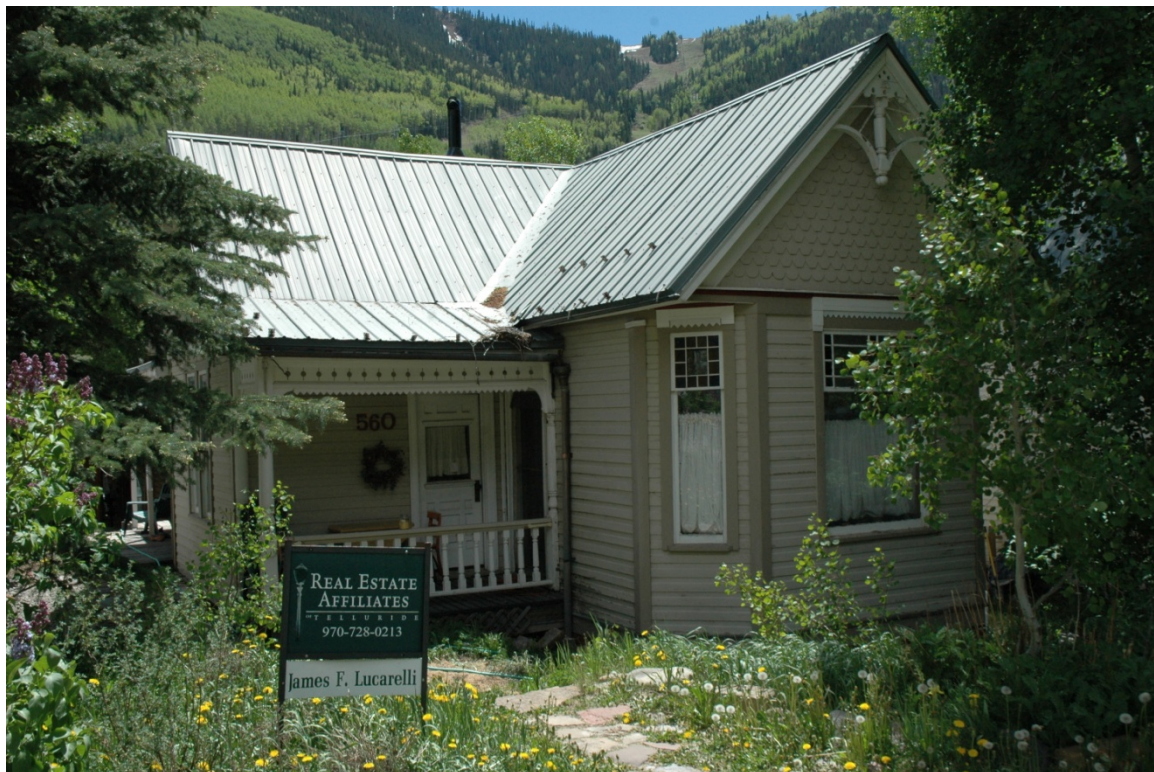
21. General architectural description:  
**This residence consists of an original single-story L-shaped, cross-gabled dwelling, with an older hipped-roof addition to the south (rear) elevation. The house is supported by a poured concrete foundation, faced with painted bead board skirting above grade. The exterior walls are clad with painted light beige horizontal weatherboard siding, with painted dark beige 1" by 4" corner boards. Painted beige variegated wood shingles appear in the upper gable ends on the north and east elevations. The facade upper gable end (north elevation) also sports a distinctive pierced gable ornament. The cross-gabled roof is steeply-pitched, with metal roofing material and painted white boxed eaves. Two painted white wood-paneled doors, each with an upper sash light, enter the east half of the facade from an open front porch. This porch features a wood plank floor, a painted white open wood railing with turned balusters, painted white turned columns with brackets, a pierced frieze with a sawtooth motif, and a shed roof. A painted white wood-paneled door, with nine upper sash lights, enters the basement level six steps below grade on the south (rear) elevation. A large canted bay forms the west half of the facade, beneath the front-facing gable. The bay features a large center single-hung sash window, and flanking narrower single-hung sash windows with stained glass lights in the upper sash over a single pane in the lower sash. The bay also displays elaborate wood moldings with a sawtooth motif. Windows elsewhere are primarily single and paired 1/1 double-hung sash, with painted white wood frames and painted beige wood surrounds.**

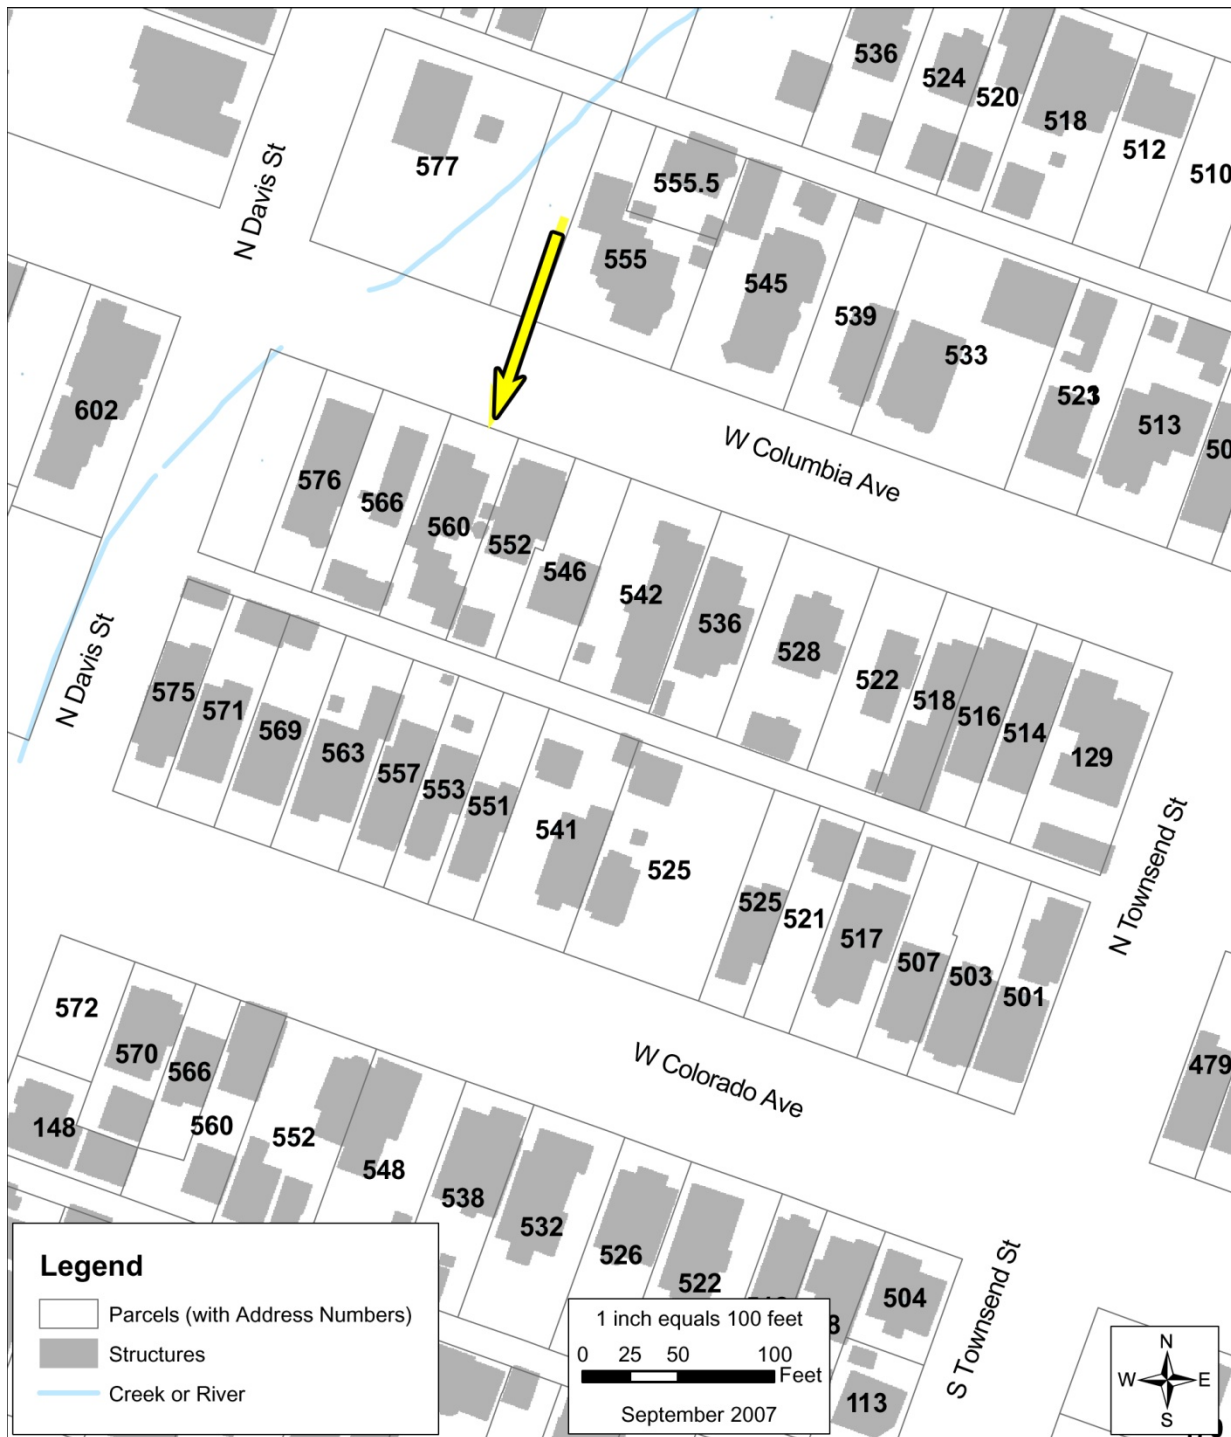
## Sketch Map

This is the eleventh house west of Townsend Street on the south side of W. Columbia Avenue. Four flagstone steps descend a few feet from the front sidewalk along Columbia to the yard and house which is sited slightly below street level. A planted grass front lawn features mature landscaping including a grove of aspen trees. The house is set back minimally from the street compared to most other houses in this block.
