COLORADO CULTURAL RESOURCE SURVEY

Architectural Inventory Form

- 1. Resource number: **5SM.1746**
- 2. Temporary resource number: **N/A**
- 3. County: **San Miguel**
- 4. City: **Telluride**
- 5. Historic Building Name: **Byers' Photography Studio**
- 6. Current Building Name: **Ranta Shop Building**
- 7. Building Address: **107 (119) N. Fir Street**
- 8. Owner Name and Address: **Vicki Eidsmo-Ranta
P. O. Box 475
Telluride, CO 81435**

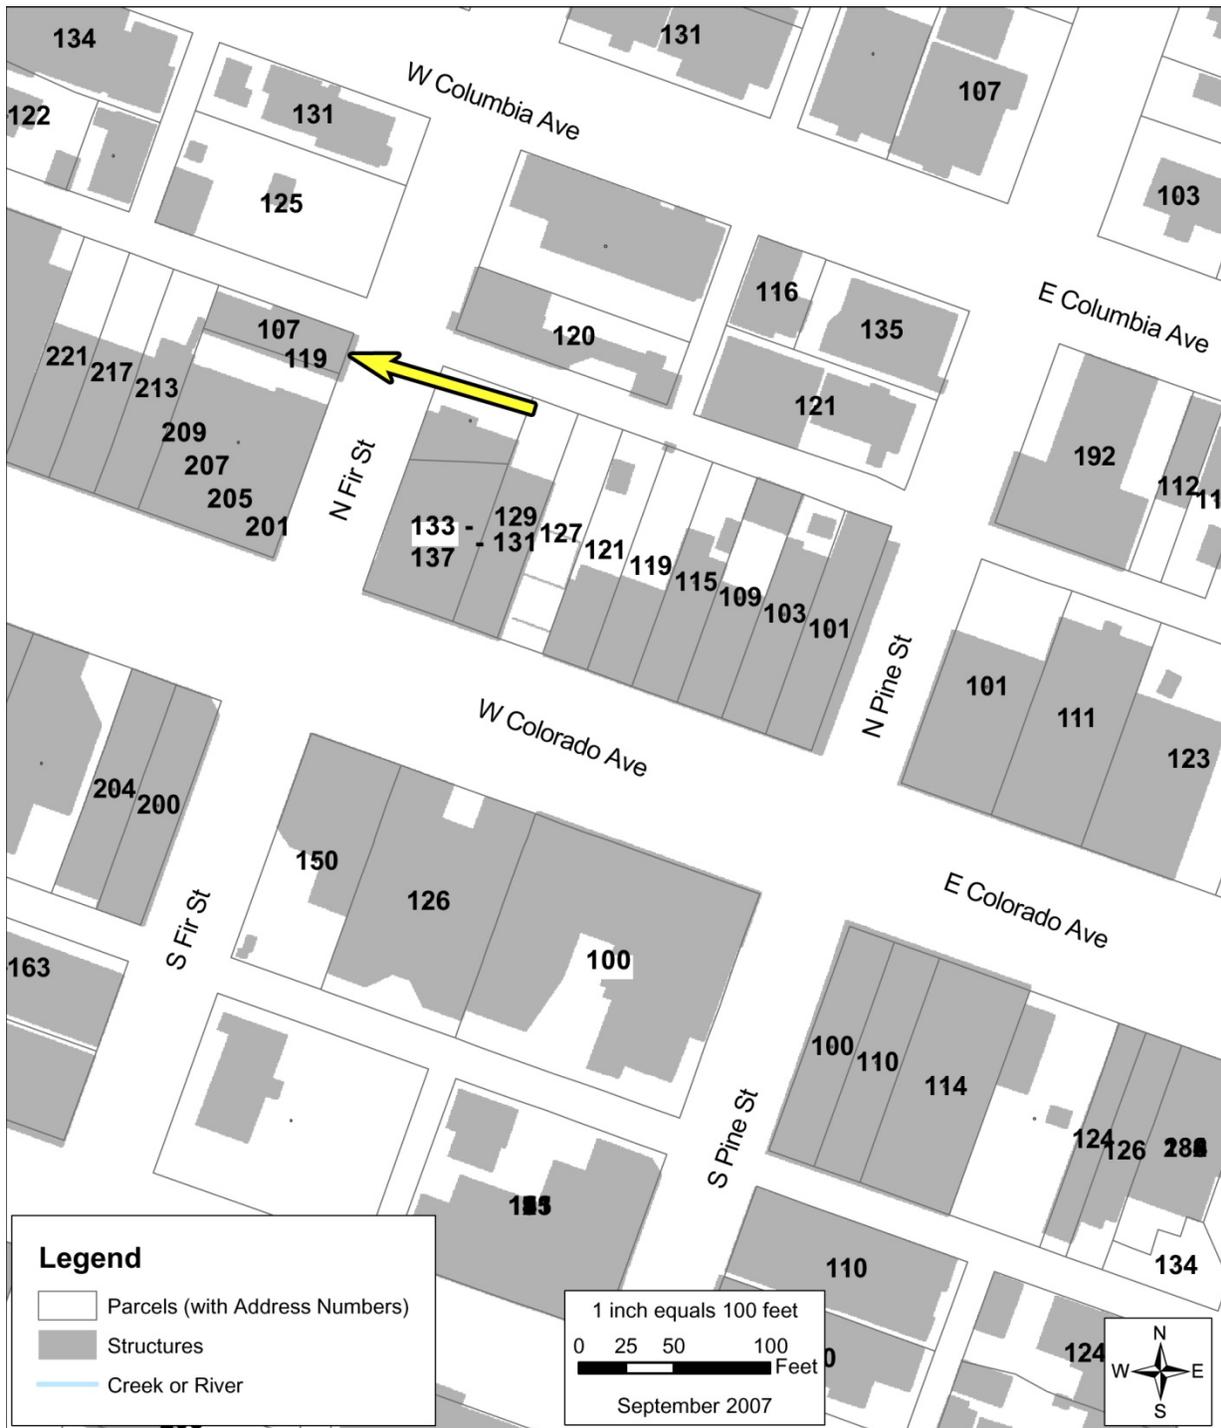
Sketch Map

This building is located on the west side of Fir Street in the block between Colorado and Columbia Avenues. The building fronts directly onto the sidewalk along Fir Street, with an alley to the north.
