COLORADO CULTURAL RESOURCE SURVEY

Architectural Inventory Form

- Determined Eligible – National Register
- Determined Not Eligible – National Register
- Determined Eligible – State Register
- Determine Not Eligible – State Register
- Need Data
- Contributes to eligible National Register District
- Noncontributing to eligible National Register District

- 1. Resource number: **5SM.1745**
- 2. Temporary resource number: **N/A**
- 3. County: **San Miguel**
- 4. City: **Telluride**
- 5. Historic Building Name: **Jarvis House**
- 6. Current Building Name: **The Cornerhouse Grille**
- 7. Building Address: **131 N. Fir Street**
- 8. Owner Name and Address: **Thomas E. Wirth  
P. O. Box 1826  
Telluride, CO 814351826**

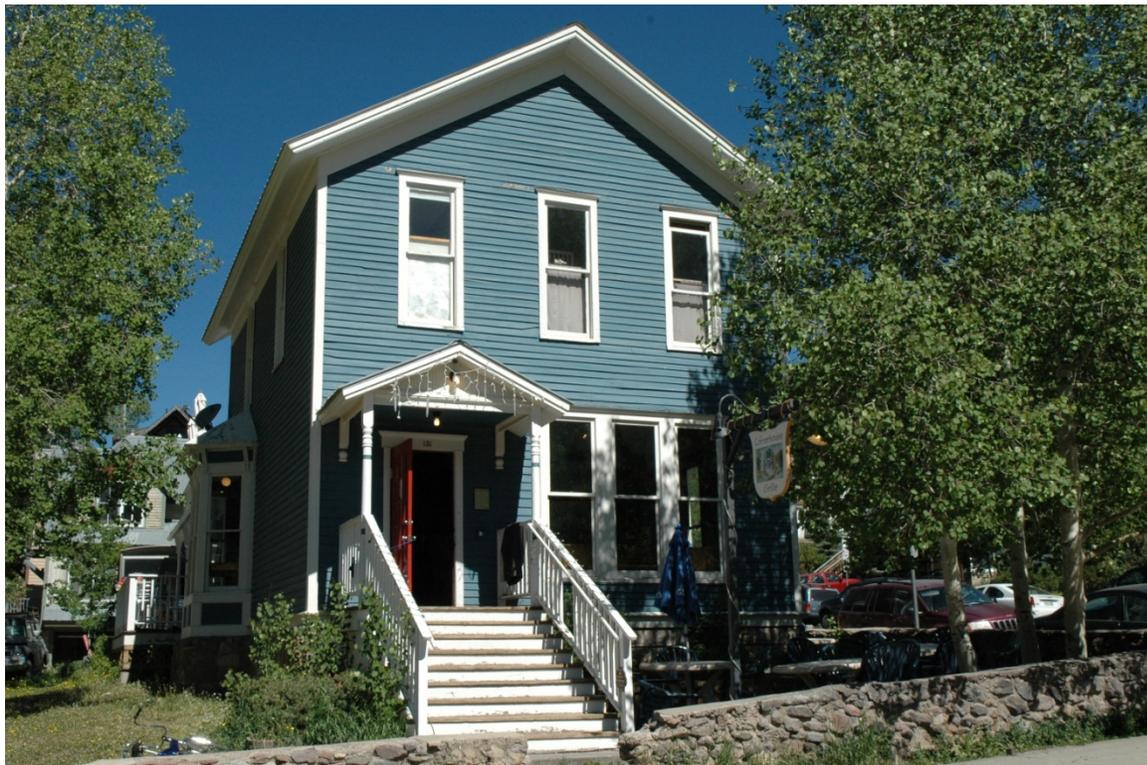
**This building is composed of an original 1½-story front gabled section, which measures 23½' N-S by 31½' E-W, and a two-story gabled addition to the west (rear) elevation. The addition measures 23' N-S by 31½' E-W, and is slightly offset of the original. The building is supported by a poured concrete and stone foundation, while its exterior walls are clad with painted blue horizontal wood siding with painted white 1" by 4" corner boards. The gabled roof is low-to-moderately pitched, with metal roofing material and painted cream white boxed eaves. The building's asymmetrical facade faces toward Fir Street on the east elevation. A painted red, 15-light, glass-in-wood-frame door enters the south end of the facade from a 10-step open wood porch. The porch features a wood plank floor, a painted white open wood railing, painted white turned columns, and a gabled roof. A canted hipped-roof bay, with four 1/1 double-hung sash windows, is on the original south elevation. Windows on the original section are otherwise 1/1 double-hung sash with painted white wood frames and surrounds. Two wood-paneled doors, each with one upper sash light, enter the north end of the addition's west elevation from a small hipped-roof porch which wraps around the addition's northwest corner. Another wood-paneled door enters the west end of the north elevation from the wraparound porch. On the addition's south elevation, two wood-paneled doors open onto an outdoor dining area, below a second story porch. A glass-in-wood-frame atrium door opens onto the second story porch.**

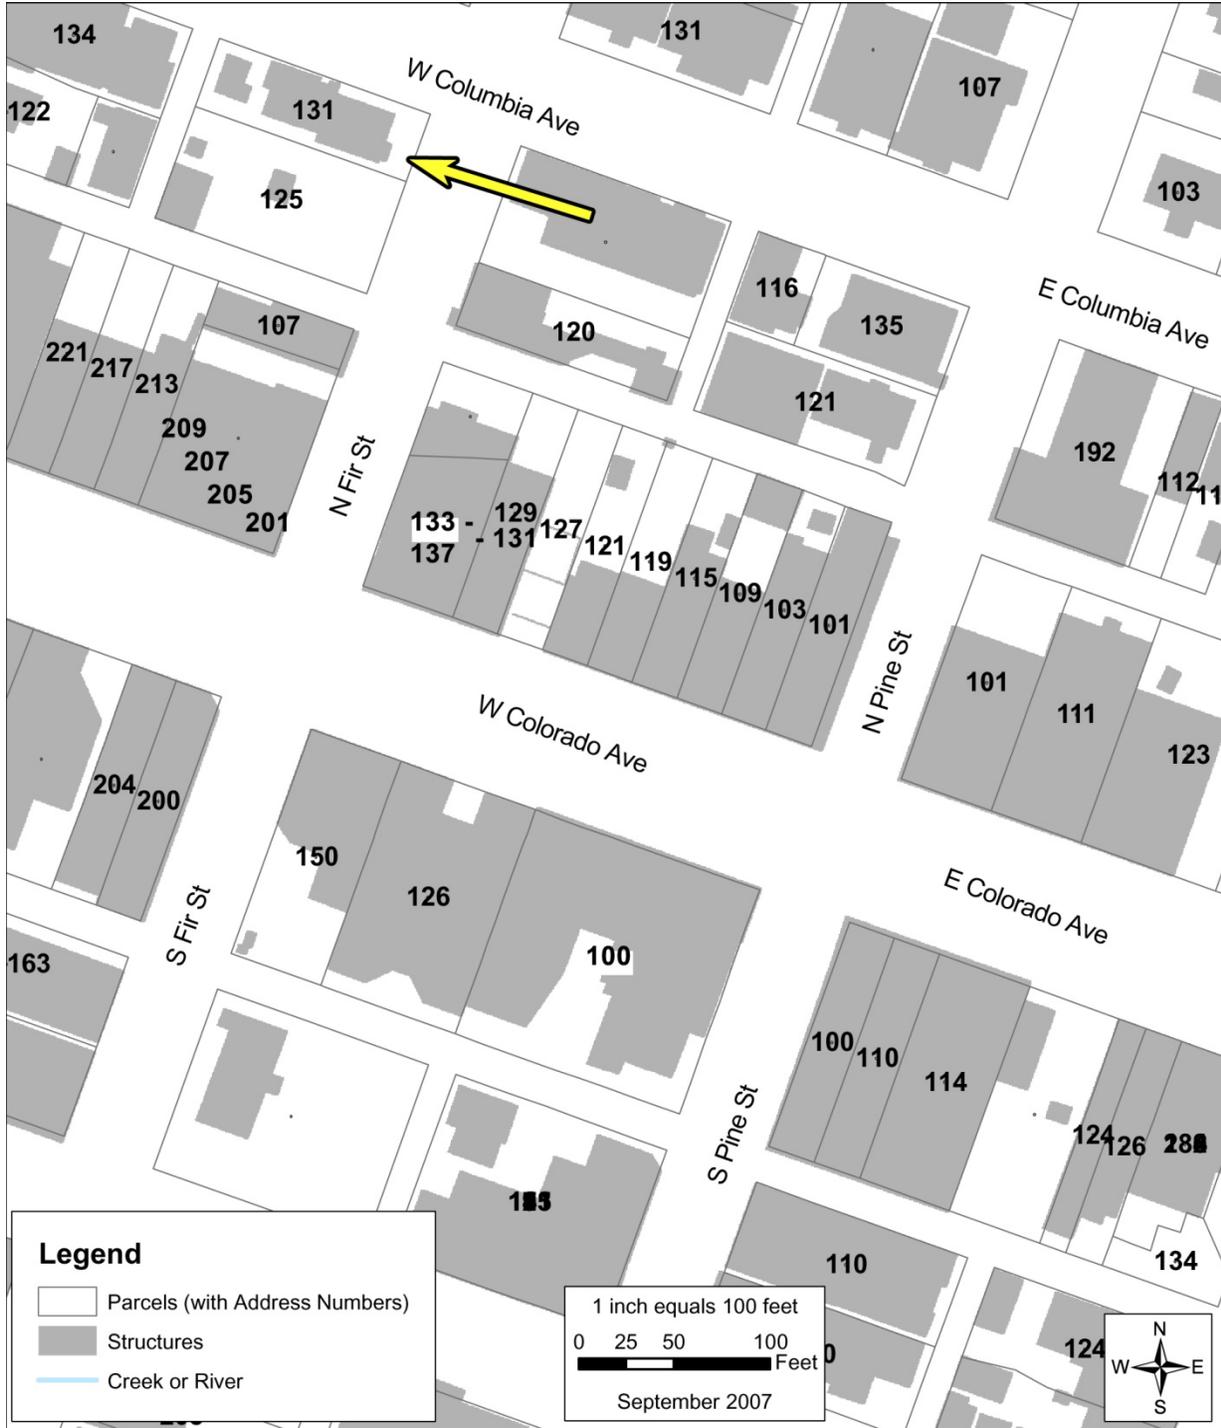
## Sketch Map

**This well-maintained property is located at the southwest corner of N. Fir Street and Columbia Avenue. A planted grass lawn, with mature landscaping, flanks the building. A stone retaining wall parallels the sidewalks along Fir and Columbia.**
