COLORADO CULTURAL RESOURCE SURVEY

Architectural Inventory Form

- 1. Resource number: **5SM.1754/THAS.96**
- 2. Temporary resource number: **N/A**
- 3. County: **San Miguel**
- 4. City: **Telluride**
- 5. Historic Building Name: **Unknown**
- 6. Current Building Name: **Patterson House**
- 7. Building Address: **236 N. Fir Street**
- 8. Owner Name and Address: **William O. Patterson, III and Joanne Crosby Case Patterson  
4218 Sunnyside Road  
Edina, MN 55424**

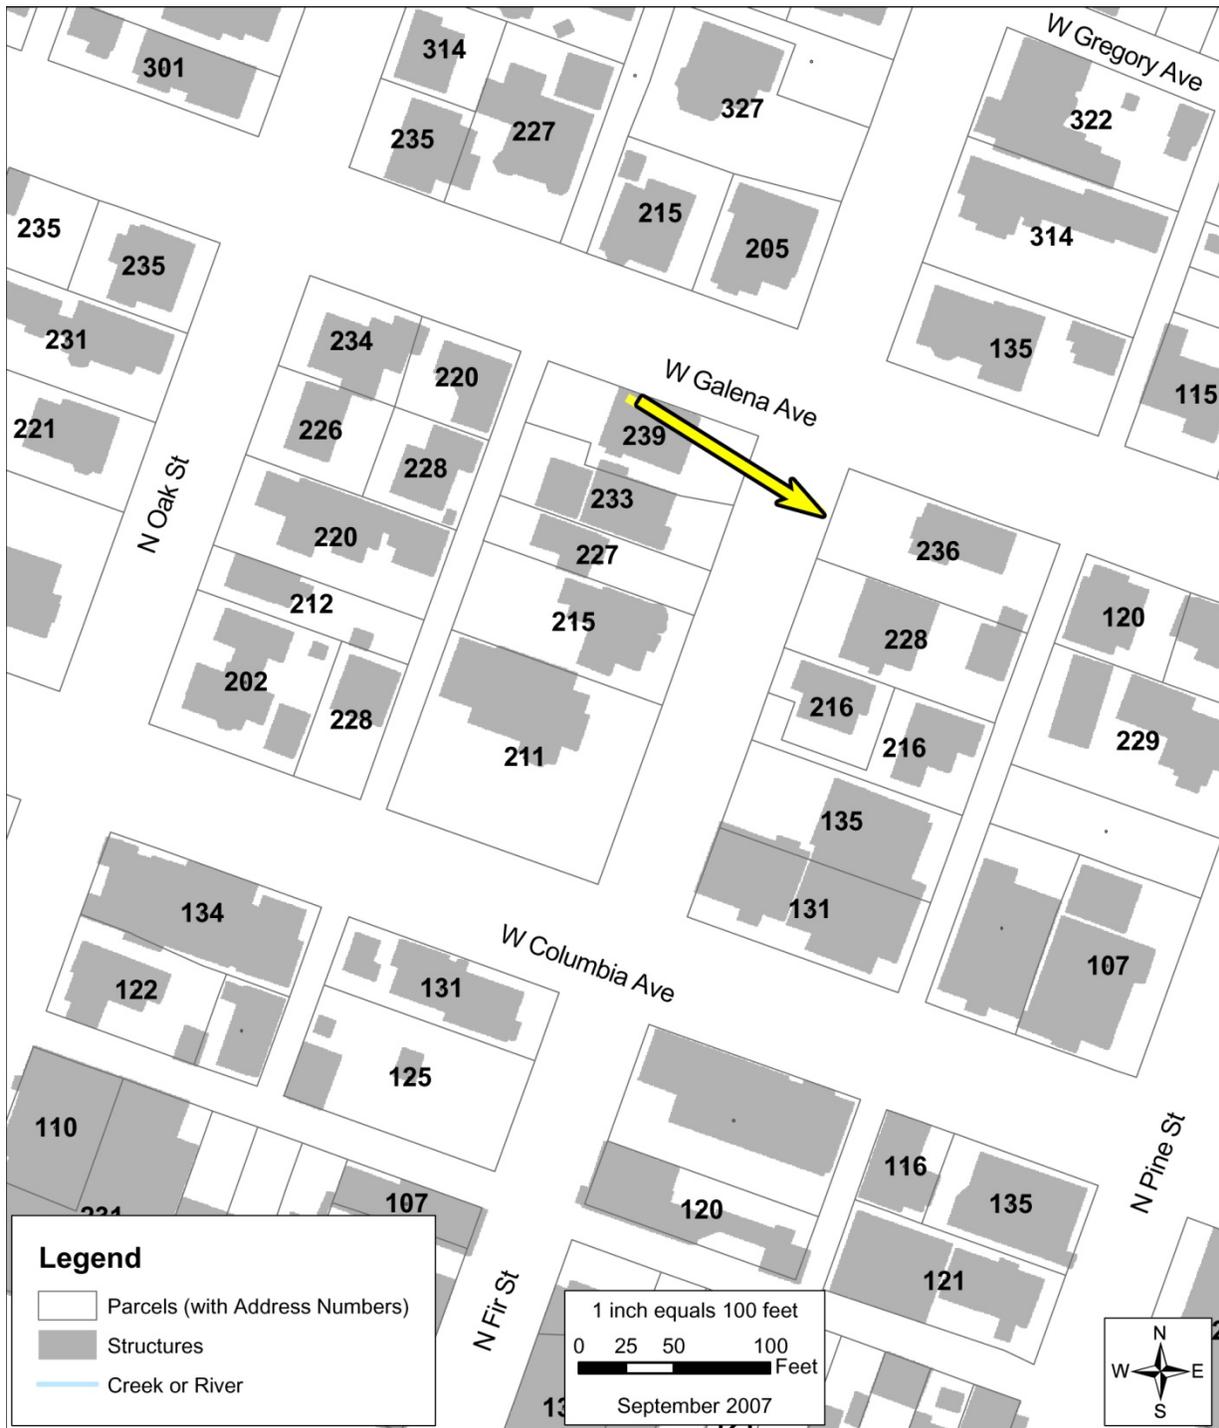
## Sketch Map

**This property is located at the southeast corner of N. Fir Street and Galena Avenue. The house is surrounded by a planted grass lawn, with a large cottonwood or willow tree near the front northwest corner of the house.**

**A shed (previously recorded as THAS #96 at the rear southeast corner of this property), is now joined with another shed (THAS #98) located at the rear of the property next door at 228 N. Fir Street (5SM.1846). The two former sheds now form a secondary residence.**
