COLORADO CULTURAL RESOURCE SURVEY

Architectural Inventory Form

I. IDENTIFICATION

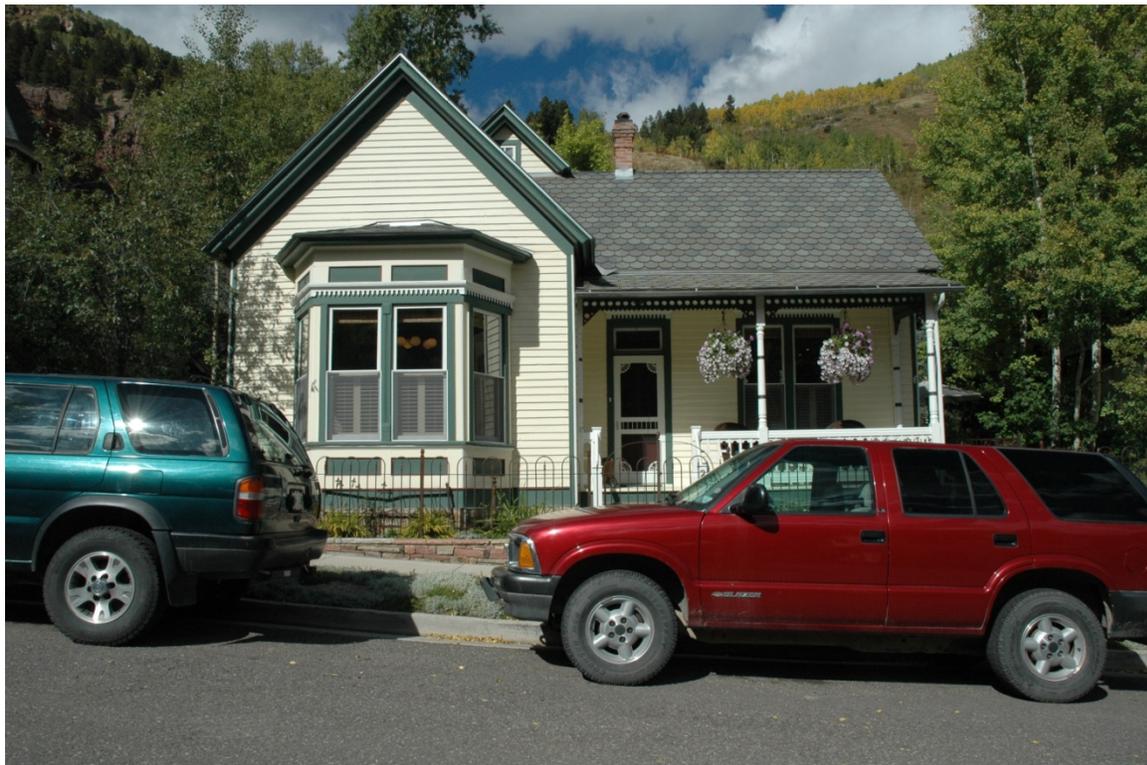
21. General architectural description:  
**This is a historic (circa 1892) cross gabled dwelling, remodeled in 2004 with a rear addition and a new foundation and basement level beneath the original house. The original house features a T-shaped cross-gabled plan. It is supported by a non-historic poured concrete foundation, faced with a sandstone veneer above grade. The exterior walls are clad with painted cream yellow horizontal wood siding with painted green 1" by 4" corner boards. A painted green 1x board, with a painted burgundy wood water table, separates the siding from the foundation. The cross-gabled roof is steeply-pitched, with black asphalt composition shingles and painted green boxed eaves. A red brick chimney with a corbelled cap is on the roof ridge. A gabled wall dormer with a 1/1 double-hung sash window, and a shed-roofed dormer with two 4-light windows, are on the west elevation. A shed-roofed dormer with three 1/1 double-hung sash windows is near the north end of the east-facing roof slope. The house's asymmetrical facade faces Galena Avenue on the south elevation. A painted red wood-paneled door, with two vertically-oriented upper sash lights and a transom light, enters the east half of the facade from an open front porch. The porch is approached by three wood steps, and features a wood plank floor, an open wood railing, painted white, green and red turned columns with brackets, a painted green pierced sawtooth frieze, and a low-pitched hipped roof. A painted cream yellow wood-paneled door enters an enclosed shed-roofed porch at the west end of the original north elevation. An original hipped-roof bay, with four 1/1 double-hung sash windows, penetrates the facade wall west of the front porch. Original windows elsewhere are primarily 1/1 double-hung sash with painted white wood frames and painted green wood surrounds.**

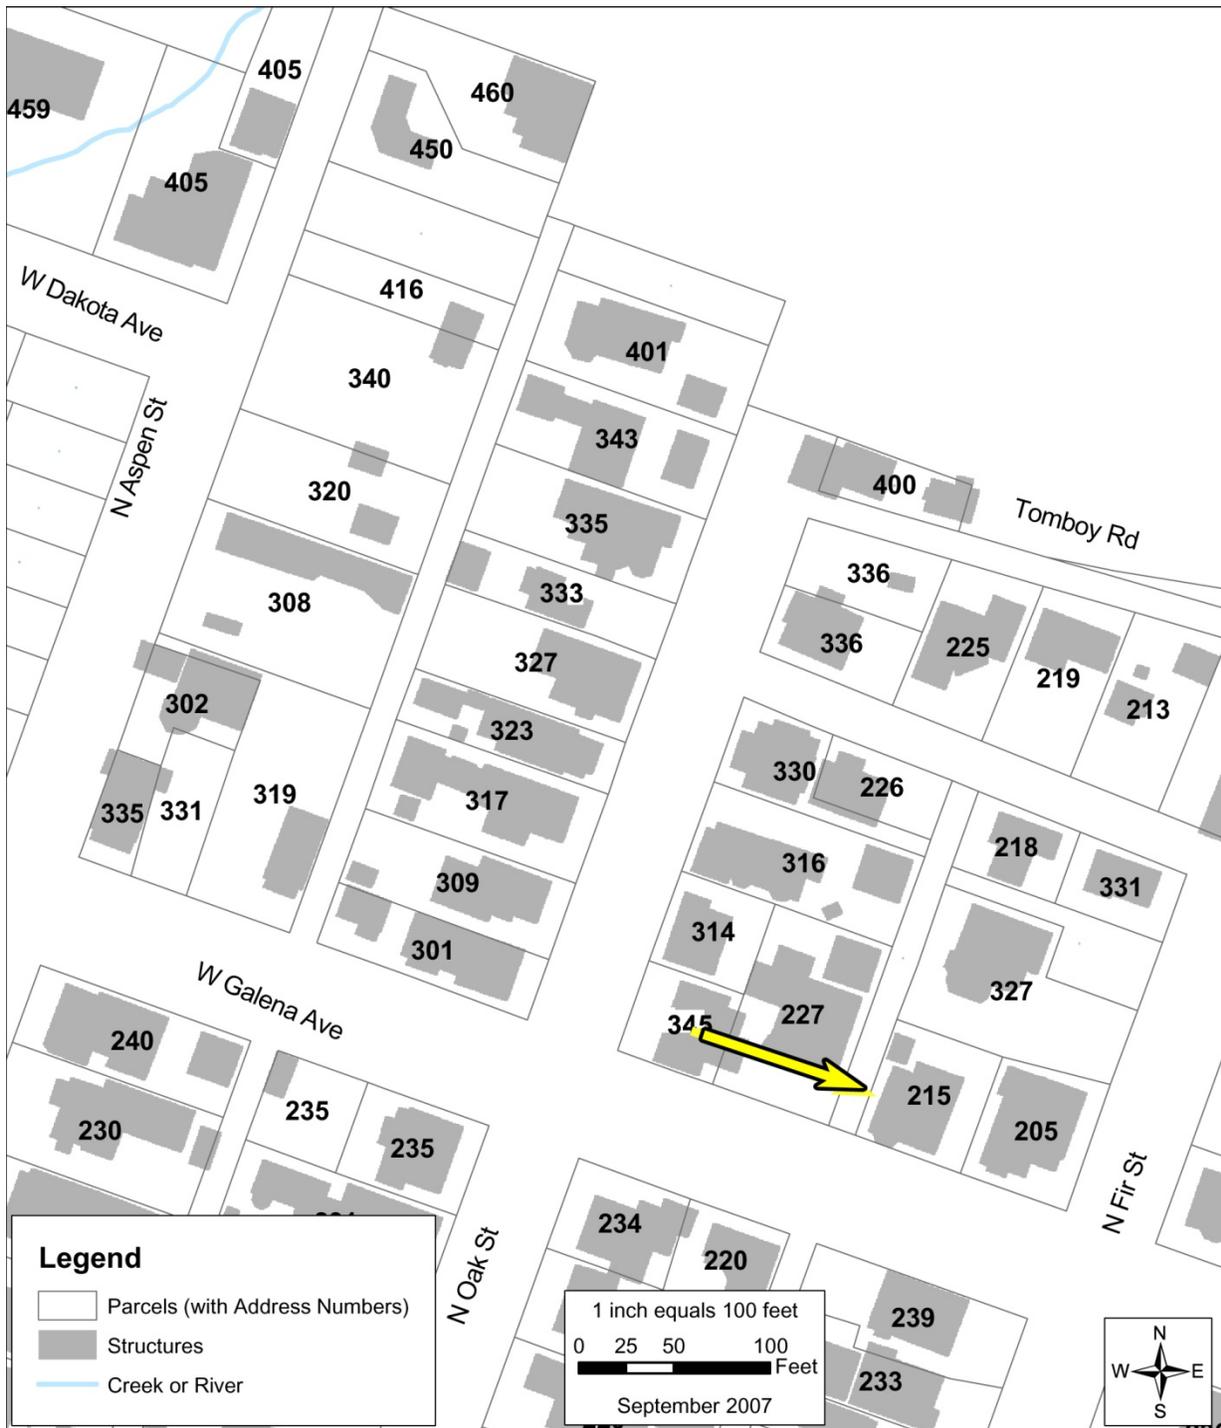
## Sketch Map

23. Landscape or special setting features:  
**This well-maintained property is located on the north side of Galena Avenue in the block west of Fir Street. A small front yard and narrow side yard are nicely landscaped with native plants and flowers and flagstone pavers. A sandstone retaining wall topped by a wrought iron fence parallels the front sidewalk. An alley is to the west.**

<b><u>Shed</u></b>
A shed, which measures approximately 10' by 8', is located a short distance northeast of the house. This structure's exterior walls are clad with stained brown board-and-batten, and it is covered by a shed roof. The entry door is on the west elevation. A 6-light window with a painted white wood frame penetrates the south elevation.
