COLORADO CULTURAL RESOURCE SURVEY

Architectural Inventory Form

- 1. Resource number: **5SM.1816**
- 2. Temporary resource number: **N/A**
- 3. County: **San Miguel**
- 4. City: **Telluride**
- 5. Historic Building Name: **Dennis House**
- 6. Current Building Name: **Rosenblum House**
- 7. Building Address: **231 E. Galena Avenue**
- 8. Owner Name and Address: **Rosenblum Mort in care of Bateau Almeri
3 Port Des Champs Elysees75008
Paris France, XX 0**

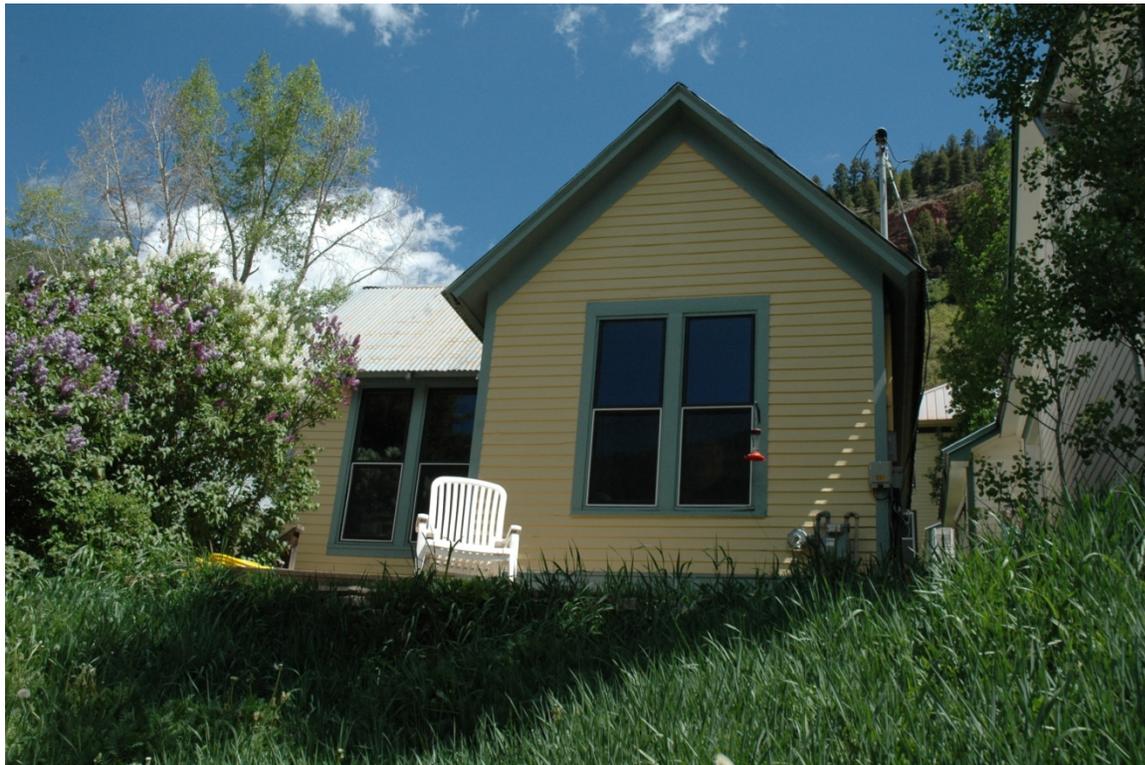
18. Roof configuration: **Gabled Roof / Cross Gabled Roof**
19. Primary external roof material: **Metal Roof**
20. Special features: **Porch, Chimney**
21. General architectural description:
This is a single-story, T-shaped, wood frame dwelling, with a shed-roofed extension at the west end of the north (rear) elevation. The front-gabled, east, wing of the T-shaped section measures 24' N-S by 12' E-W. The side-gabled, west, wing of the T-shaped section measures 12' N-S by 10' E-W. The shed-roofed extension measures 13½' N-S by 13½' E-W. The house rests on a poured concrete foundation, or possibly on a stone foundation covered with concrete pargeting. The exterior walls are clad with painted yellow horizontal wood siding with painted green 1" by 4" corner boards, while the roof is covered with metal. The eaves are boxed, with painted green wood trim, and a red brick chimney is located on the ridge. The asymmetrical facade faces Galena Avenue on the south elevation. A distinctive painted brown wood-paneled door, with Queen Anne lights and with a transom light, enters the west half of the facade from an uncovered wood plank porch which measures 6' by 8'. A wood deck extends from the porch. A painted green and yellow wood-paneled door enters the west elevation from a 5-step wood porch which is covered by a shed roof. The home's original windows are entirely paired 1/1 double-hung sash, with painted white or green wood frames and painted green wood surrounds.

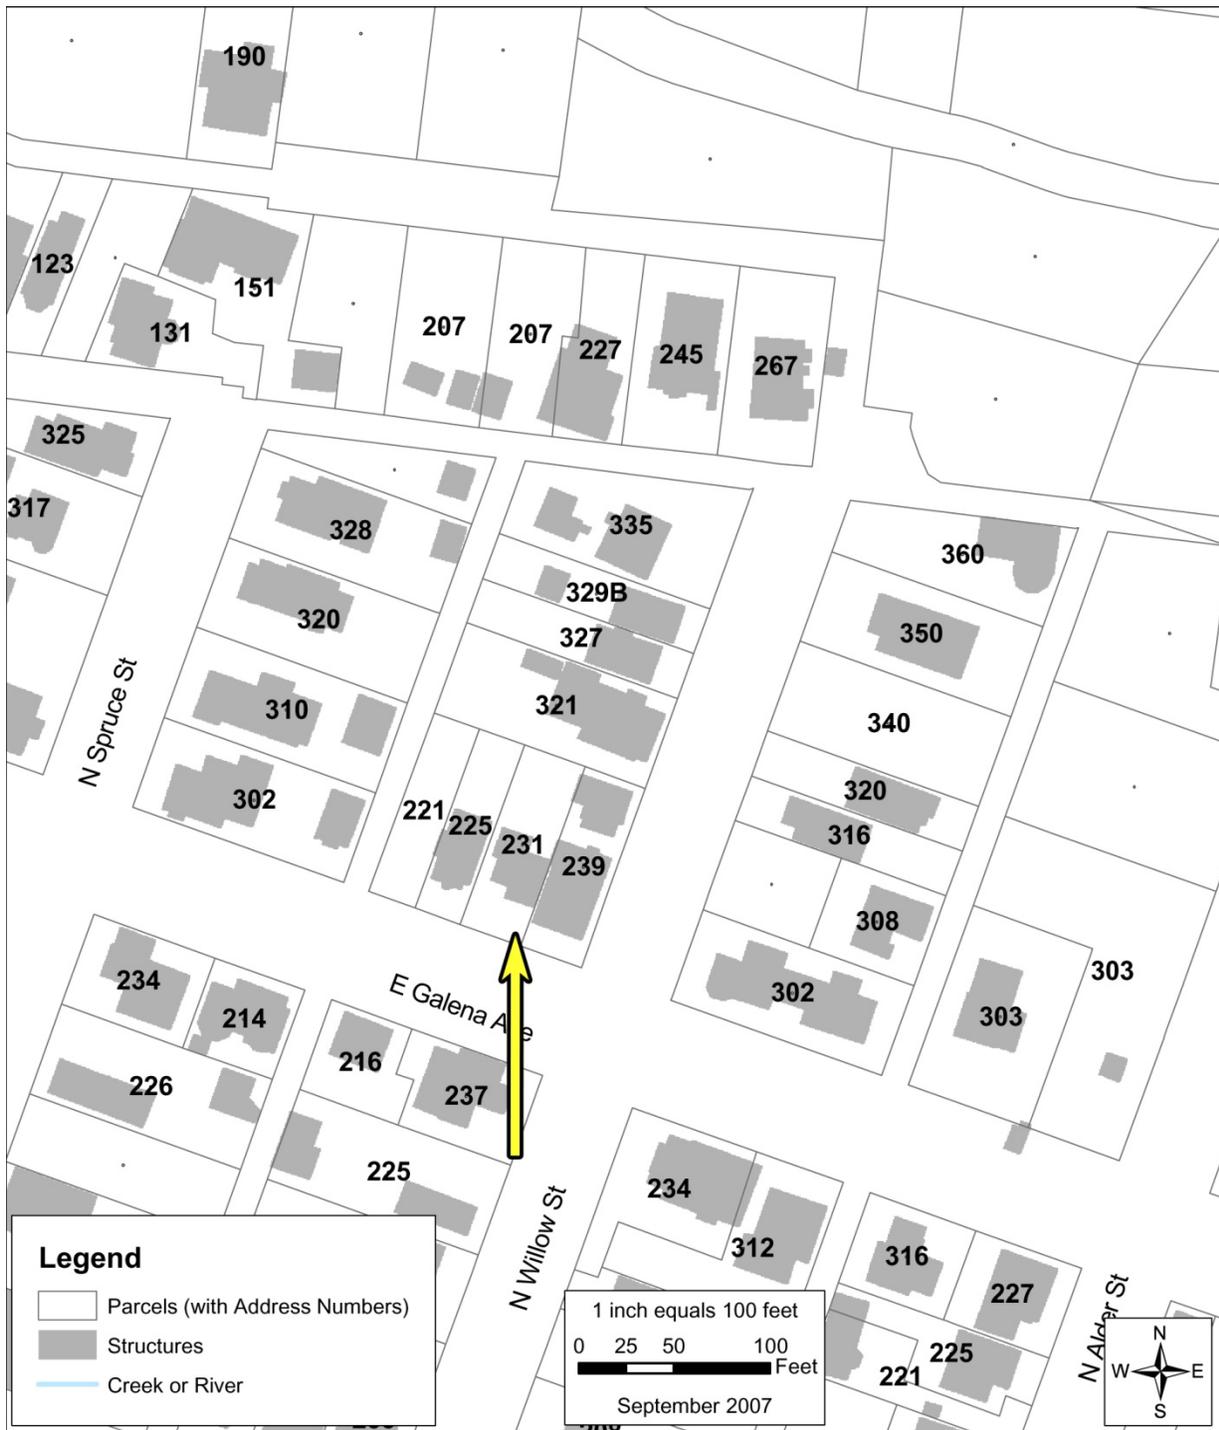
Sketch Map

This house is located on a hill slope above the north side of Galena Avenue in the block west of Willow Street. A long flight of wooden steps, with a wood railing and broken by two landings, ascends from Galena to the front porch. A small planted grass front yard is landscaped with native plants, flowers, and aspen trees. The slope below the yard, as well as behind the house to the north features natural vegetation.
