COLORADO CULTURAL RESOURCE SURVEY

Architectural Inventory Form

- 1. Resource number: **5SM1818**
- 2. Temporary resource number: **N/A**
- 3. County: **San Miguel**
- 4. City: **Telluride**
- 5. Historic Building Name: **Unknown**
- 6. Current Building Name: **Mayer House**
- 7. Building Address: **239½ E. Galena Avenue**
- 8. Owner Name and Address: **Virginia Mayer  
P. O. Box 36  
Telluride, CO 814350036**

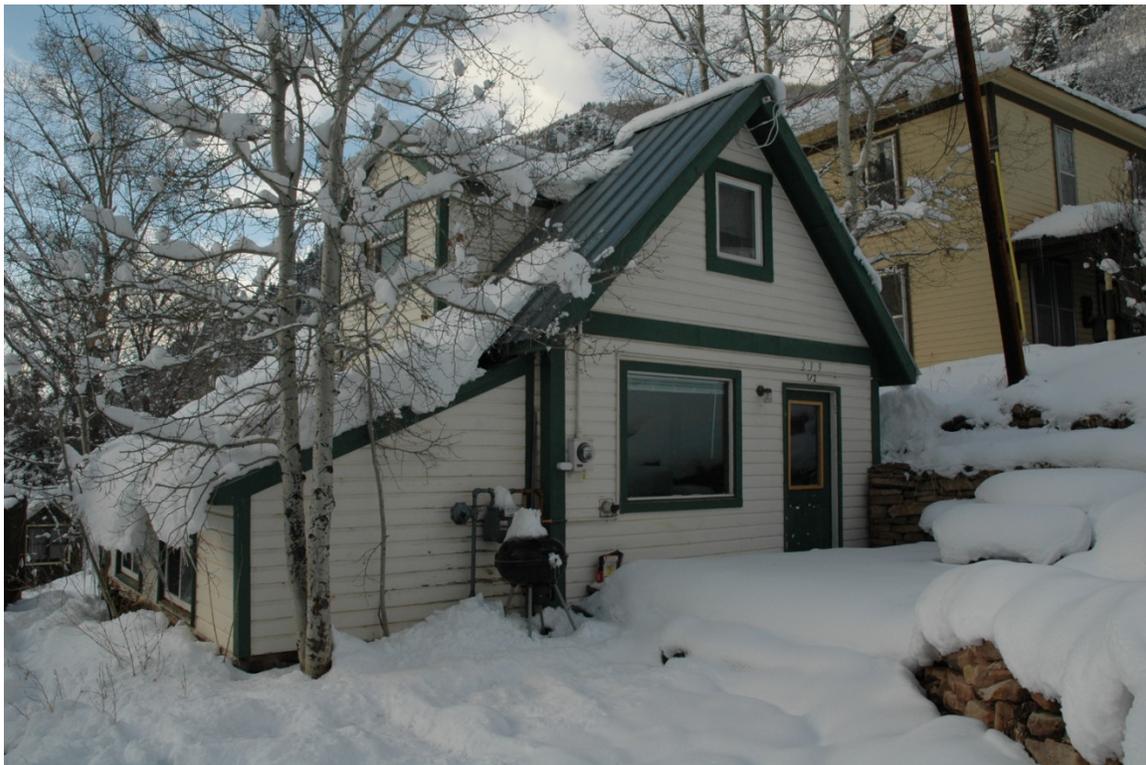
THLD RATING:

Supporting to District

**This is a small 1½-story front gabled dwelling with low shed-roofed extensions to its south (side) and west (rear) elevations. The house is supported by a low stone or concrete foundation, and its exterior walls are clad with painted cream yellow horizontal weatherboard siding with painted green 1" by 6" corner boards. The roof is covered with metal, and the eaves are boxed with painted green wood trim. A large, non-original, gabled dormer is on the south-facing roof slope. The house's asymmetrical facade faces Willow Street on the east elevation. A green metal-paneled door, with one upper sash light, enters the north end of the facade from a small uncovered porch. A large, non-original, single-light fixed-pane window penetrates the facade wall south of the front door. Another, smaller, single-light fixed-pane window penetrates the facade's upper gable end. Two 2-light windows penetrate the wall of the shed-roofed extension on the south elevation.**

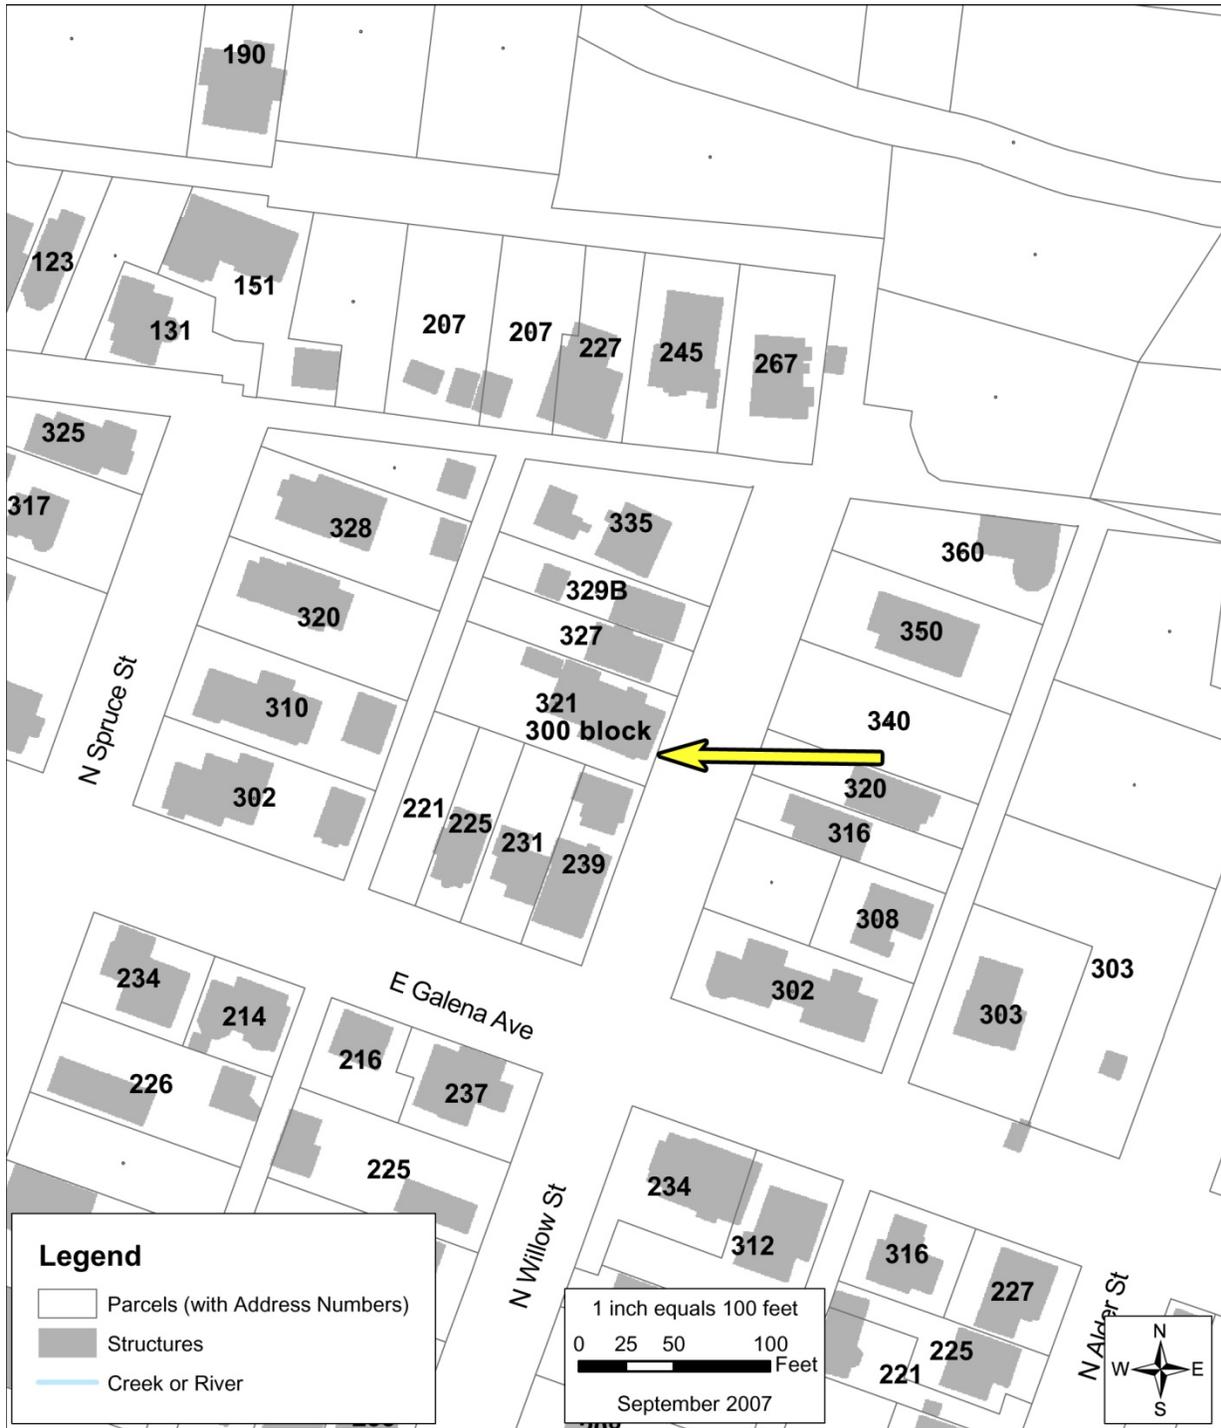
## Sketch Map

22. Architectural style: **No Defined Style**  
 Building type:
23. Landscape or special setting features:  
**This small house is located between the property at 239 E. Galena Avenue to the south, and the property at 321 N. Willow Street to the north, northwest of the intersection of Galena and Willow. Although this house has a Galena Avenue address, it faces Willow Street to the east.**
