COLORADO CULTURAL RESOURCE SURVEY

Architectural Inventory Form

- Determined Eligible – National Register
- Determined Not Eligible – National Register
- Determined Eligible – State Register
- Determine Not Eligible – State Register
- Need Data
- Contributes to eligible National Register District
- Noncontributing to eligible National Register District

- 1. Resource number: **5SM.1711**
- 2. Temporary resource number: **N/A**
- 3. County: **San Miguel**
- 4. City: **Telluride**
- 5. Historic Building Name: **Hooper House**
- 6. Current Building Name: **TGC Corp. House**
- 7. Building Address: **335 W. Galena Ave**
- 8. Owner Name and Address: **Millie Holdings LLC  
5445 DTC PKWY Penthouse 4  
Greenwood Village, CO 80111**

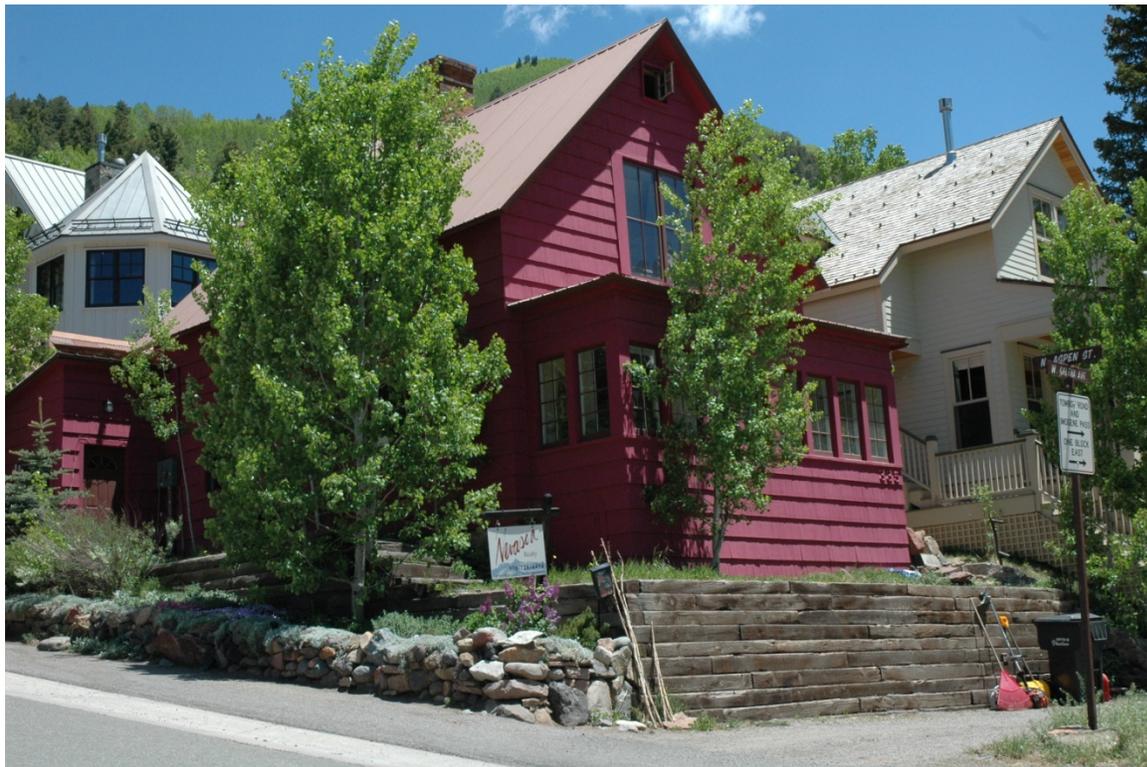
21. General architectural description:  
**This residence consists of three elements: a main 1½-story front gabled section which measures 29½' N-S by 22' E-W; an enclosed hipped-roof front porch which measures 6' N-S by 20' E-W, a single-story shed-roofed extension to the north (rear) elevation which measures 11' N-S by 28' E-W. The house is supported by a low stone foundation, while its exterior walls are clad with red square-cut asbestos shingle siding. The front gabled roof is steeply pitched, and is covered with brown metal roofing material. The eaves are boxed. There are two red brick chimneys: one on the north-facing roof slope, and the other, with a corbelled cap, centered on the ridge. Hipped-roof dormers, each with two 1/1 double-hung sash windows, are located on the east and west roof slopes. Ten concrete steps lead to a paneled door which enters the east end of the enclosed front porch on the south elevation. The enclosed porch is also penetrated by a band of ten 10-light windows. Two 2/2 double-hung sash windows, and a small 4-light window at the peak, penetrate the façade's upper gable end, overlooking the enclosed porch. Three single-light windows penetrate the west elevation.**

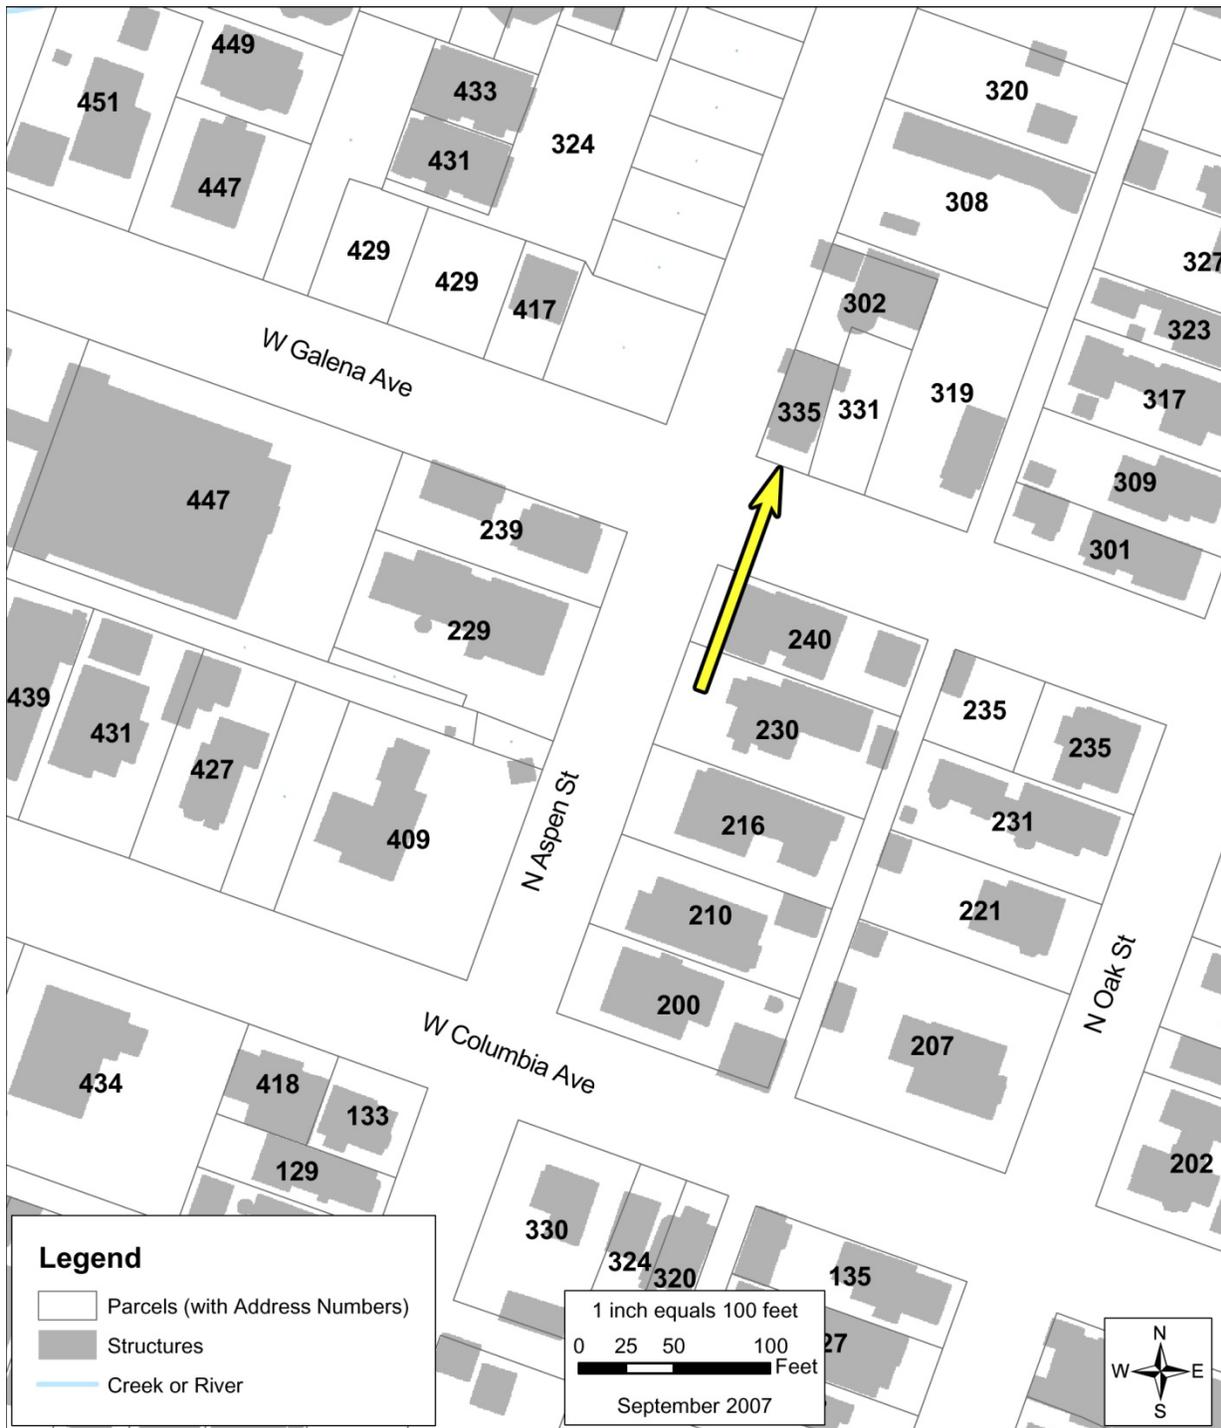
## Sketch Map

22. Architectural style: **No Defined Style**  
 Building type:
23. Landscape or special setting features:  
**This house is located at the northeast corner of Galena Avenue and Aspen Street. A stone retaining wall and railroad ties, used as landscaping elements, extend along the west and south property lines. The property is landscaped with native plants, flowers and grass.**
