COLORADO CULTURAL RESOURCE SURVEY

Architectural Inventory Form

- 1. Resource number: **5SM.1696**
- 2. Temporary resource number: **N/A**
- 3. County: **San Miguel**
- 4. City: **Telluride**
- 5. Historic Building Name: **Unknown**
- 6. Current Building Name: **Temple House**
- 7. Building Address: **235 (345) W. Galena Avenue**
- 8. Owner Name and Address: **John W. Temple
2300 NW Corporate Blvd, Ste. 238
Boca Raton, FL 33431**

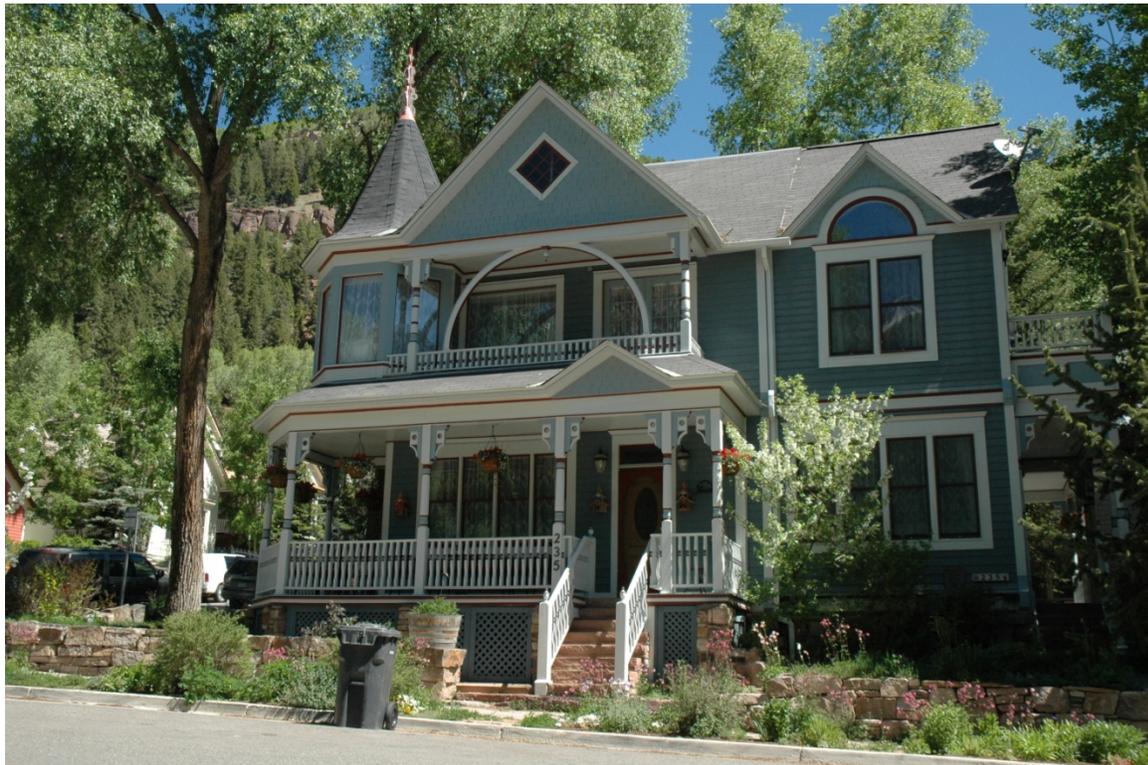
21. General architectural description:
Located at the northeast corner of Galena Avenue and Oak Street, this residence is supported by a concrete foundation faced with coursed sandstone blocks. Its exterior walls are clad with painted blue horizontal wood siding, with painted white 1" by 6" corner boards. Painted pale blue square-cut wood shingles appear in the upper gable ends. A painted white with burgundy accents 1' by 6" board forms a belt course between the first and second stories. The house is covered by a steeply-pitched truncated hipped roof, with multiple intersecting gables, and with a polygonal-roofed tower at the front southwest corner. The roof is finished with black asphalt composition shingles and painted white boxed eaves. An ornate wooden finial is affixed to the corner tower's roof peak. A stone fireplace chimney is located on the west elevation. Windows are predominantly 1/1 double-hung sash, in multiple groupings, with painted burgundy wood frames and painted white wood surrounds. However, fixed-paned diamond-shaped windows are located in the upper gable ends on the north and south elevations. A stained natural brown wood-paneled front door, with an oval-shaped upper sash light, and with a transom light, enters the façade (south elevation) from a wraparound porch. The porch is approached by eight sandstone steps, and features a tongue-in-groove wood floor, a painted white open wood railing, turned columns with brackets, and a low-pitched hipped roof with an intersecting gable. A set of paired painted pale blue glass-in-wood-frame doors open from the second story onto a second story façade porch. This upper porch is set within a rounded arch and features a tongue-in-groove wood floor, an open wood railing, and bracketed turned columns. A side entry porch, with a second story porch above, is located on the east elevation.
