COLORADO CULTURAL RESOURCE SURVEY

Architectural Inventory Form

I. IDENTIFICATION

- 1. Resource number: **5SM.1850**
- 2. Temporary resource number: **N/A**
- 3. County: **San Miguel**
- 4. City: **Telluride**
- 5. Historic Building Name: **Unknown**
- 6. Current Building Name: **Ed's Shed**
- 7. Building Address: **400 Block W. Galena Avenue**
- 8. Owner Name and Address: **Alta Investments, LLC  
7676 Highway 145  
Telluride, CO 81435**

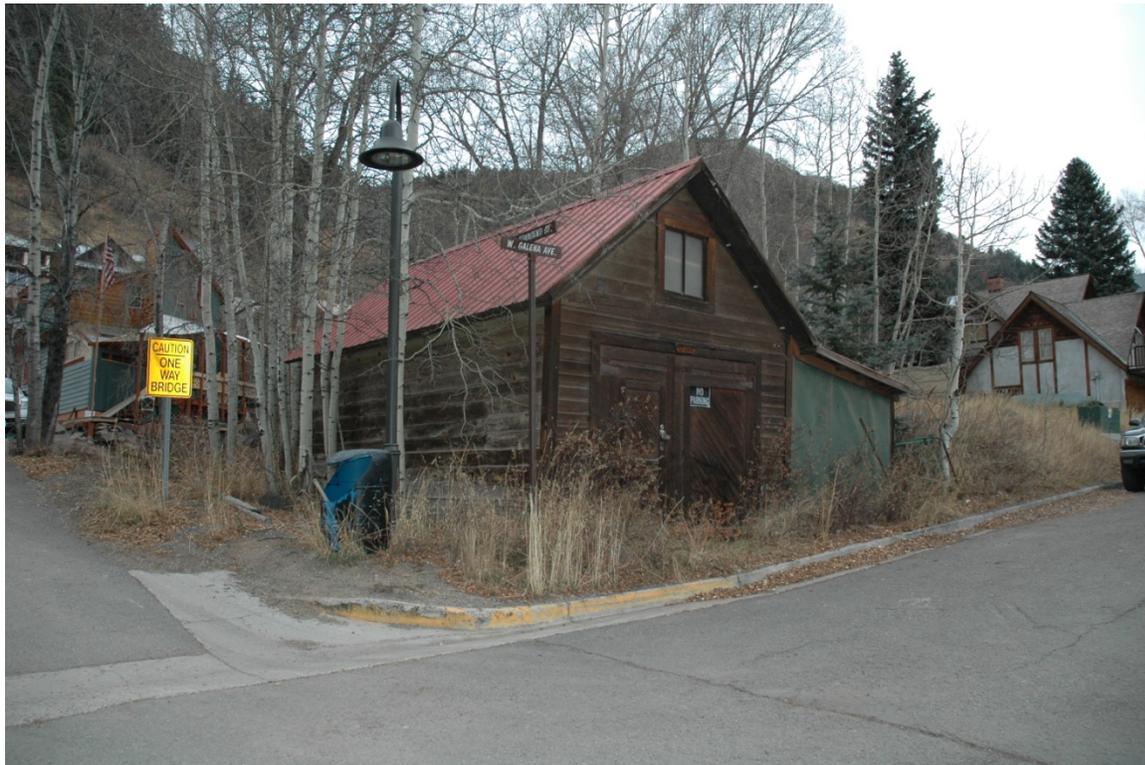
**This building is composed of a 1½-story front gabled section which measures approximately 20' N-S by 12' E-W, and a shed-roofed extension to the east elevation which measures approximately 20' N-S by 8' E-W. The building rests on wood timbers on grade, with an earthen floor. The exterior walls of the main 1½-story section are made of horizontal weatherboard siding and horizontal wood planks, with 1" by 4" corner boards, while the walls of the shed-roofed extension are clad with rolled green asphalt. The gabled roof is steeply-pitched, with red metal roofing material and stained brown boxed eaves. A set of paired diagonal plank garage doors, side-hinged with metal strap hinges, face Galena Avenue on the south elevation. A wooden sign band with the words "Ed's Shed" is fastened to the south elevation wall above the garage doors. A 2-light window penetrates the south elevation's upper gable end.**
