COLORADO CULTURAL RESOURCE SURVEY

Architectural Inventory Form

- 1. Resource number: **5SM.1848**
- 2. Temporary resource number: **N/A**
- 3. County: **San Miguel**
- 4. City: **Telluride**
- 5. Historic Building Name: **Unknown**
- 6. Current Building Name: **Galena's Edge Telluride LLC House**
- 7. Building Address: **447 W. Galena Avenue**
- 8. Owner Name and Address: **Galenas Edge Telluride, LLC
775 Baywood Drive, Suite 207
Petaluma, CA 94954**

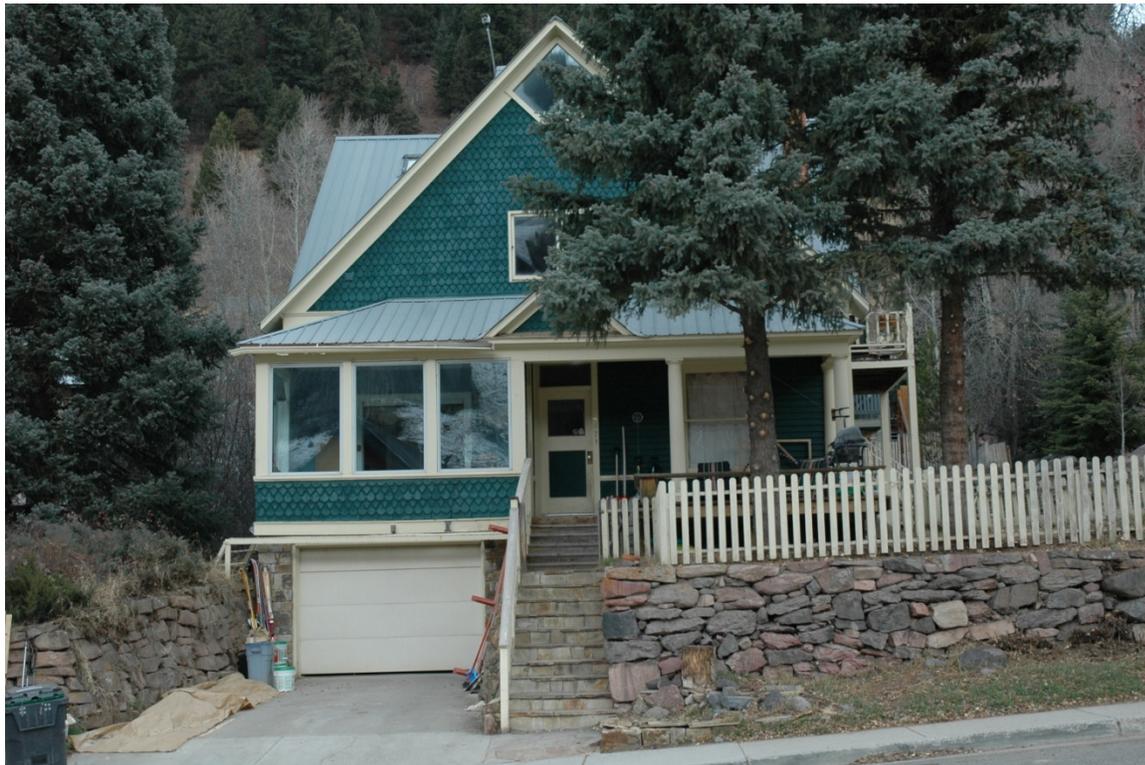
21. General architectural description:
This 1½-story house is supported by a low stone foundation which is covered with concrete pargeting. The foundation walls above grade are topped by a wide band of painted turquoise variegated wood shingles, with a painted cream white wood water table and a painted cream white 2x wood belt course. Above the belt course, the exterior walls are clad with painted turquoise horizontal wood siding with painted cream white 1" by 4" corner boards. The house is covered by a steeply-pitched cross gable roof, with metal roofing material and painted cream white boxed eaves. A red brick chimney is near the east end of the south-facing roof slope, while a small gabled dormer is near the north end of the east-facing roof slope. Non-historic skylights are at either end of the east-facing roof slope. Painted turquoise variegated wood shingles appear in the upper gable ends. A canted bay, with three 1/1 double-hung sash windows, is located on the east elevation. The home's original windows elsewhere are also primarily 1/1 double-hung sash with painted cream white wood frames and surrounds. Non-historic, pentagon-shaped, fixed-pane windows are located in the upper gable ends on the south and east elevations, while a diamond-shaped fixed-pane window is in the west elevation's upper gable end. A set of stone steps lead from near the front sidewalk along Galena Avenue to the front porch which is covered by a low-pitched hipped roof. The western 1/3 of the porch is enclosed with multiple fixed pane and casement windows. The eastern 2/3s of the porch is open, with painted cream white Tuscan columns and with an intersecting gable over the stairs. A small single-story, enclosed, gabled porch is on the north (rear) elevation. A basement-level garage is incorporated into the building's lower west end.

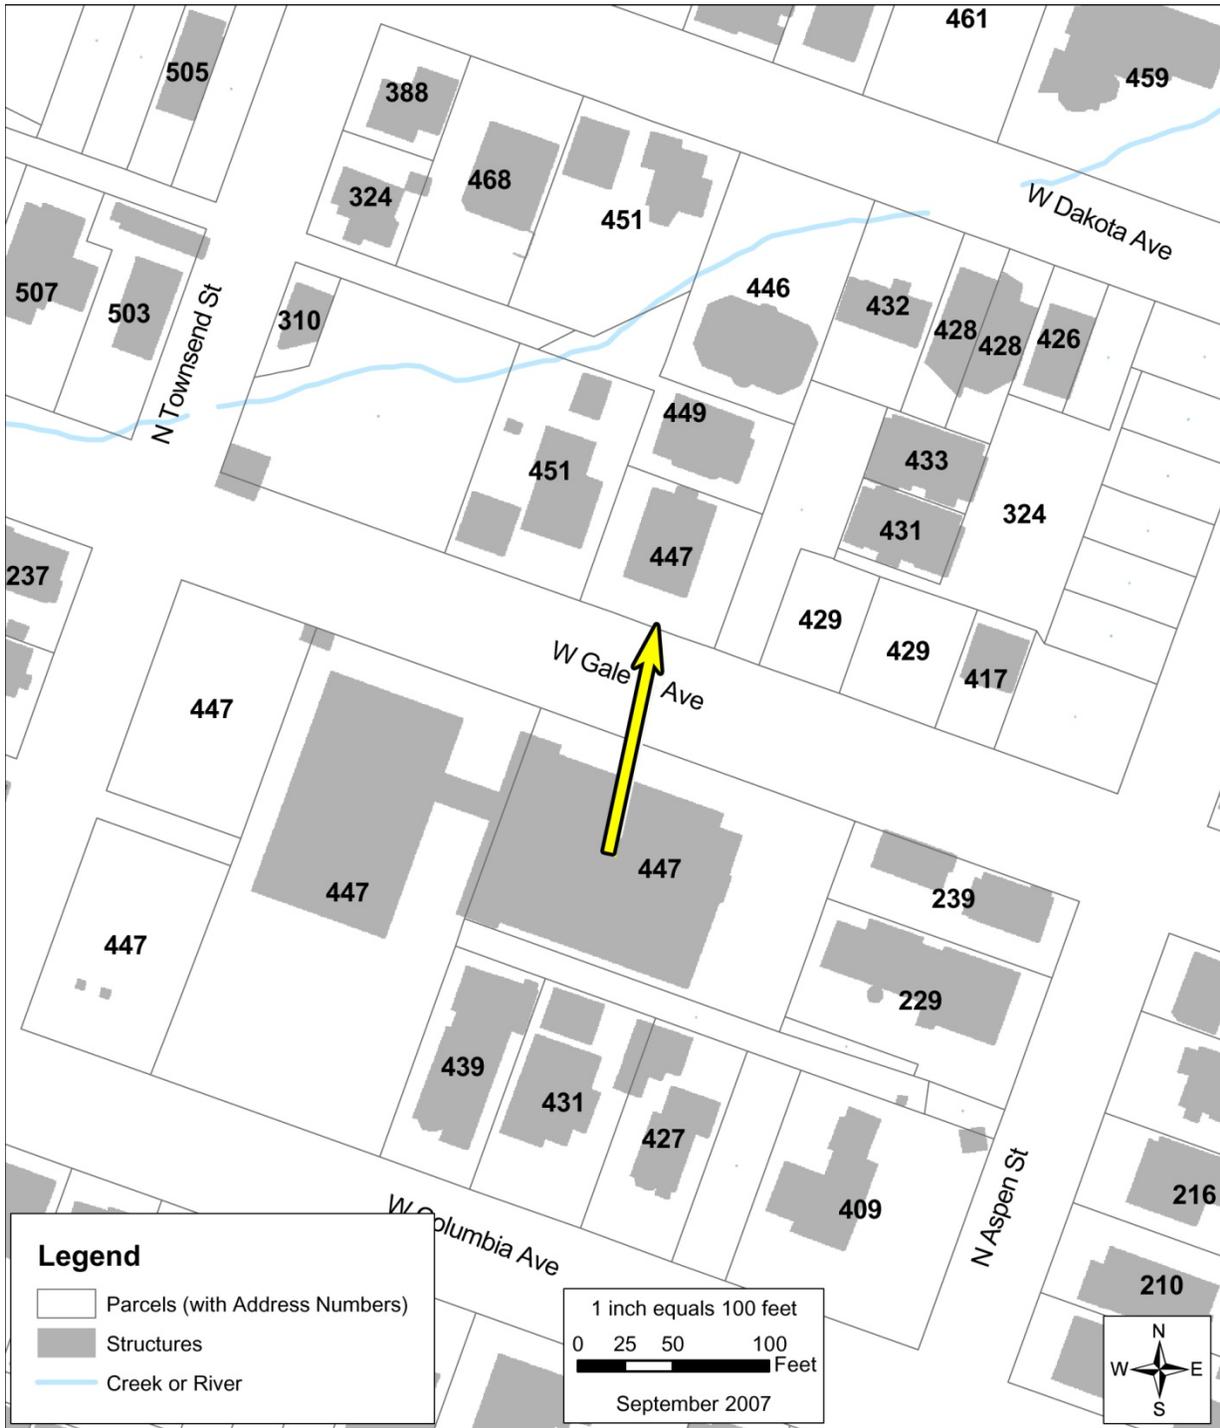
Sketch Map

This property is located on the north side of Galena Avenue in the middle of the block between Townsend and Aspen Streets. A painted white picket fence extends along a stone retaining wall which is inset from the curb along Galena Avenue. The Telluride Elementary School is located across Galena to the south.
