COLORADO CULTURAL RESOURCE SURVEY

Architectural Inventory Form

I. IDENTIFICATION

- 1. Resource number: **5SM.1738/THAS.1**
- 2. Temporary resource number: **N/A**
- 3. County: **San Miguel**
- 4. City: **Telluride**
- 5. Historic Building Name: **Waite House (possibly)**
- 6. Current Building Name: **Miller House**
- 7. Building Address: **503/507 W. Galena Avenue**
- 8. Owner Name and Address: **Christopher D. Miller Trust  
P. O. Box 2160  
Telluride, CO 81435**

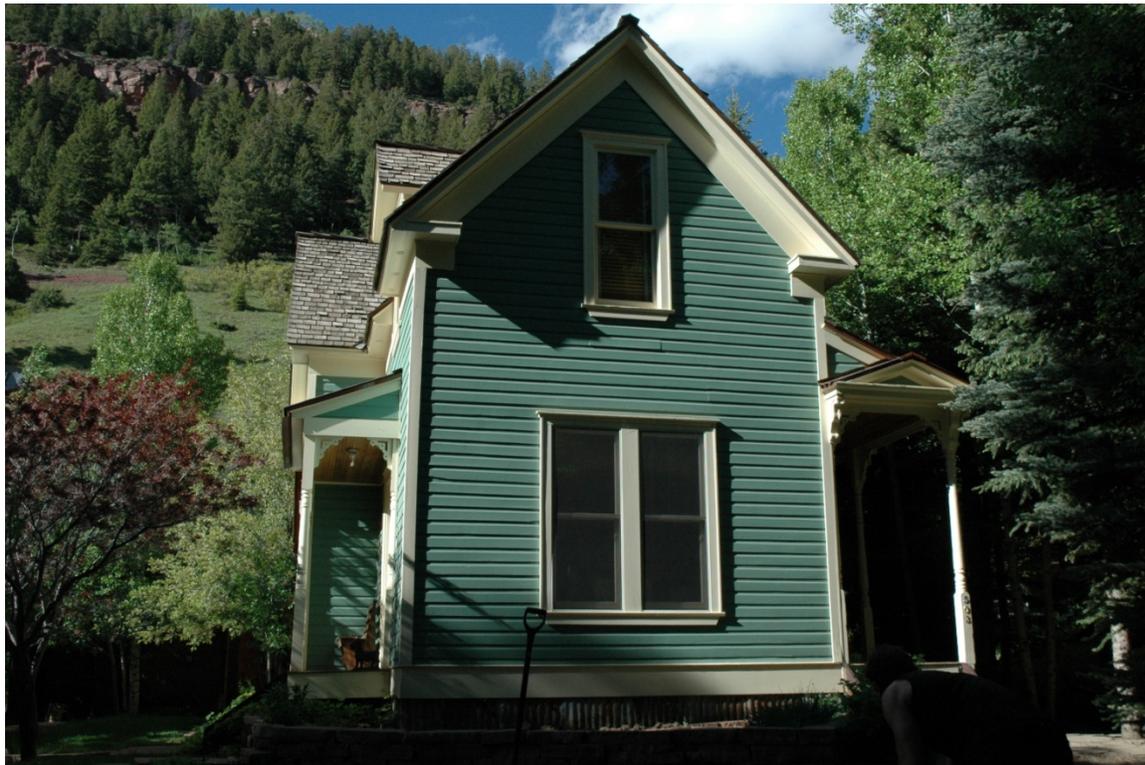
21. General architectural description:  
**This 1½-story L-shaped dwelling is supported by a stone or concrete foundation covered by corrugated metal skirting. The exterior walls are clad with painted green horizontal weatherboard siding with painted cream white 1" by 4" corner boards. The cross-gabled roof is steeply-pitched, with wood shingles and painted cream white boxed eaves. Gabled wall dormers, with 1/1 double hung sash windows, are on the west and east elevations. A red brick chimney with a corbelled cap is on the ridge. Original windows appear to be entirely single and paired 1/1 double-hung sash with painted cream white wood frames and surrounds. The entry into 503 W. Galena Avenue is a painted cream white wood-paneled door, with one upper sash light, which enters the south end of the east elevation from an open porch. This porch has a wood plank floor, two painted cream white turned columns, pierced brackets, and a shed roof with an intersecting gable. The entry into 507 W. Galena Avenue is a painted cream white wood-paneled door, with one upper sash light, which enters the south end of the west elevation from an open porch. This porch is approached by three metal steps and features a wood plank floor, painted cream white turned columns, pierced brackets, and a shed roof. A shed-roofed addition to the north (rear) elevation measures approximately 18' N-S by 20' E-W. The addition's foundation is covered with corrugated metal skirting, while its exterior walls are made of stained brown board and batten. The roof is covered with corrugated metal, and there is a large gabled dormer on the north elevation with three single-light awning windows. Two other single-light awning windows penetrate the addition's north elevation. A painted cream white wood-paneled door, with one upper sash light, enters the addition's east elevation from a 4-step wood stoop.**
